**6 ST GEORGE'S TERRACE
NW1 8XH**

**Design and Access
Heritage Statement**

07/12/2020

Document produced by:
Coste + Beno Ltd
Architecture | Construction
20 Leaf Close, Northwood
HA6 2YY

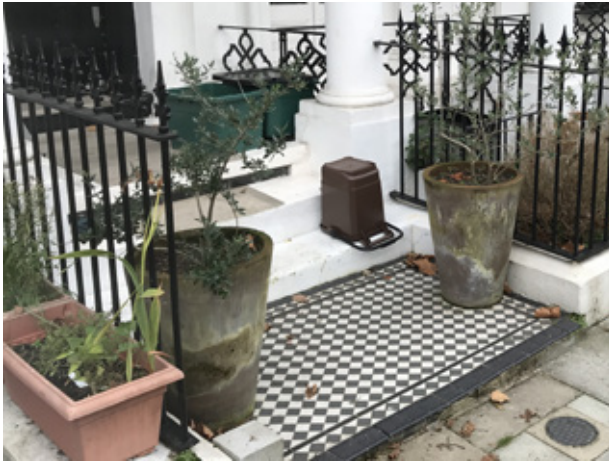
The property is accessible to the ground floor via four steps, the first of which has a number of dislocated ceramic mosaic tiles which we are proposing to be lifted up and carefully cleaned of the old adhesive and relaid back into place. All stairs are to be cleaned and repainted / resealed.

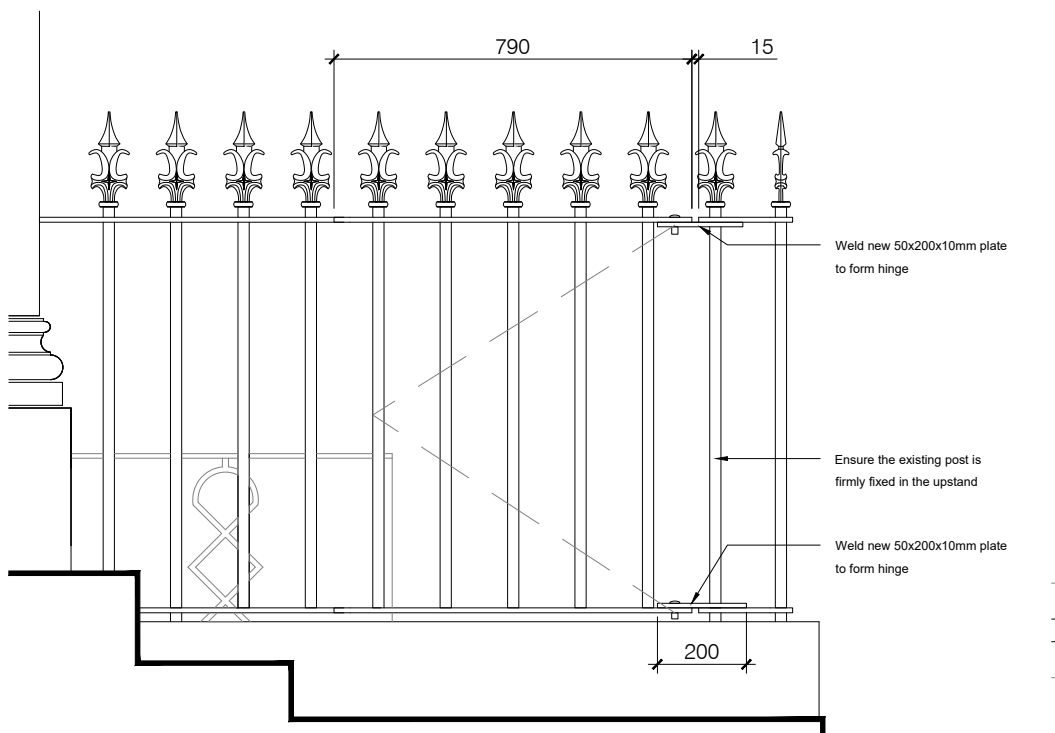
A new gate to is to be formed in the existing metal railing to give access to front planter next to the ceramic mosaic tiles. The existing railing will be cut and modified by welding two new 200x10mm plates to the existing 50mm wide metal plate that links the vertical bars to create two hinges. All to be primed against

corrosion and finished with two coats of gloss black metal paint. The new proposed gate will be identical in appearance to the existing railing and therefore will have minimal visual impact while providing practical and safe access to maintain the plants.

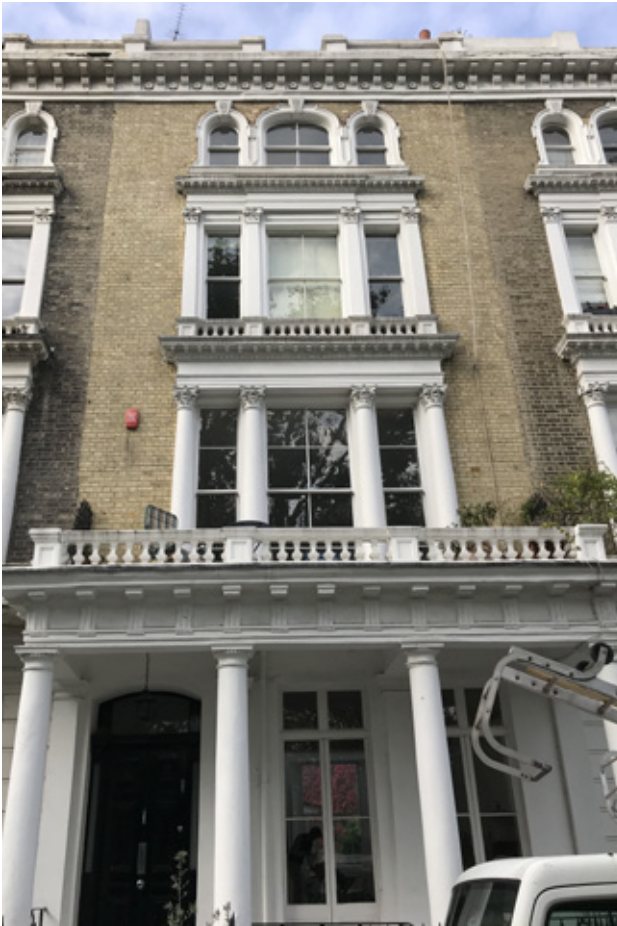
Our proposal is to fully repair and redecorate all the stuccoed Doric porch, capitals, entablature, cornice details, balustrades etc. Repair all blown or cracked render. Minimal original material to be removed during repair works. The use of cutting discs is preferred where possible to minimise vibrations. Rub down, clean and repair all timber work using Repair Care products as per manufacturer's specifications according to each type and size of decay and damage to the original wooden frames. Redecorate with high quality exterior wood paint in gloss white finish.

A maximum of 5 bricks to be replaced where necessary with matching reclaimed bricks, re-pointing mortar to match type and colour of existing. All metal work to be rubbed down, repaired if necessary and redecorated with gloss black metal paint.

The two 20 years old timber french doors on the mansard roof level to be replaced due to extensive timber decay. Size and design of the new doors to match exactly the existing doors.

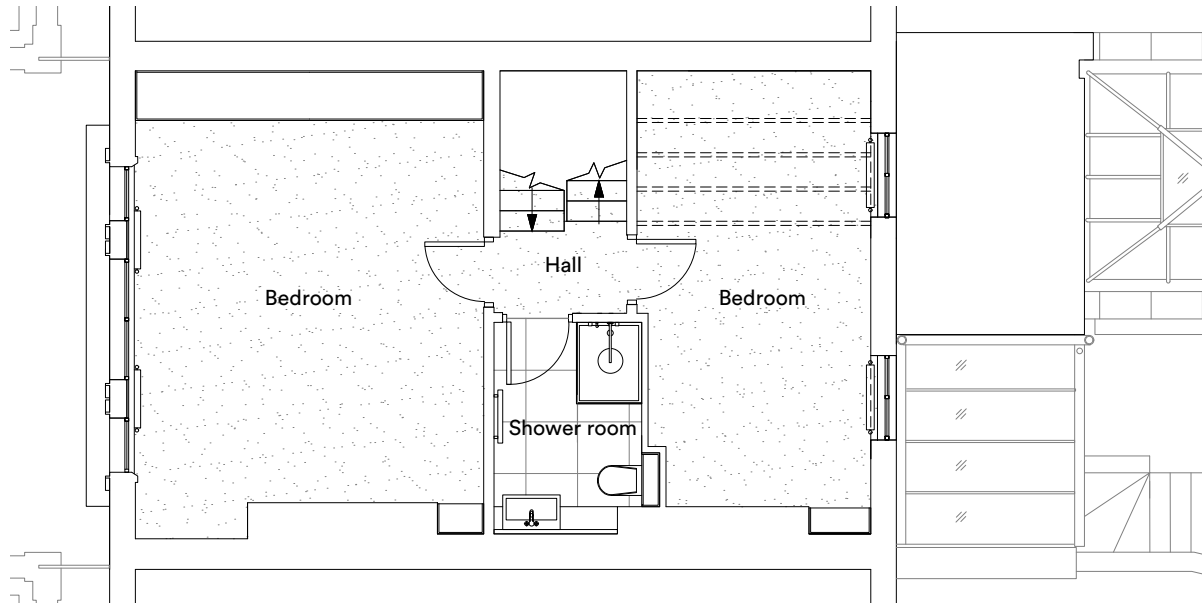
Ref drawing 20.204

The third floor rear bedroom rear bedroom needs to receive significant repairs works to the two sash windows, lintels and parapet above due to very poor brickwork and pointing condition which led to water infiltration and major timber decay. The two windows on this rear elevation is proposed to be completely replaced due to extensive damage with new single glazed timber sash windows to exact design and size as existing windows. The decayed timber lintels to be replaced by pre-stressed concrete lintels and brick parapet to be rebuild using reclaimed bricks to match existing with pointing colour and stroke to match existing.

Part of the ceiling joists and ceiling finishes in this rear bedroom have been damaged by the fourth floor shower leak. Upon investigations it was noted that the ceilings and walls have both been covered with modern plasterboard. We propose to carefully strip out the effected areas of the non-original ceiling, replace the timber joists which are structurally affected, close off with new plasterboard ceiling and redecorate throughout.

The bathroom is to be converted into a shower room and receive refreshed finishes throughout.

The front bedroom non-original poor quality wardrobe is to be rebuilt and all floor to receive new carpet, with all walls, ceilings and woodwork carefully redecorated.

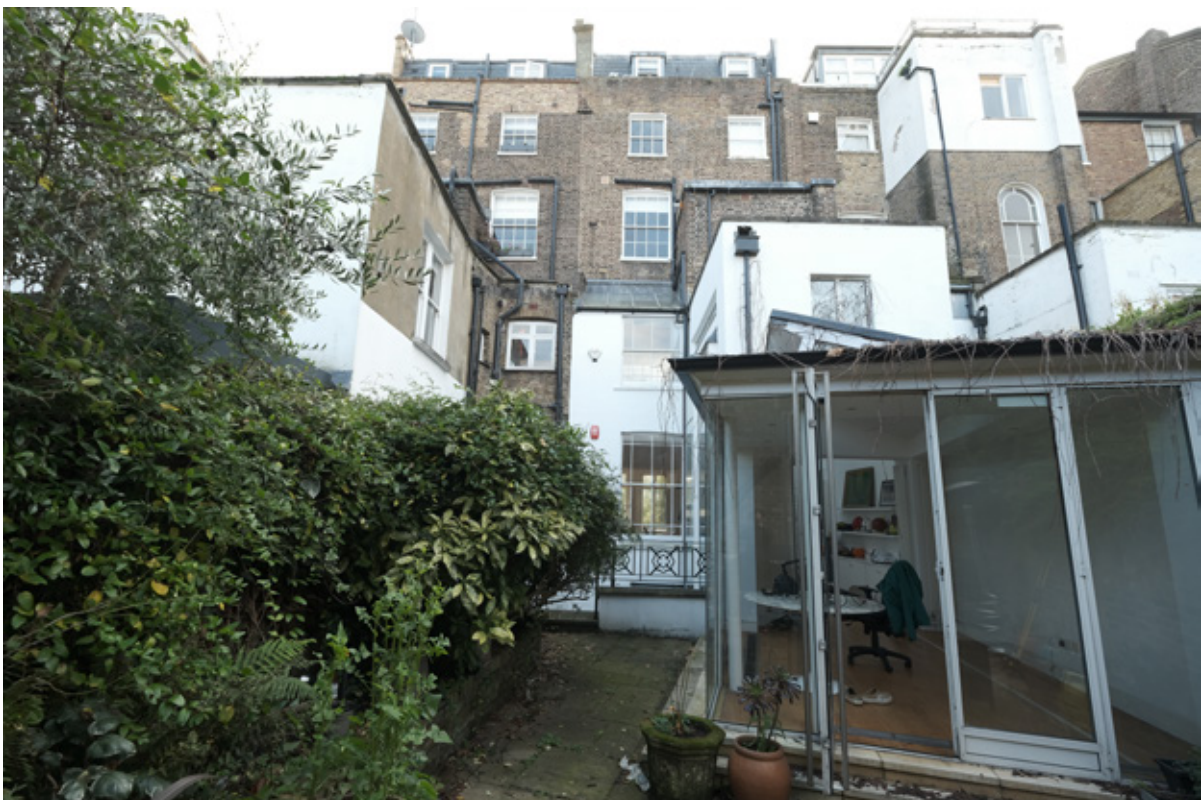
Photo from the rear garden

The works proposed to the rear facade relate to the changing of the 20 years old conservatory glazing and the rebuilding of the third floor rear parapet brickwork as mentioned elsewhere in this document. All the redundant cabling and services equipment to be removed from the facade, all lead work to be carefully cleaned and resealed with patination oil.

Repair all blown or cracked render. Minimal original material to be removed during repair works. The use of cutting discs is preferred where possible to minimise vibrations. Rub down, clean and repair all timber work using Repair Care products as per manufacturer's specifications according to each type and size of decay and damage to the original wooden frames. Redecorate with high quality exterior wood paint in gloss white finish.

All damaged bricks to be replaced where necessary with matching reclaimed bricks, re-pointing mortar to match stroke and color of existing. All metal work to be rubbed down, repaired if necessary and redecorated with gloss black metal paint.
