**Project Name:** PATRICK PARSONS

Inspection Standard: MSCC4 Sewers & Drainage GB (SRM4 Scoring)

mopoution birodiom	Downstream	Upstream Node:	0141
140-146 Camden Street	Inspected Length:	54.00 m	<b>Upstream Pipe Depth:</b>	
Road	Total Length:	54.00 m	Downstream Node:	BOUNDARY
	Joint Length:	0.00 m	Downstream Pipe Depth:	
Combined		Pipe Shape:	Circular	_
Gravity drain/sewer		Dia/Height:	2,134 mm	
		Pipe Material:	Brick	
No flow control		Lining Type:	No Lining	
Sample survey to determine asset condition		Lining Material:	No Lining	
	Road  Combined  Gravity drain/sewer  No flow control	Road  Total Length:  Joint Length:  Combined  Gravity drain/sewer  No flow control	Road  Total Length: 54.00 m  Joint Length: 0.00 m  Combined  Gravity drain/sewer  Pipe Shape: Dia/Height: Pipe Material: Lining Type:	Road  Total Length: 54.00 m  Joint Length: 0.00 m  Combined  Gravity drain/sewer  Pipe Shape: Circular  Dia/Height: 2,134 mm  Pipe Material: Brick  No flow control  Lining Type: No Lining

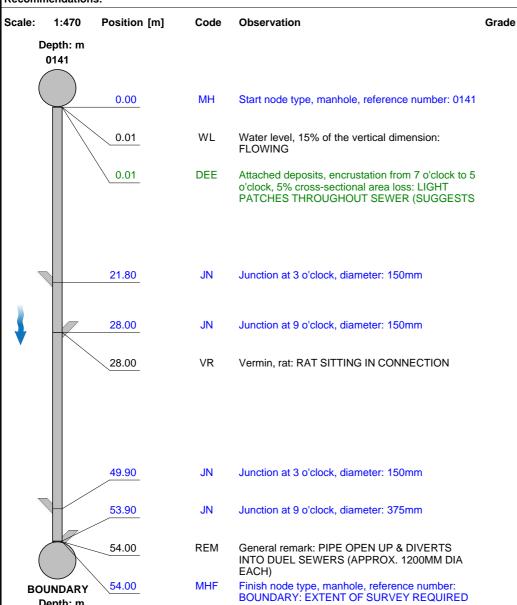
WL @ 0.01 m

2, 00:01:46, 0.01 m Attached deposits, encrustation from 7 o'clock to 5 o'clock, 5% cross-sectional area loss, LIGHT PATCHES THROUGHOUT SEWER (SUGGESTS SLIGHT INFILTRATION SEEPAGE)
