20073/R1/BC/RevP1

29 Steele's Road
Basement impact assessment

Constant Structural Design

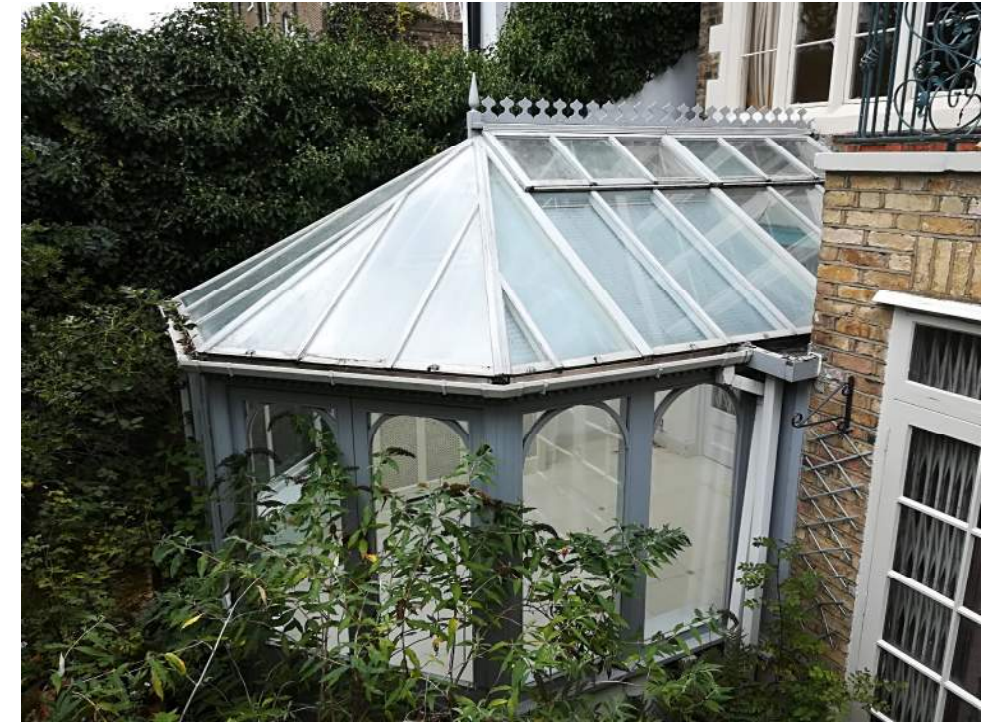
Figure 3.1 – Photo of existing conservatory

A minor excavation is proposed below an existing conservatory to lower the floor level locally.

The existing rear conservatory is at lower ground floor level, located against the party wall with no.28 Steele's Road. It has been established that the existing floor levels either side of the party wall are similar.

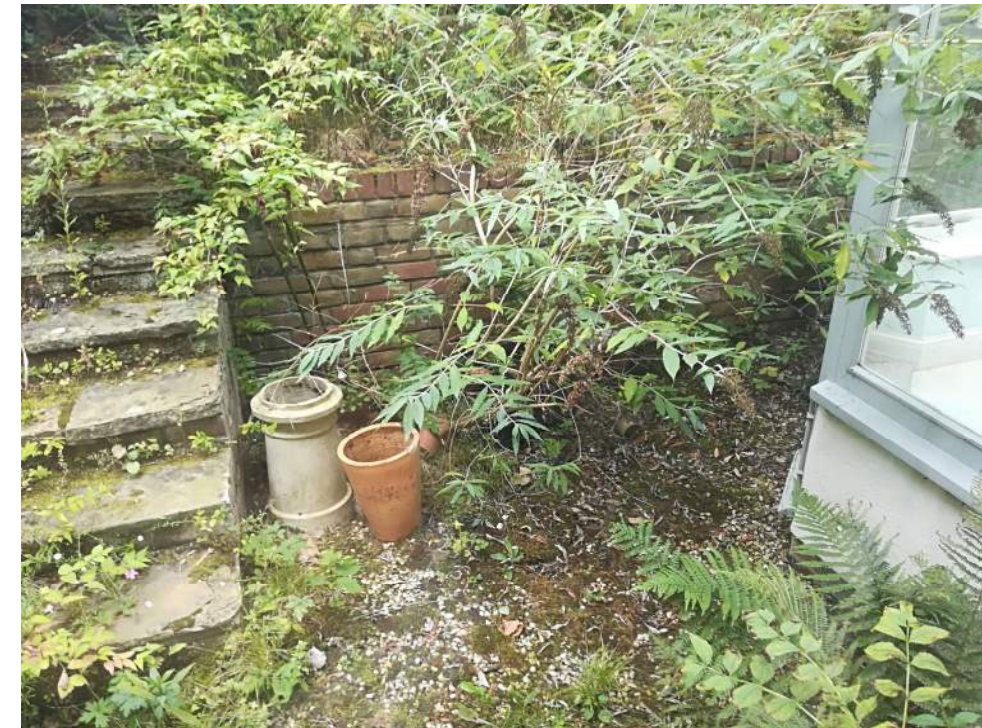
Figure 3.2 – Photo of existing rear terrace to be retained

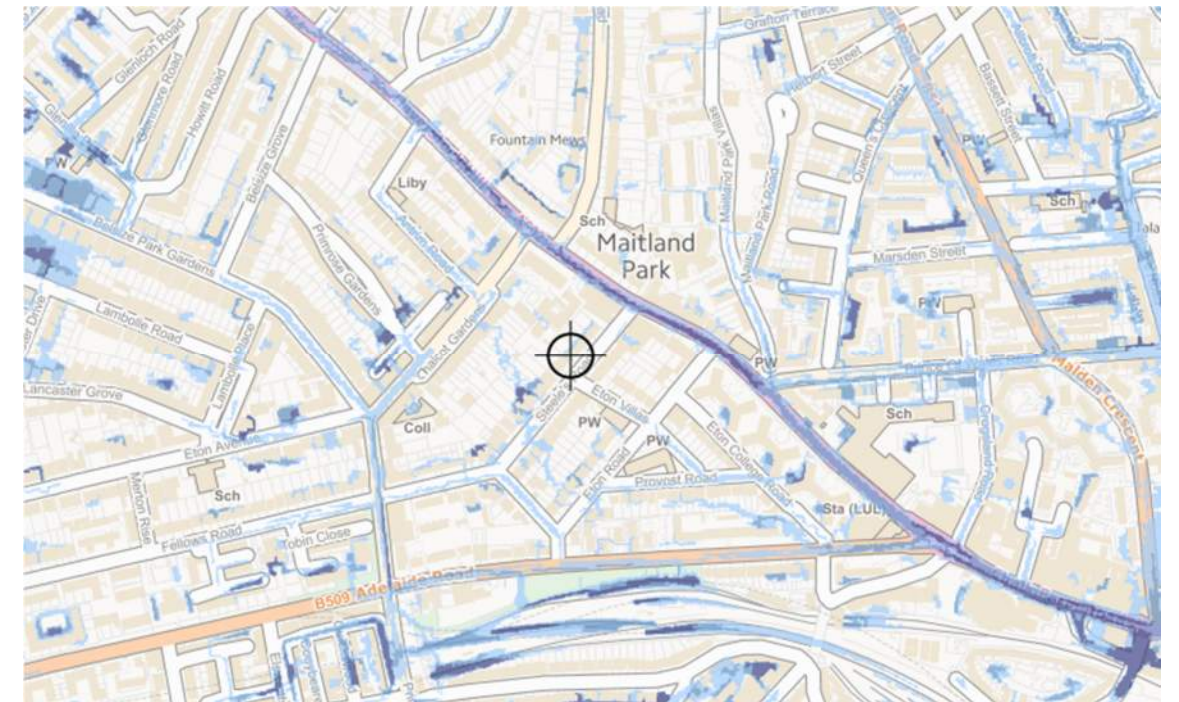
Gov.uk flooding maps indicate the site as low risk.

Figure 11.2 – Surface water flooding risk (Environment Agency)
