## **Basement Impact Assessment**

**58A Fellows Road, London  
NW3 3LJ**

Ref: GGC20816/R1

December 2020

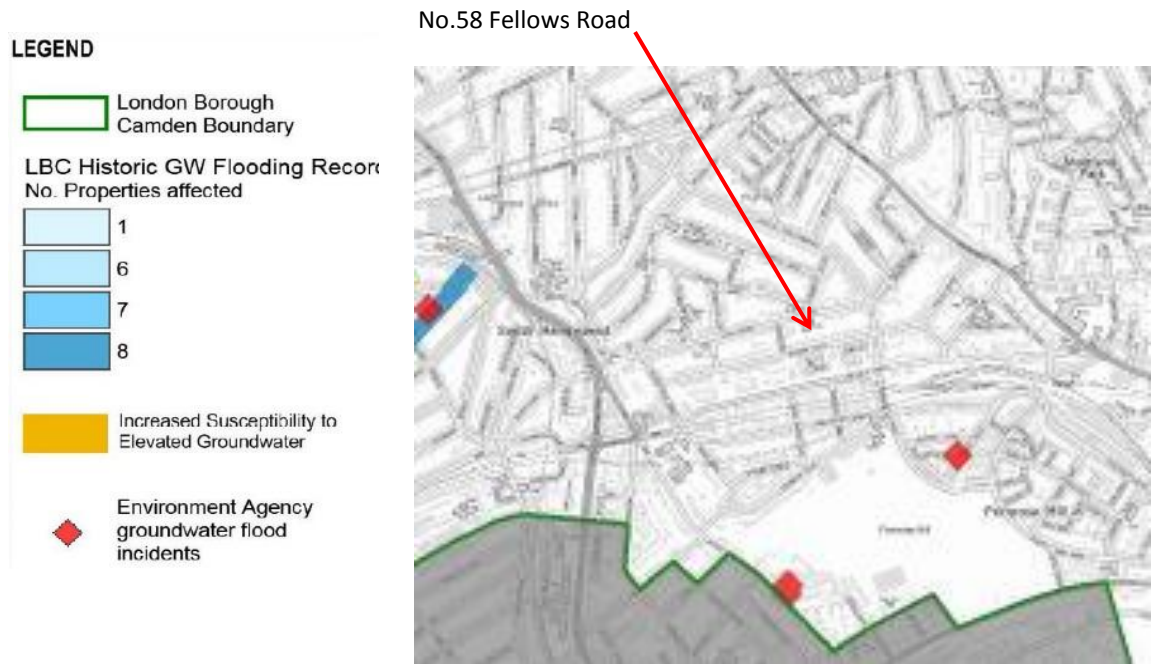
**Figure 9:** Increased Susceptibility to Elevated Groundwater – extract from Figure 4e of the SFRA. Ordnance Survey © Crown copyright 2014. All rights reserved. Licence No.100051531.

- 6.8 Groundwater flooding incidents were presented on Figure 4e of the Camden SFRA (see Figure 9 below). Around 44 incidents have been reported in the entire borough, but none were close to Fellows Road (and some of those records were at sites underlain by London Clay, so may have been surface water flooding which was mis-identified as groundwater flooding).

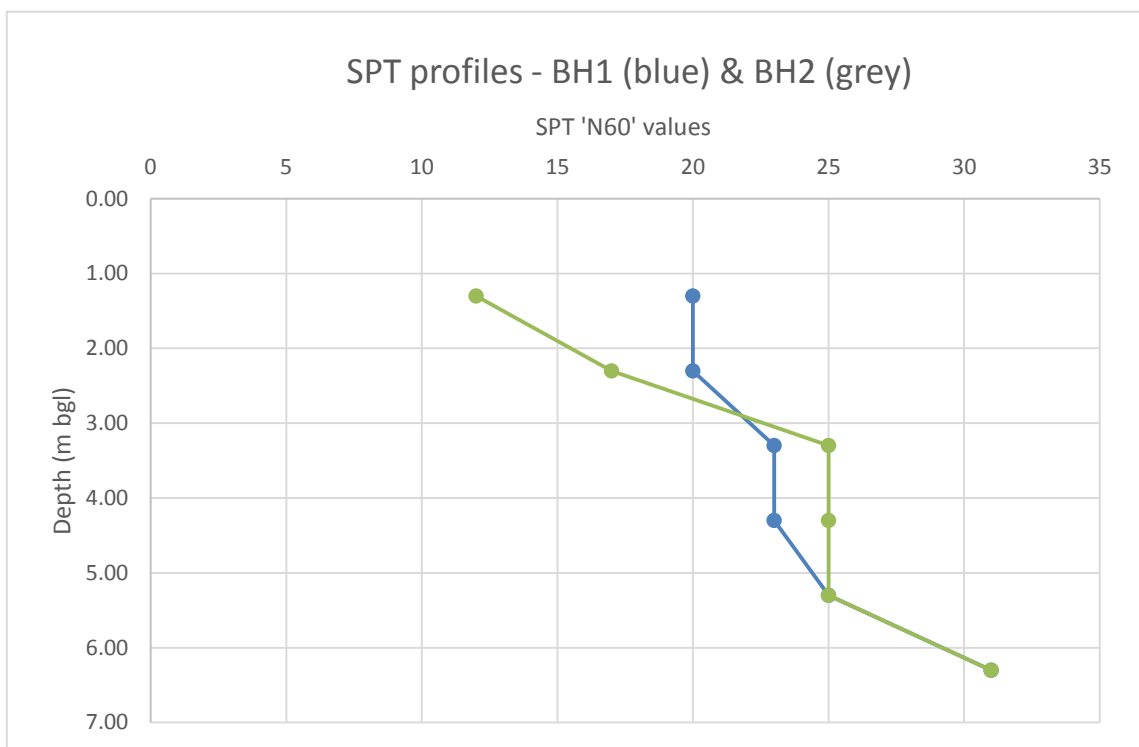
9.4 Standard Penetration Tests (SPTs) were carried out in both boreholes at one metre intervals. The resulting 'N60' values (blows to drive the 300mm test length, after 150mm of 'seating' driving, corrected for test-related matters) are recorded at the relevant depths on the borehole log (in Appendix F), and have also been plotted as profiles against depth in Figure 10 below. The SPT values show an overall trend of increasing shear strength with depth, as is typically found in these strata.

**Figure 10:** SPT 'N' values with depth

- 10.4.12 The founding level (formation) of the underpins and slab will be **50.47m AOD** (approximately 4.4-6.0m bgl – see paragraphs 3.2 & 3.3). The Standard Penetration Test (SPT) 'N60' values, which reflect the presence of fissures in these clays, were 23 and 31 at that level (see Figure 10 and GEA's borehole logs in Appendix F). Using the lower value and converting that to undrained cohesion ( $C_u$ ) using the relationship identified by Stroud (1974) gave a  $C_u$  value of **103kPa** just below the proposed founding depth for the basement.

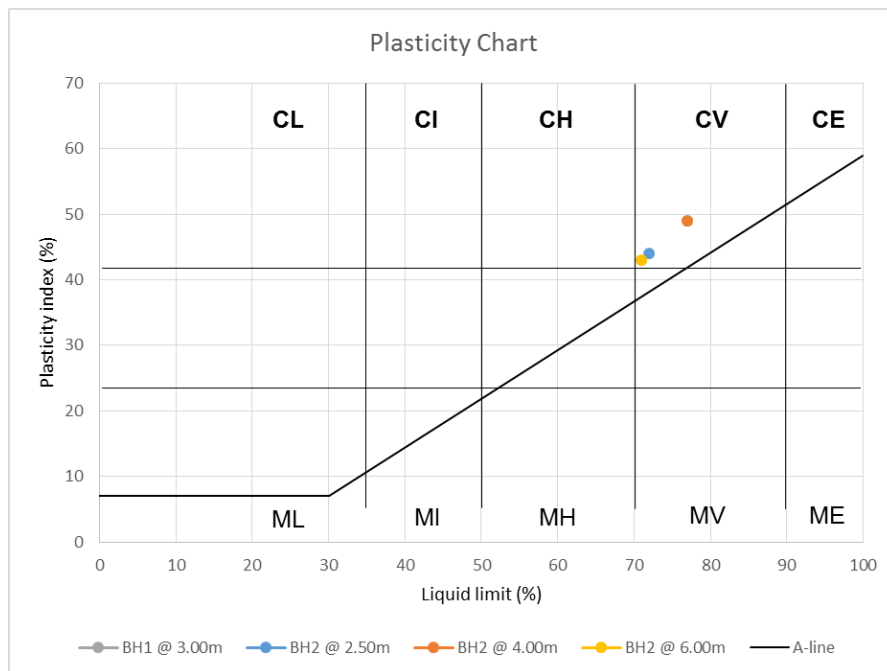
**Figure 11:** Plasticity chart for samples recovered from BHs 1 & 2.

- 9.10 Plasticity tests were performed on four samples of Head Deposits/Weathered London Clay. All four samples were both found to be of Very High Plasticity (see Figure 11 below), as classified by BS5930 (2015), and High Volume Change Potential, as defined by the NHBC (NHBC Standards, 2020, Chapter 4.2, Building near Trees).

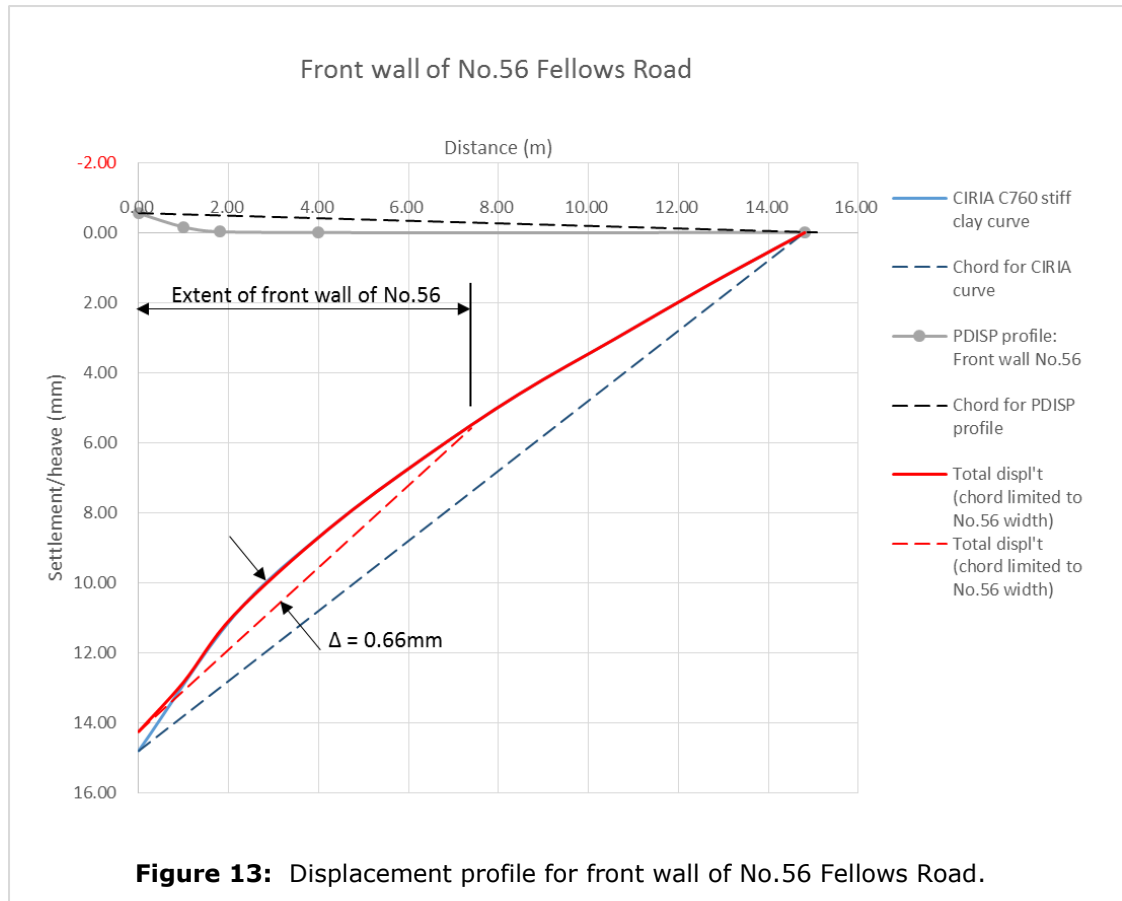
Figure 13 presents these settlement profiles for the front wall of No.56, with allowance also made for the affected wall being shorter than the zone of influence of the ground movements. The maximum  $\Delta = 0.66\text{mm}$ , which represents a deflection ratio,  $\Delta/L = 8.92 \times 10^{-5}$  (0.009%).

10.6.9 The settlement caused by relaxation of the ground alongside the basement, in response to excavation of the retaining wall, can be estimated using the settlement profile for the worst case (low stiffness) scenario presented in Figure 6.15b of CIRIA Report C760. This CIRIA data should be combined with the long-term movements predicted by the PDISP analysis, between Stage 1 (short-term) and Stage 2 (long-term); the settlement profiles are then summed to find the maximum deflection,  $\Delta$ .

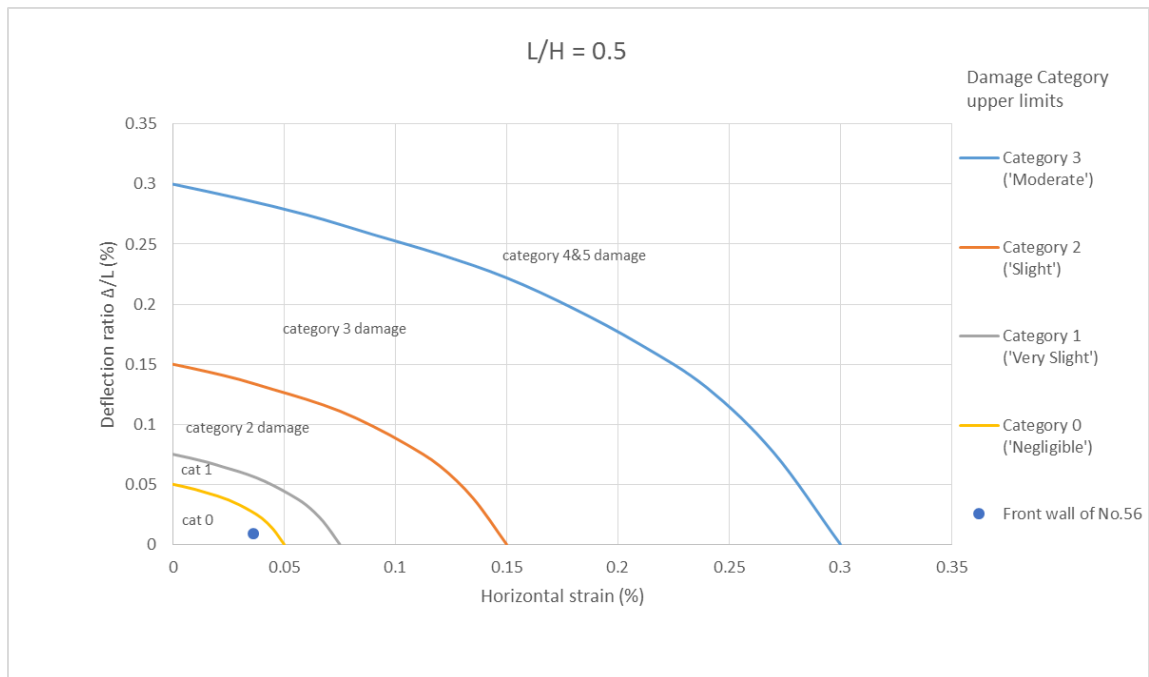
10.6.10 Using the graphs for  $L/H = 0.5$  these deformations represent a damage category of 'negligible' (Burland Category 0,  $\epsilon_{lim} = <0.050\%$ ), as given in CIRIA SP200, Table 3.1, and illustrated in Figure 14 below.

**Figure 14:** Damage category assessment for front wall of No.56 Fellows Road.

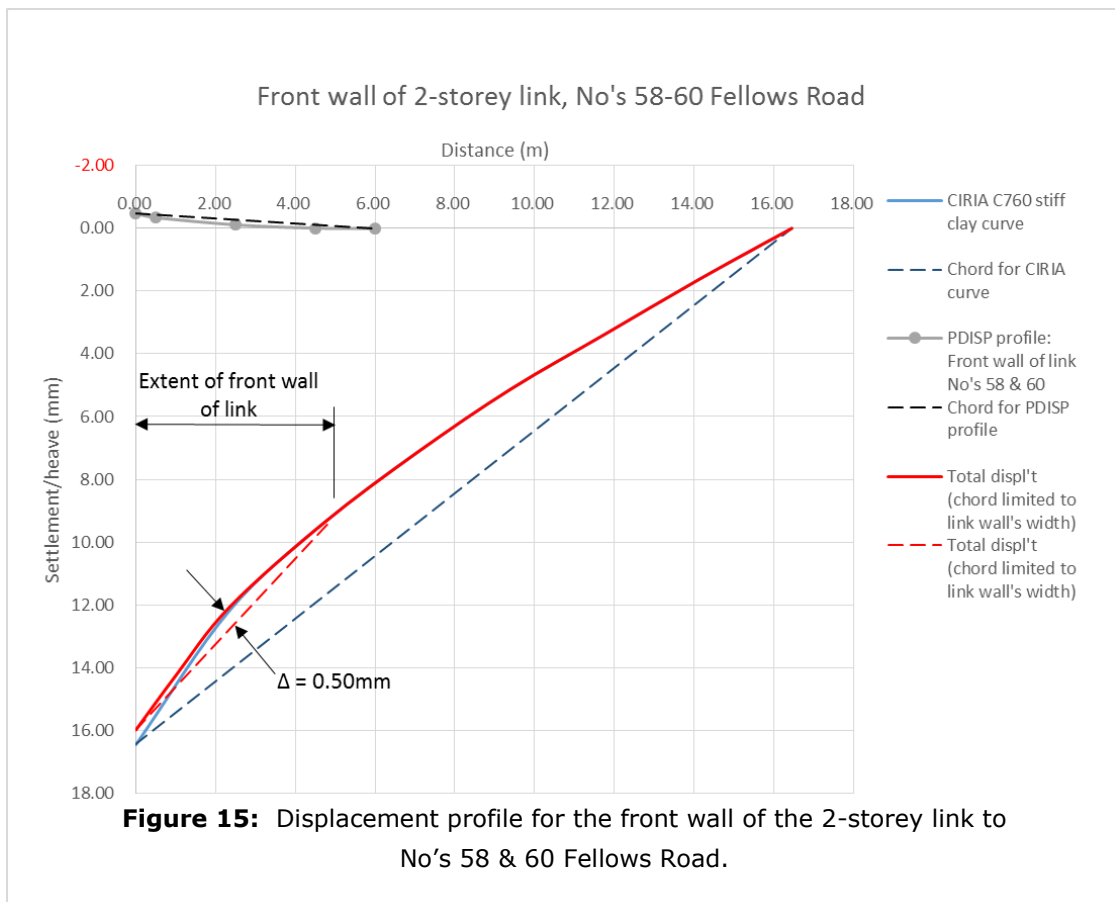
10.6.13 Assessment of the maximum deflection also followed the same procedure as before, using the low stiffness settlement profile in Figure 6.15b of CIRIA Report C760 combined with the long-term movements predicted by the PDISP analyses between Stage 1 and Stage 2. The maximum deflection,  $\Delta = 0.50\text{mm}$ , as shown in Figure 15, which represents a deflection ratio,  $\Delta/L = 1.02 \times 10^{-4}$  (0.010%).
