# Appendix 5

Building Damage Assessment/ Burland Assessment

PROJECT	Belgrove House	TITLE	Preliminary Thames Water & Cadent Gas GMA		
DATE	08/12/2020	SCALE	NTS	CAD FILENAME	-
DRAWN	OH	CHECKED	MW	PROJECT No.	4259
				DRAWING No.	-
				REV	R06A

PROJECT <b>Belgrove House</b>		TITLE <b>Preliminary Building Damage Assessment</b>	
DATE <b>08/12/2020</b>	SCALE <b>NTS</b>	CAD FILENAME <b>-</b>	STATUS <b>-</b>
DRAWN <b>OH</b>	CHECKED <b>MW</b>	PROJECT No. <b>4259</b>	DRAWING No. <b>-</b>
			REV <b>R06A</b>

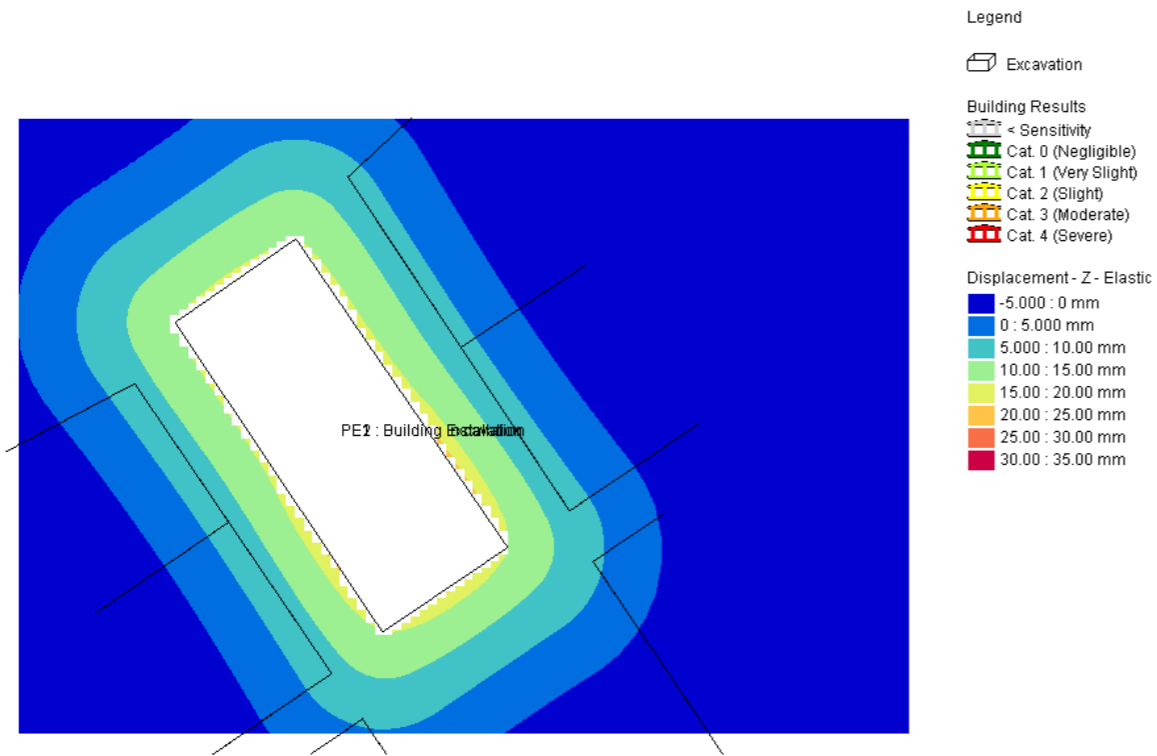
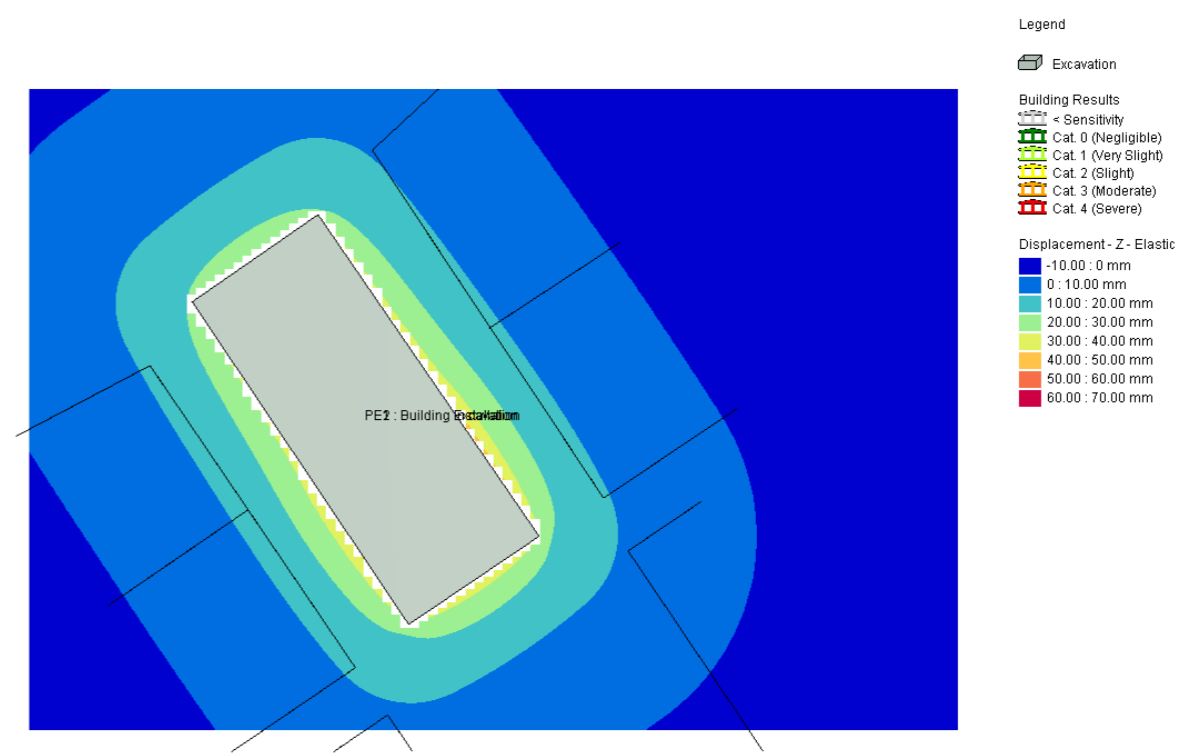
# Short Term Analysis (Undrained)

# Long Term Analysis (Drained)

The Building Damage Assessment for Belgrove House is based on the following sequence:  
 1. Installation & Excavation of the basement.  
 2. Loading with the new building loads

The building height has been assumed to be 10m

All buildings are within Category 0 Category 1 in the Burland Damage Category.
