Statement of compliance

This documentation is submitted as part of an approval of details application to discharge Condition 14 attached to planning permission reference: 2019/3138/P at 115-119 Camden High Street, which requires details comprising a "Method Statement for Below Ground Structures".

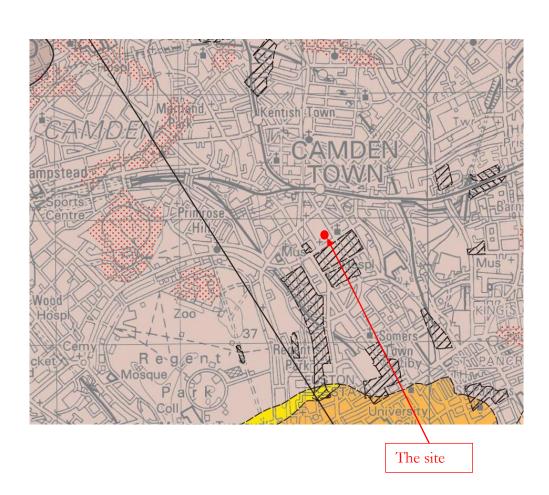
Clancy Consulting Ltd	
	115-119 Camden High Street	Figure
U	Extract from The BGS Map	5
	North London, England and Wales Sheet 256. Solid and Drift Geology 1: 50,000.	·
