Heritage Statement

37 Doughty Street, London, WC1N 2AA

January 2021

On behalf of
37 Doughty Street Limited

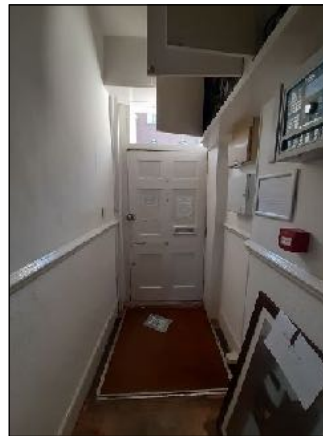
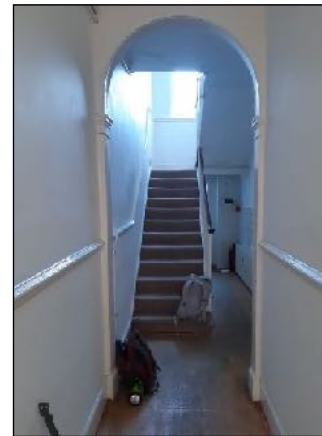
Fig 9a: Entrance area

Fig 9b: Entrance area

To the terrace some of the original sash windows to the rear remain and have glazing bars. Many of the original windows have been lost from no. 37 (figs 9a&b). There are more soil vent pipe and rain water pipe runs to the rear façades and this has particularly marred the setting to the rear of no. 37 and 38.
