CGL_09529 – Tottenham Mews: LBC Comment Tracker

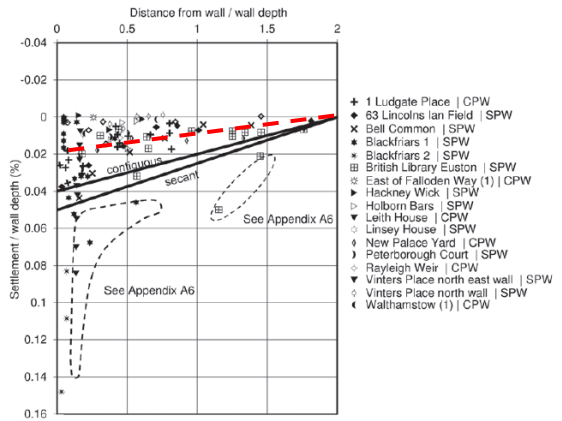
Comment Ref	Date Received	LBC Comment Subject	LBC BIA Query	CGL Comment	Response Date	Status
				<p>behind the wall are noted, it is stated that these are due to adverse ground conditions, poor drilling techniques, and/or effects from adjacent footings. This site has 'standard' ground conditions with the London Clay present at the relatively shallow depth; therefore provided construction is appropriately controlled and monitored, significant displacements are not anticipated.</p> <p>It is further noted that CGL has another case study, pending publication – also demonstrating installation movements in line with the majority of CIRIA C760/580 case study data:</p>

<p>b Vertical movements Figure 6.8 Ground surface movements due to bored pile installation in stiff clay (normalised)</p>		
			<p>4.15 - it is requested that a statement is included in the Geotechnical BIA that a construction methodology similar to that applied in the case study ('hit one miss three' pile installation and full casing of piles) will be applied in the subject site too, in order to control ground movements), in accordance with the GMA</p>	<p>By necessity a contiguous piled wall is constructed in a hit and miss fashion. This is so that the wet concrete in recently constructed nearby piles is not damaged during the construction process. This process is set out in the ICE Specification for piling and embedded retaining walls (SPERWall) document, which will form the basis of the piling method for</p>
