**BIA G1808-RP-01-E4**  
**Supplementary Note G1808-SN-01-E1**

**Project** 31 Willoughby Road NW3 1RT  
**Subject** Response to Campbell Reith Audit D3

**Project Ref** G1808  
**Date** 02/21

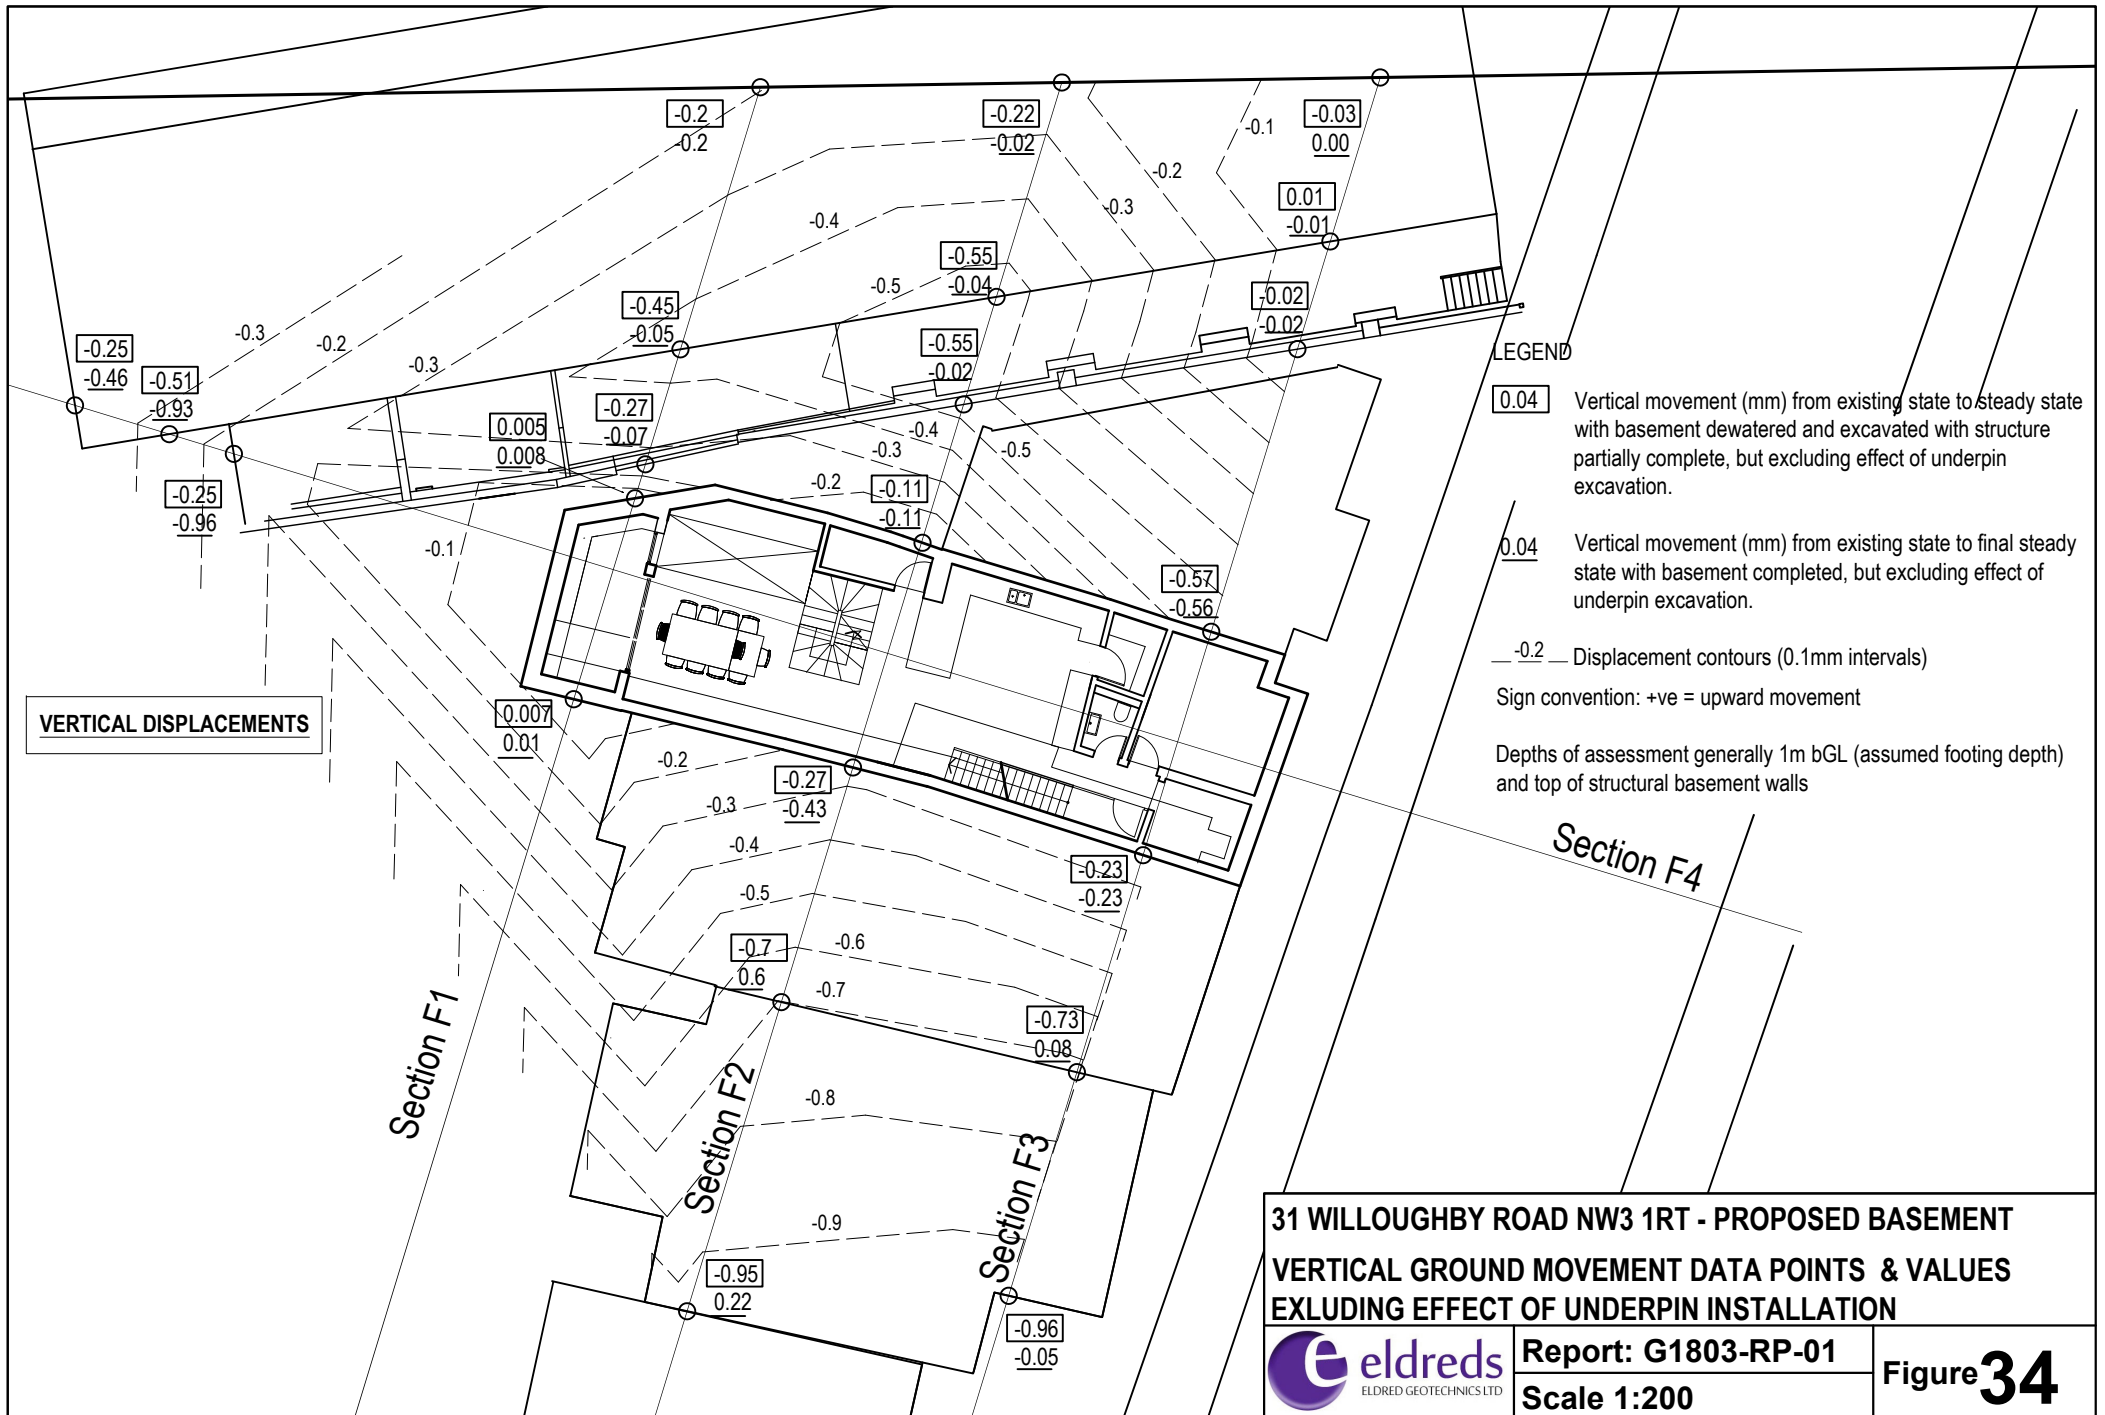
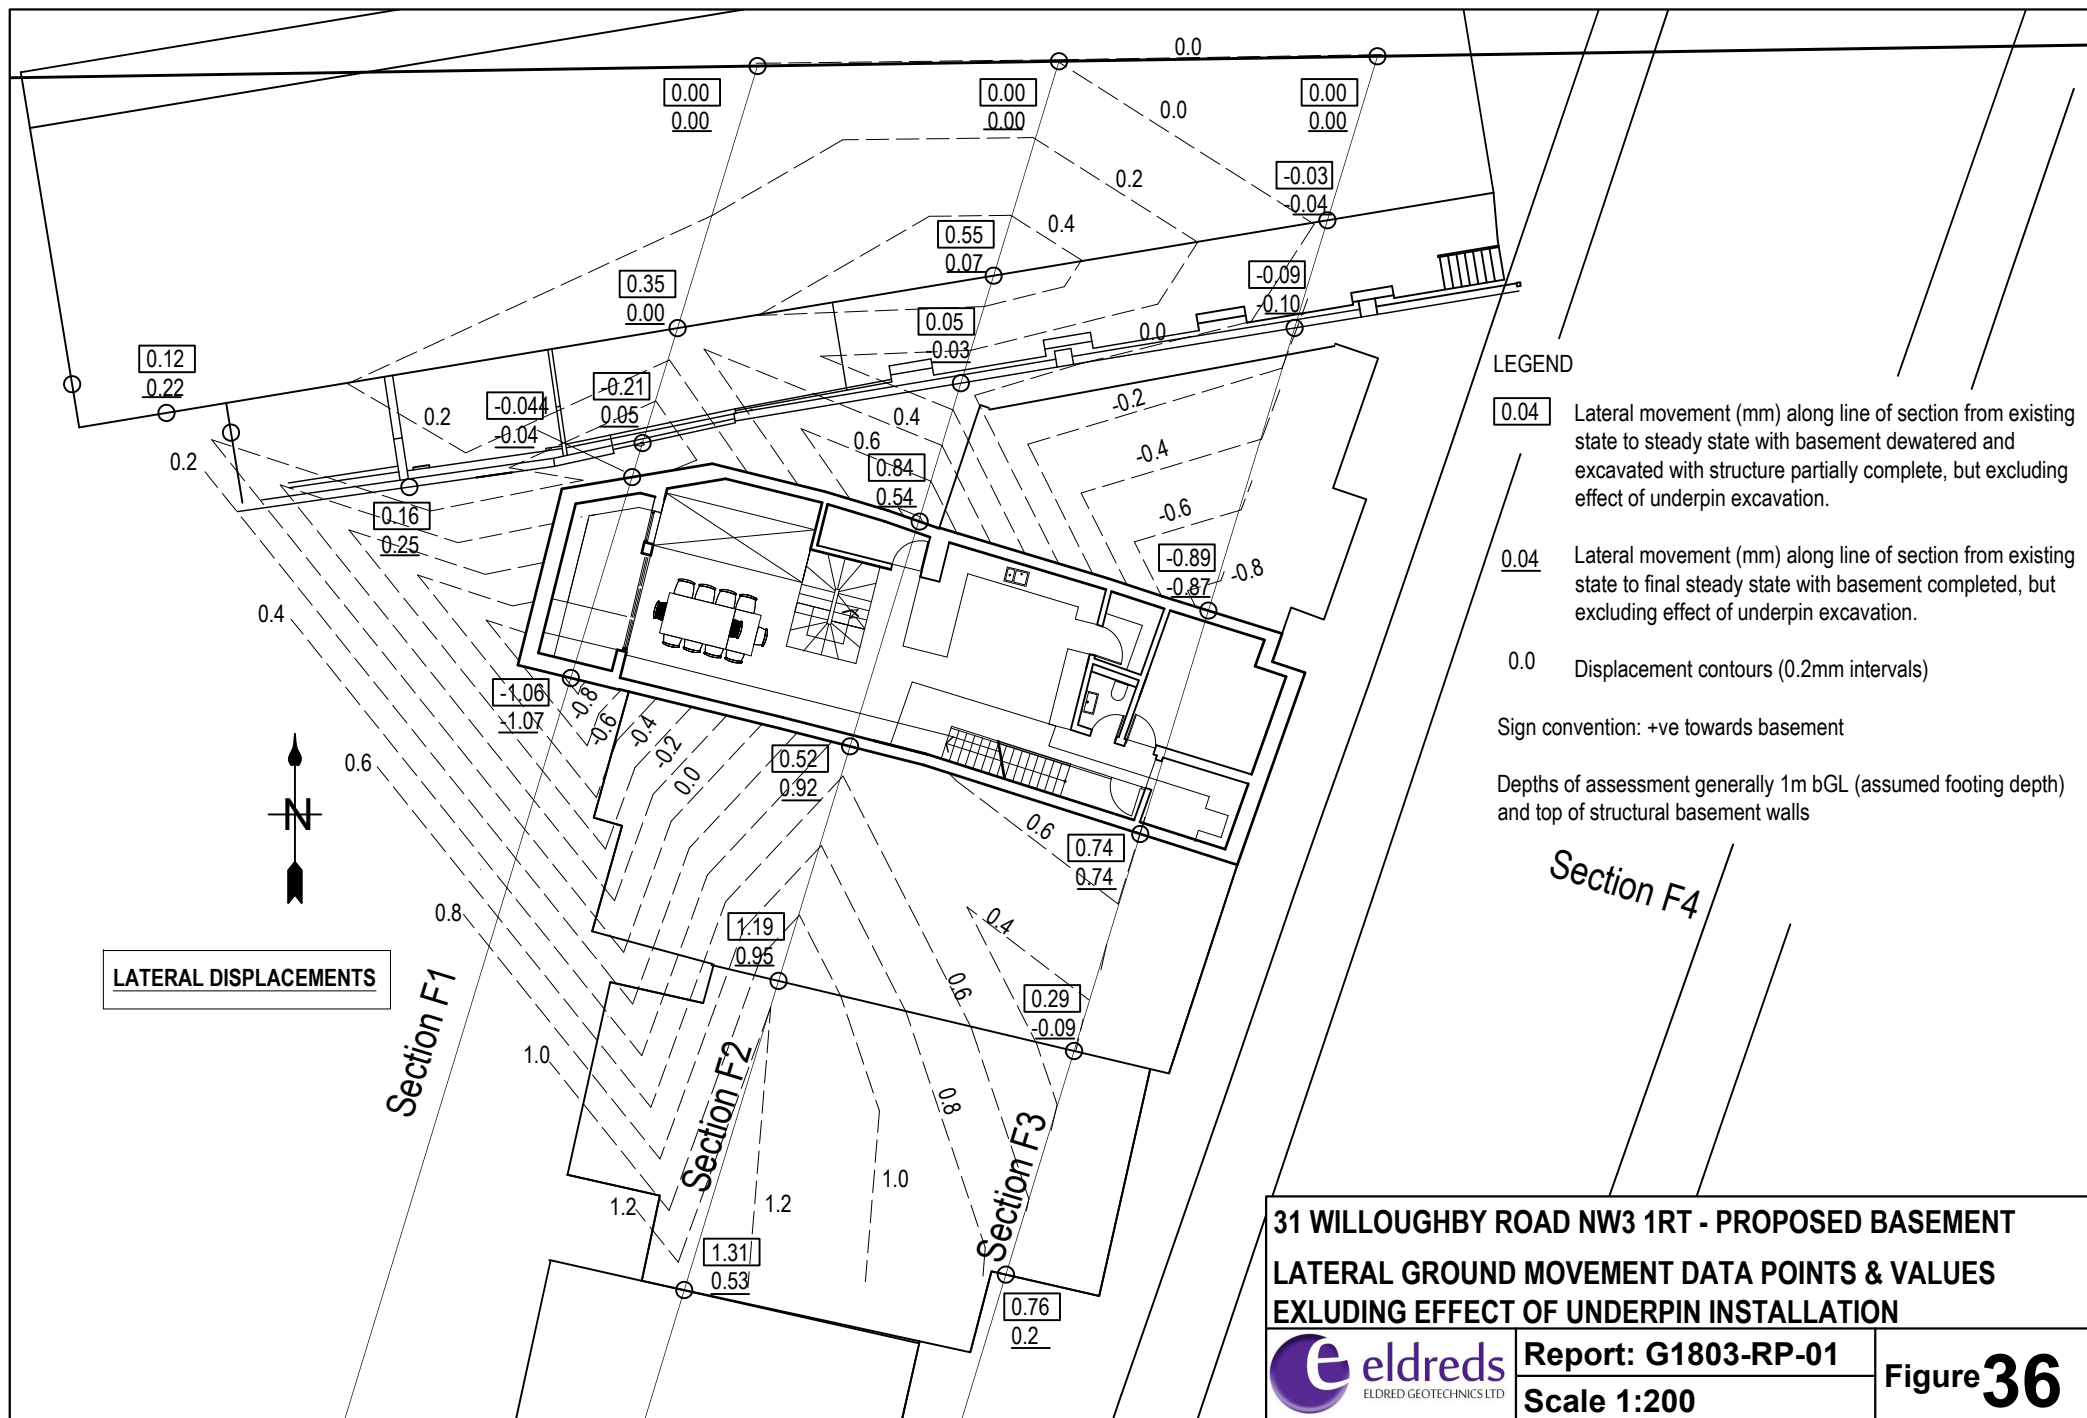
| Figure 37 | Lateral ground movement: Addition of analysis results and notional allowance for underpin installation.<br><br>Damage risk assessment (Cording) including dame category chart (3 pages) |

| Figure 36 | Lateral ground movement data points & values excluding the effect of underpin installation |
