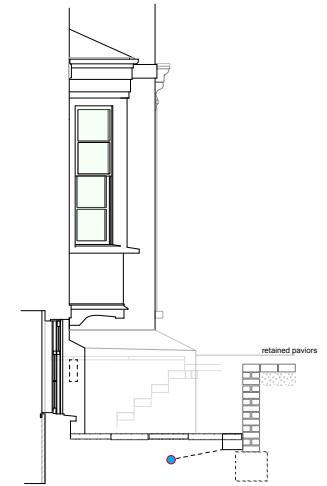
SECTION A 1:50

reclaimed york stone paving guiley moved away from house wall, retaining wall in brick herringbone paviors retained - revealed masonry vented cavities rendered in Roman cement decorated as per house in microporous silicate paint

new land drain

retained paviors

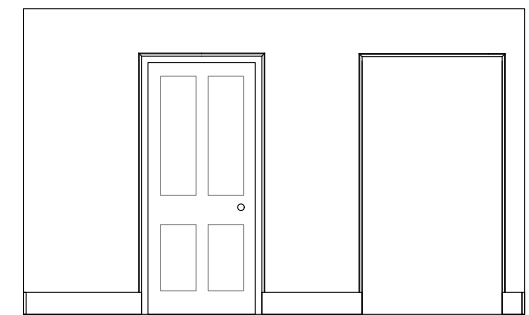
elevation D

20 diameter timber
 dowel corner detail to doorways and opening
 170x20mm softwood square edged skirting
 dowel corners run onto top edge of skirting
 timber linings to doorways

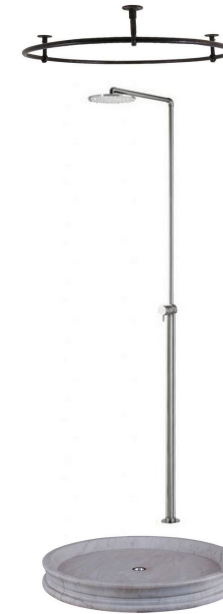
ceiling mounted rail - fixing points aligned to existing ceiling joists

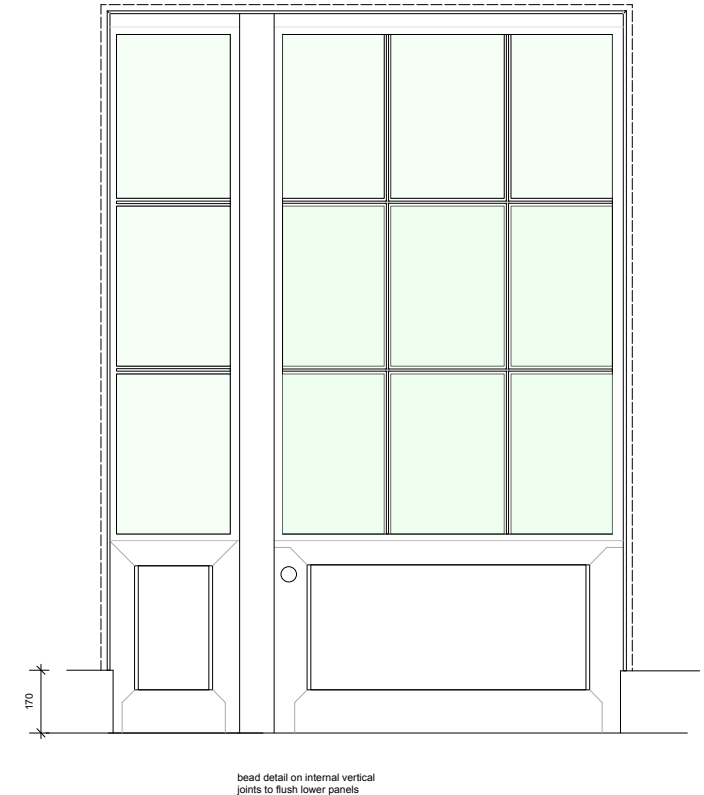
external elevation 1:10

section CC

internal elevation 1:10

Opening
Removal of brick infill to use small power tools - no breakers to be used to avoid vibration damage
Concrete beam retained in situ - structural assessment by qualified site engineer of beam to confirm integrity prior to opening up, propping should not be required.
