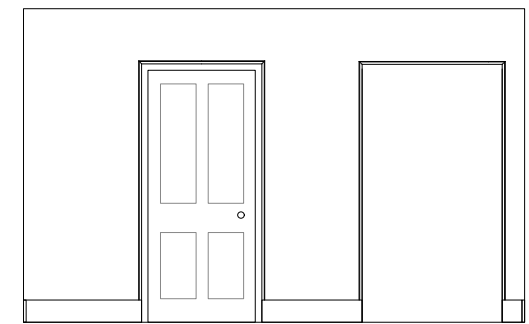
20 diameter timber
 dowel corner detail to doorway and opening
 170x20mm softwood square edged skirting
 dowel corners run onto top edge of skirting
 timber linings to doorways
