## 23 Gloucester Crescent

### *Design and Access Statement*

Revised May 2021

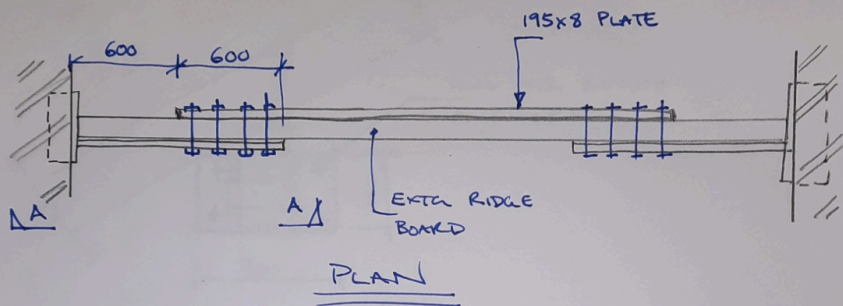
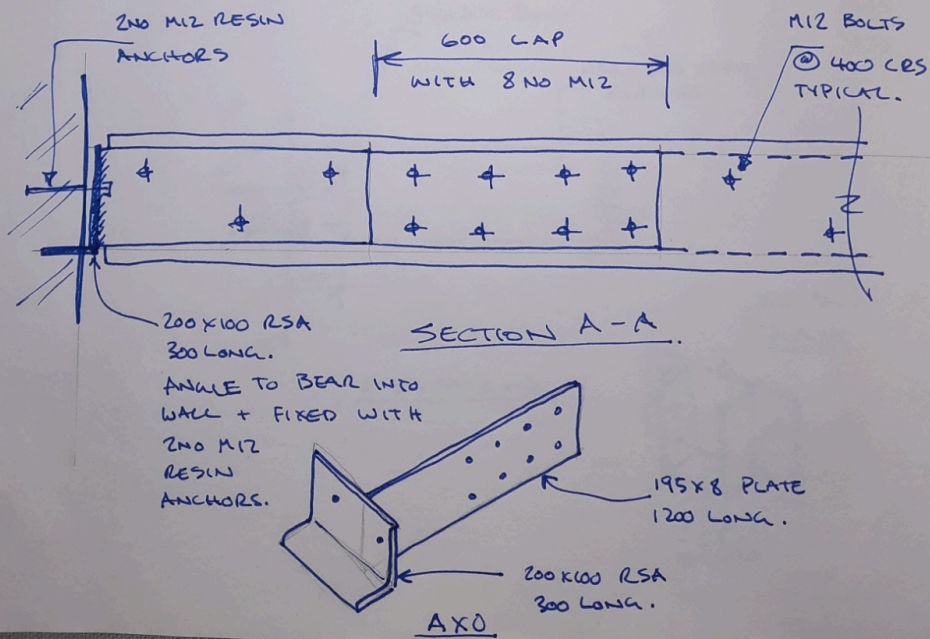
Appendix ii

JOB Title: GLoucester Crescent  
RIDGE BOARD  
STRENGTHENING.

Morton Partnership specification of structural scheme defining steel plate supports and bearing plates to existing ridge beams.

The Ridge beams are in poor condition and have inadequate bearing onto the masonry walls, therefore failing to alleviate the roof load from the damaged valley beam. The Morton Partnership requires the use of a steel 'splint' to one side of each ridge beam of to allow the ridges to be retained, re-supported and to in turn support the valley beam. The decayed bearing end of the valley beam as it meets the side wall requires intervention to restore bearing capacity if the beam is to be retained. The retention of historic fabric is a priority, so the Morton Partnership have detailed a steel support plate to replace the decayed timber and provide a secure bearing into the wall. No alterations to the wall will be required, however the removal of the decay will be needed, with two 195x10mm steel plates bolted together through original beam, welded to a stiffener plate and bearing plate set within the wall (refer to appendices).

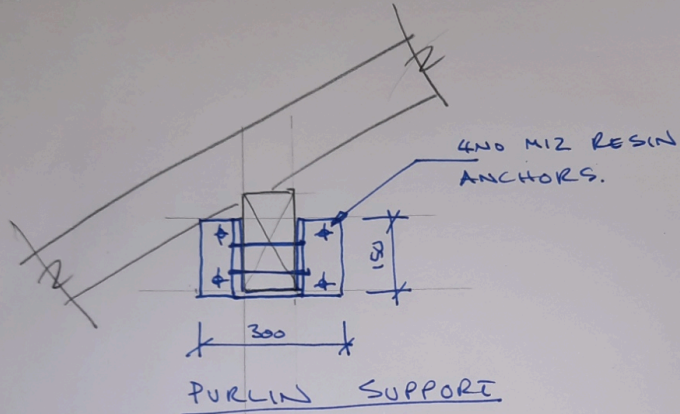
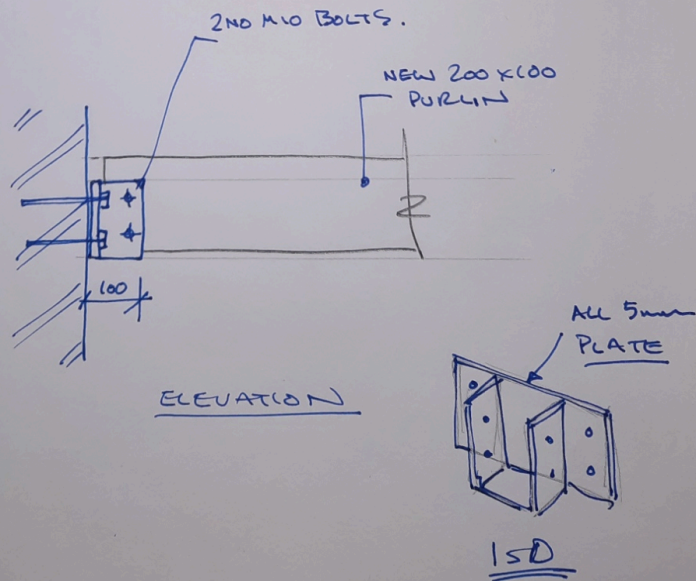
### Appendix iii

Morton Partnership details for purlin connections to masonry walls minimizing intervention to the brickwork.
