Appendix 4  
IStructE Papers

A paper to be presented and discussed at a meeting of the Institution of Structural Engineers, 11 Upper Belgrave Street, London SW1X 8BH, on Thursday 18 April 1985, at 6.00 pm.

# The Granary site— design and construction of a mechanised letter-sorting office

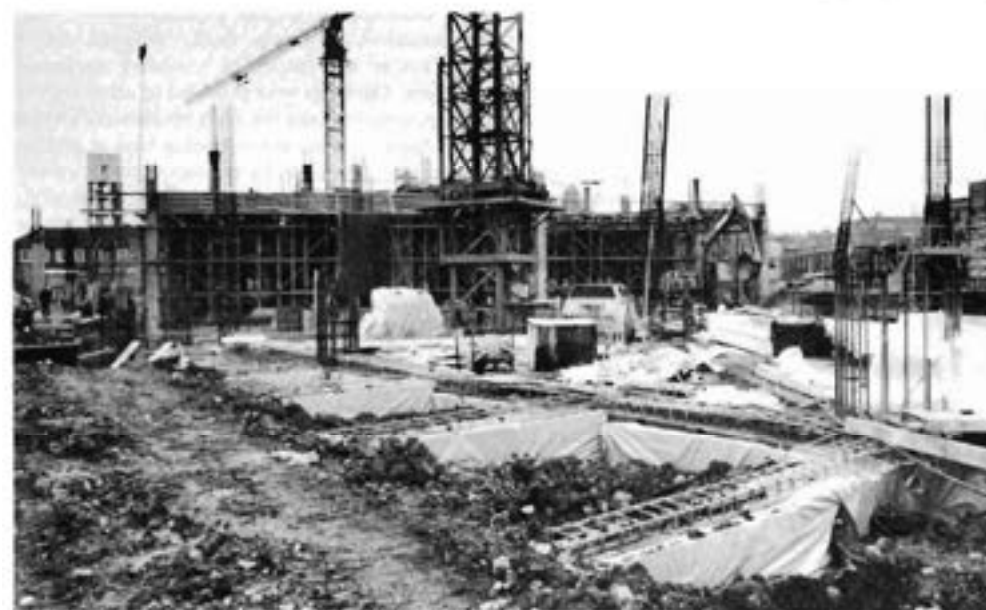
Fig 9. Clayboard protection to ground beams

The piles supported caps which in turn received ground beams carrying the suspended ground-floor slab, the whole construction being protected against heave by 100 mm thickness of Clayboard (see Fig 9). The pile caps and ground beams were designed to resist the bending moments and shear forces induced in them by the lateral deflection of the piles. As the horizontal ground movement along the centreline of the administration block would be negligible, it was decided not to sleeve the piles adjacent to this line and to take the wind forces through them to the ground.

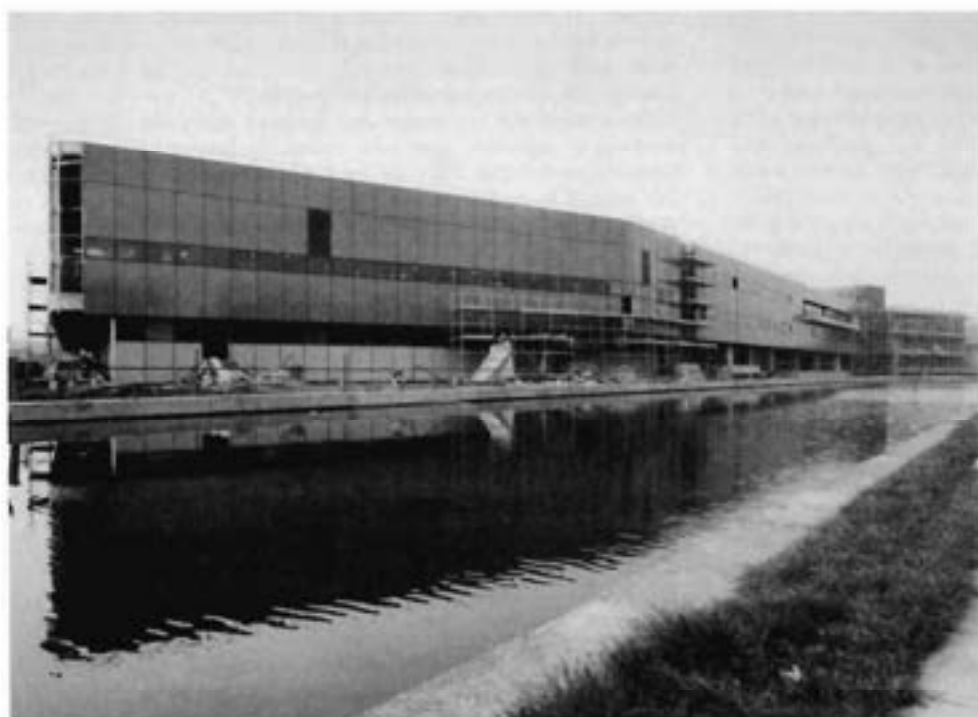
Fig 11. Canal elevation cladding nearing completion

The building was given visual cohesiveness by its principal cladding material, a curtain wall system of glass and stove enamelled sandwich panels (see Fig 11). As an exception, however, in the two-storey carpark and the lower level of the sorting office, closely spaced precast concrete mullion units were incorporated, thus allowing natural ventilation to occur in vehicle movement areas. The roof cladding was a shallow pitch corrugated aluminium system, clipped to supporting members from below, thereby avoiding the need for through fixings and also having the benefit of being free to move thermally.

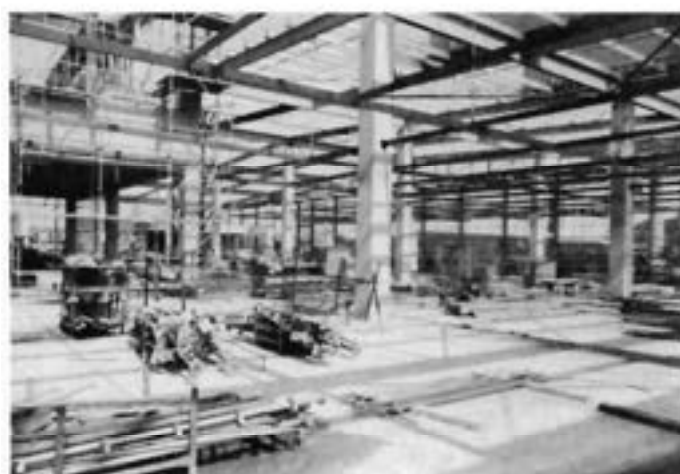
Fig 12. Services subframe in the sorting office

Beneath the sorting office roof a steelwork subframe was suspended to carry the mechanical and electrical services (see Fig 12). A further subframe was provided to the side walls to give lateral support to the curtain walling, necessitated by the high head room and wide column spacing.

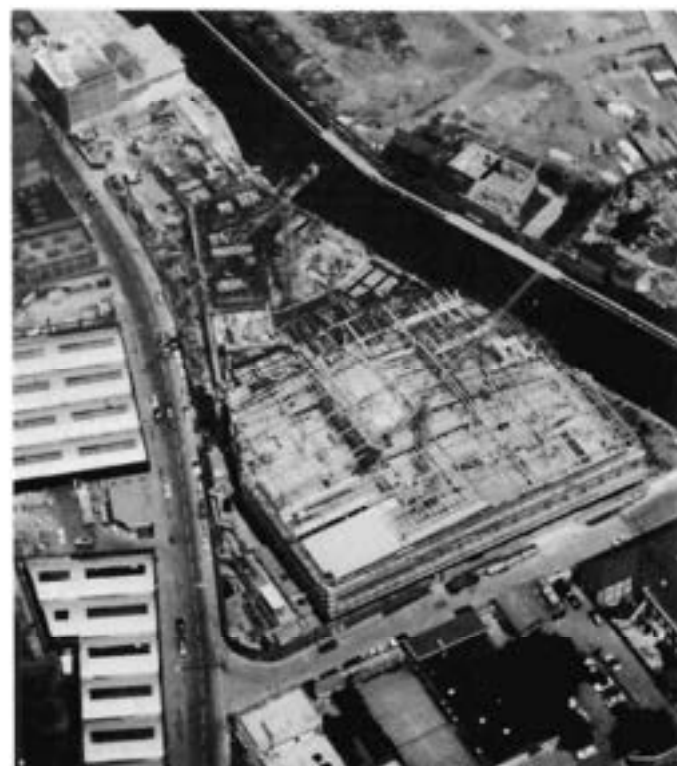
Fig 14. Aerial view—superstructure in progress

With the difficulties in the ground overcome, the construction of the superstructure progressed well (see Fig 14) with only occasional problems arising. One of these concerned the contractor's intention to cast the 7m-high columns of the lower storey of the sorting office block in one lift. To facilitate compaction of the concrete the contractor adopted a mix incorporating a superplasticising additive on the advice of a specialist

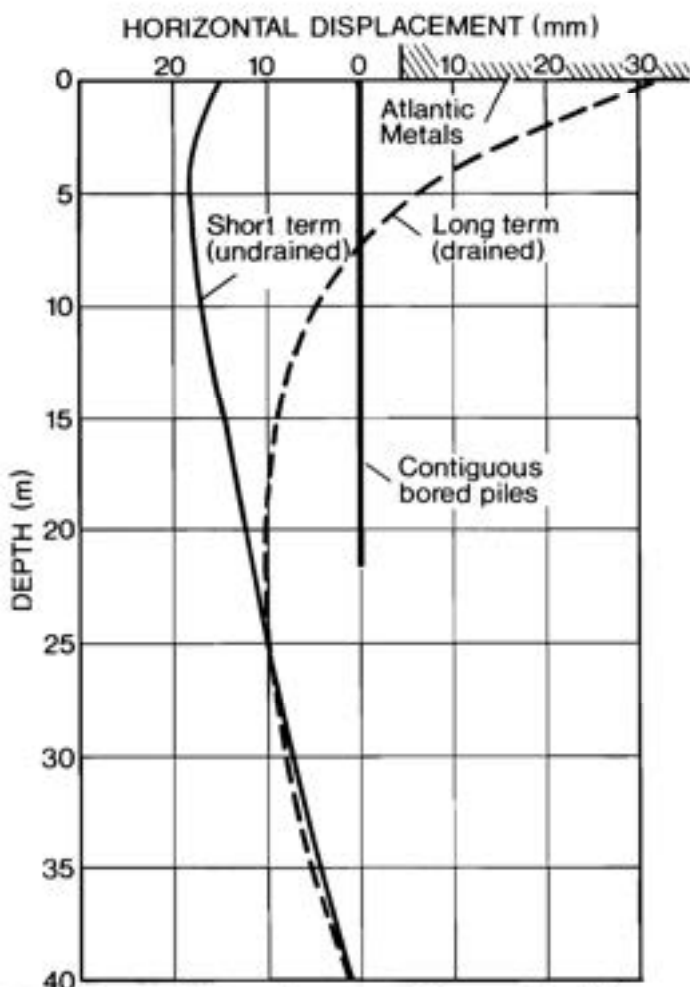
Fig D1. Computed horizontal movements of the row of bored piles

The computed horizontal movements for the line of piles at the northern boundary of the site are shown in Fig D1. It was found that the presence and length of these piles made no difference to the computed horizontal movements. This occurs because the bending stiffness of the piles is not significant compared with the stiffness of the deforming ground. The tensile stiffness of the piles is significant, however, and their effect on computed vertical movements can be seen in Fig D2. Following the method of Burland & Wroth<sup>D1</sup>, tensile strains,  $\epsilon$ , for the Atlantic Metals building were calculated, and it was shown that these were reduced below the critical value of 0.075% when the row of piles was included in the computation.
