**6 ST GEORGE'S TERRACE
NW1 8XH**

**Design and Access
Heritage Statement**

07/12/2020

Rev A 06/07/2021

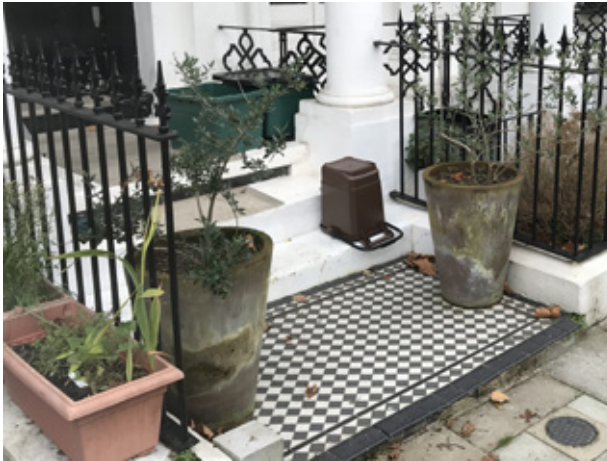
The property is accessible to the ground floor via four steps, the first of which has a number of dislocated ceramic mosaic tiles which we are proposing to be lifted up and carefully cleaned of the old adhesive and relaid back into place. All stairs where stone is exposed to be wet polished and sealed back with water based natural sealant.

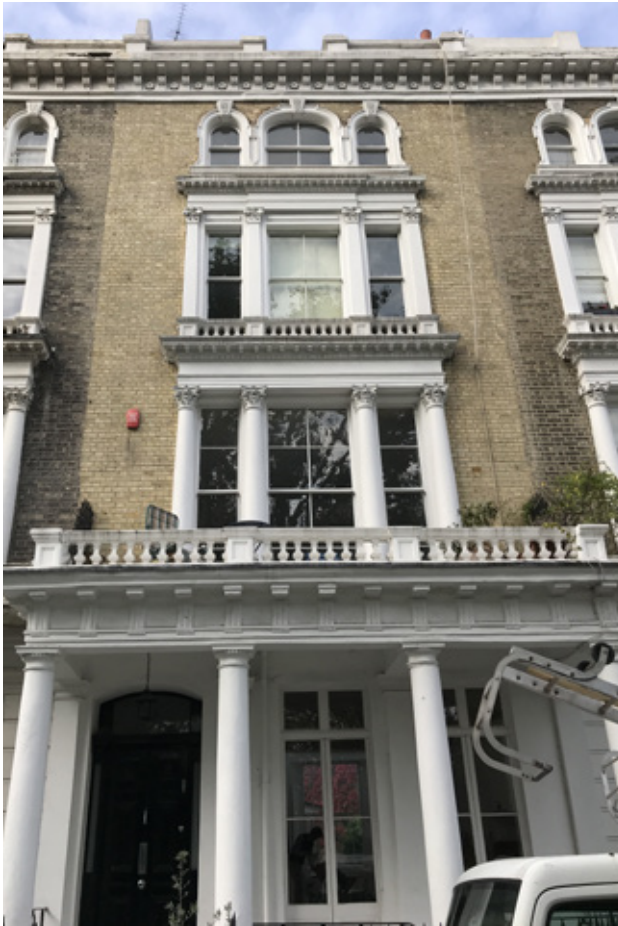
Our proposal is to fully repair and redecorate all the stuccoed Doric porch, capitals, entablature, cornice details, balustrades etc. Repair all blown or cracked render. Minimal original material to be removed during repair works. The use of cutting discs is preferred where possible to minimise vibrations. Rub down, clean and repair all timber work using Repair Care products as per manufacturer's specifications according to each type and size of decay and damage to the original wooden frames. Redecorate with high quality exterior wood paint in gloss white finish.

Brickwork and pointing is in generally good condition. All metal work to be rubbed down, repaired if necessary and redecorated with gloss black metal paint.

The two 20 years old timber french doors on the mansard roof level to be replaced due to extensive timber decay. Size and design of the new doors to match exactly the existing doors.

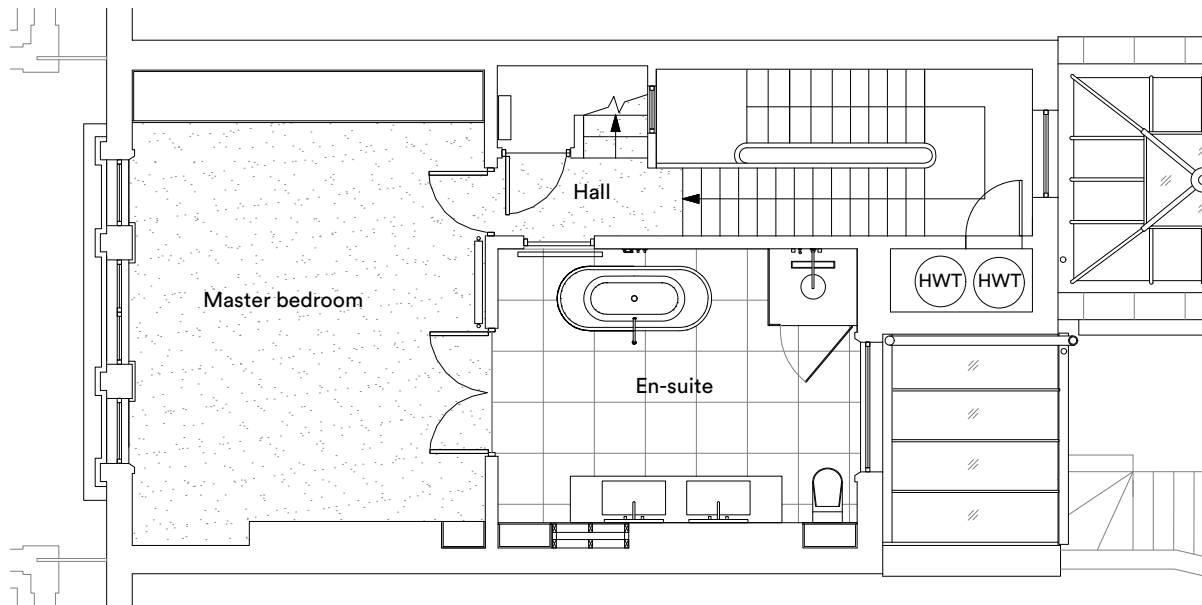
Ref drawing 20.203

On the second floor we propose to refurbish the master bedroom en-suite to new up-to-date finishes and fittings. The position of the shower and WC remains the same, the free-standing bath is moved from the centre of the room in front of the door which is to be retained but covered with a tall floor mirror. The chimney footprint has been modified in the previous major refurbishment works with the WC and a storage cupboard built on one side next to the window. We propose to infill with stud partition the opposite side of the chimney and build another storage unit to give a balanced proportion and symmetrical view with a large double vanity unit fitted on the chimney wall. Floor to be tiled.

The existing boiler and hot water cylinder located in the storage space above the half-landing is to be removed and replaced by two new hot water cylinders as part of the new hot water system which will be updated to current more efficient standards with pipes run through the existing services vertical riser located in the wall behind the shower enclosure.

The carpet in the master bedroom and second floor stairs landing is to be replaced with high quality carpet. General decoration works throughout.

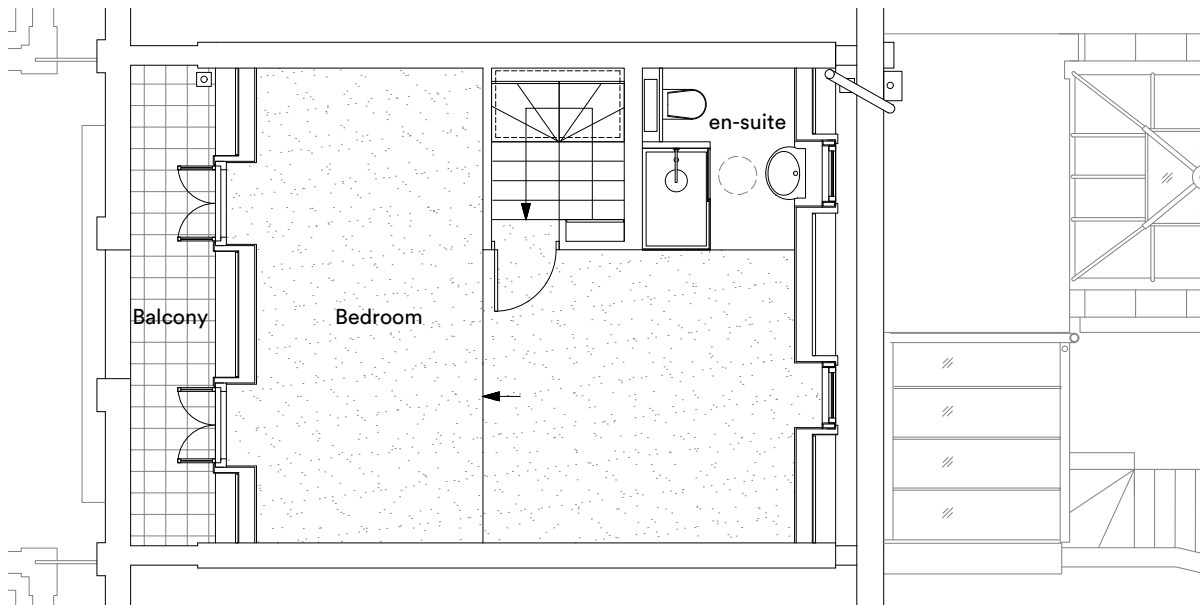
Ref drawing 20.205

On the fourth floor there are some local water leaks in the ceiling from the failing flat roof covering, shower leak which caused damaged to the ceiling of the third floor rear bedroom as mention before, and poorly maintained front balcony and rear hidden gutter which show evident water ponding. The proposals seek to solve these issues internally by replacing the sunken shower tray with new tray and shower enclosure fully waterproofed, and externally by lifting up the balcony tiles, build new falls to the gulley to ensure no water ponding on the balcony and apply new Sika waterproofing membrane to both front balcony and rear gutter.

The two sets of 20 years old timber french doors to the front of the building need to be replaced due to extensive damaged to the wooden frames with new timber french doors to match the exact design as existing causing no visual change to the front facade.

Carpet changed throughout and new vinyl in the en-suite. All walls, ceiling and woodwork to be redecorated as the rest of the house.

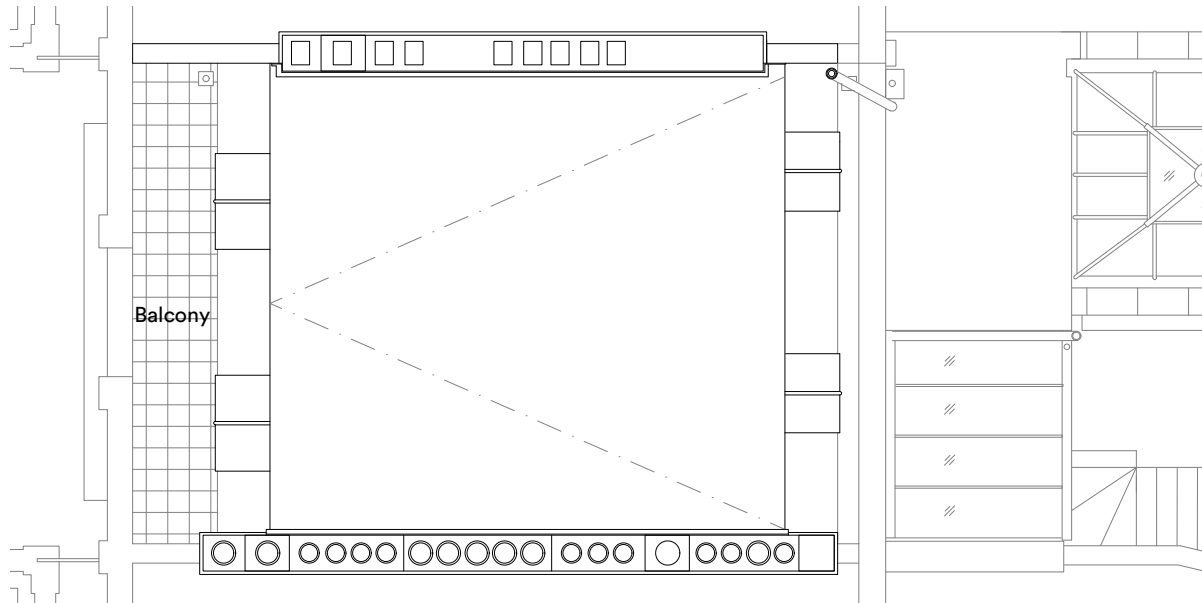
Ref drawing 20.206

The flat roof covering shows signs of deterioration causing some small leaks to the ceiling below. We propose to lift up the lead flashings and apply and overcoat of Sika waterproofing to manufacturer's specifications, flashings repositioned and replaced where necessary with Code 5 lead. Investigate, repair or replace where necessary the damaged cement flaunching. Replace cracked or missing chimney pots with reclaimed chimney pots and covers.

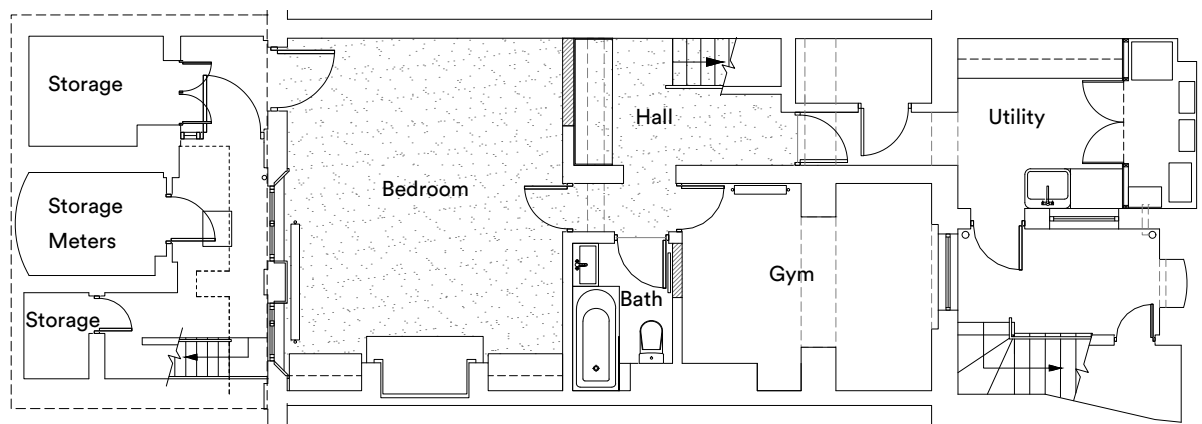
Ref drawing 20.200

The basement level has suffered many alterations during the life of the building with almost no original fabric retained. The proposals to this space are minimal and aimed to improve the functionality of the building.

It is proposed to infill the opening between the hallway and the front guest room with stud partition and install a new fire rated door to separate this space from the hallway. The current en-suite bathroom to the rear bedroom is proposed to be transformed into a bathroom accessible directly from the hallway, therefore the existing door is to be infilled with timber stud partition and an opening to be formed for the new fire rated access door. The fitted furniture in the chimney alcove of the rear bedroom is to be removed.

The boiler and hot water cylinder from the utility room are to be removed and replaced with a new larger boiler to serve the whole property, therefore not requiring two boilers as per the current arrangement. The whole hot & cold water and heating system is to be redesigned to up-to-date specifications with the new plant equipment located in an easily accessible partition at the rear of the utility room.

The old carpet to be replaced and all walls, ceilings and woodwork to be redecorated. New vinyl floor finish in the utility room.

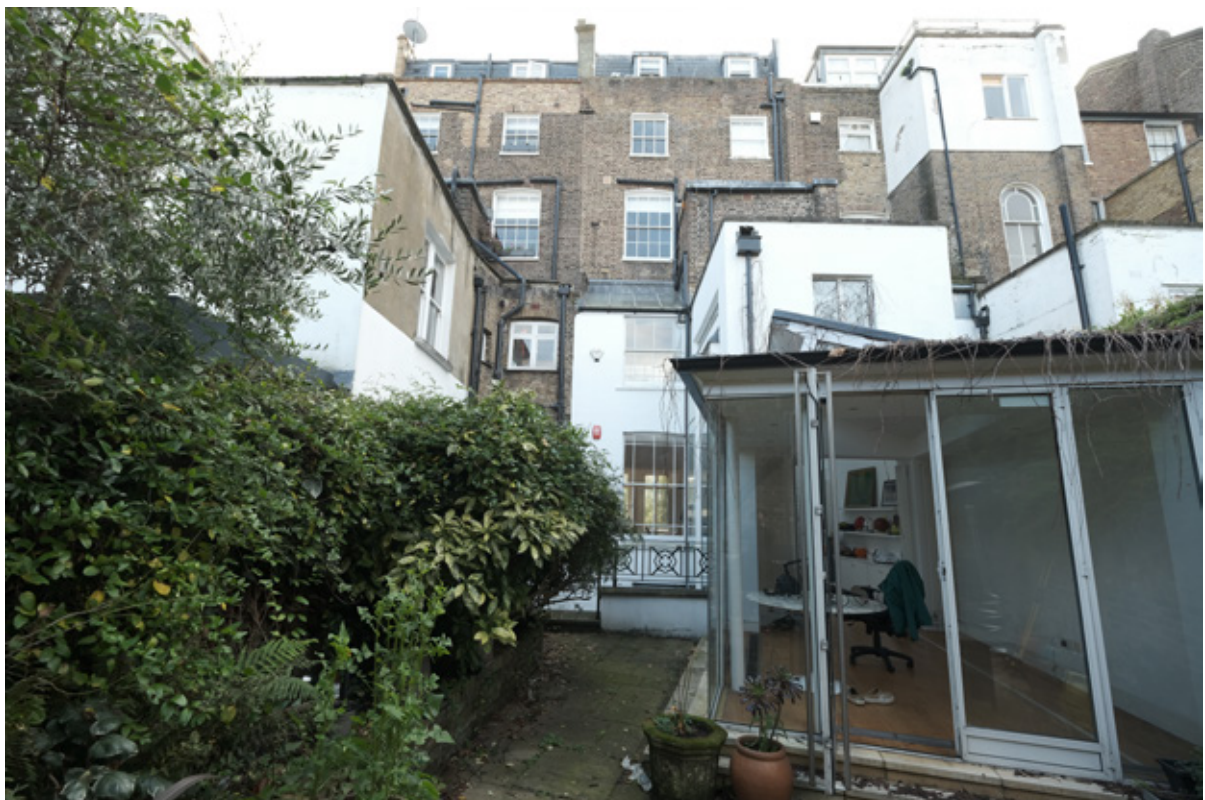
Photo from the rear garden

The works proposed to the rear facade relate to the changing of the 20 years old conservatory glazing and the rebuilding of the third floor rear parapet brickwork as mentioned elsewhere in this document. All the redundant cabling and services equipment to be removed from the facade, all lead work to be carefully cleaned and resealed with patination oil.

Repair all blown or cracked render. Minimal original material to be removed during repair works. The use of cutting discs is preferred where possible to minimise vibrations. Rub down, clean and repair all timber work using Repair Care products as per manufacturer's specifications according to each type and size of decay and damage to the original wooden frames. Redecorate with high quality exterior wood paint in gloss white finish.

All metal work to be rubbed down, repaired if necessary and redecorated with gloss black metal paint.
