TREE SURVEY AND ARBORICULTURAL METHOD STATEMENT

Report in support of an application for the erection of a three storey rear extension with first floor terrace and side extensions following the demolition of the existing side and rear extensions between the lower and first floors, demolition of the existing chimney stack; erection of a hip to valley roof extension with front and rear dormer with new hard and soft landscaping arrangement at 3 Ranulf Road, London, NW2 2BT.

7th January 2021

MDA reference N87

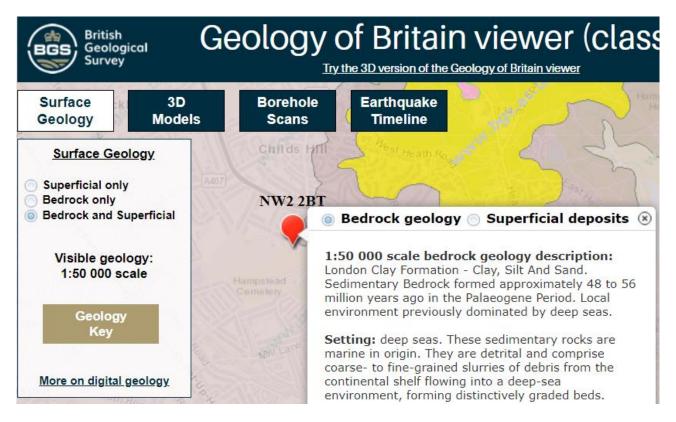
Figure 1. British Geological Survey 1: 50,000 scale map showing that the site is underlain by the Seaford Chalk Formation - Chalk

- 3.1 BS5837: 2012 advises that soil properties should be considered as part of a tree survey report. This is necessary because trees can cause damage to structures founded on soils that shrink and swell with changes in moisture content (principally clays). Such movement is exacerbated by the influence of trees and therefore if a shrinkable soil is suspected foundations should be deigned to extend below the likely zone of seasonal moisture change.
- 3.2 The British Geological Survey 1: 50,000 scale map indicates that the underlying geology of the site is shrinkable London Clay Formation Clay, Silt and Sand (Figure 1). Thus, foundations should be designed to take account of trees. If site specific investigations confirm shrinkable clay then foundations will be designed with reference to the National House Building Council's Standards Chapter 4.2 *Building near trees*.

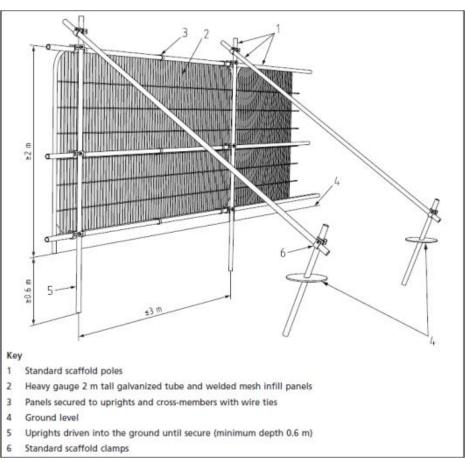
Figure 2. Diagram to illustrate design of protective fencing with scaffolding anchored into the ground

5.3 Tree protection will comprise of 2 m tall fencing installed in the positions shown at **MD4** before any demolition takes place or materials are delivered to site or construction commences. The fencing will consist of a scaffold framework, well braced to resist impacts, with vertical tubes spaced at a maximum interval of 3 m (Figure 2). Onto this, weld mesh panels or 2 m high shuttering board will be securely fixed with wire or scaffold clamps. Unbraced weld mesh panels on unsecured rubber or concrete feet will not be used as these are not resistant to impact and are too easily removed by site operatives. An alternative system of bracing which does not require a scaffold framework is shown in Figure 3.

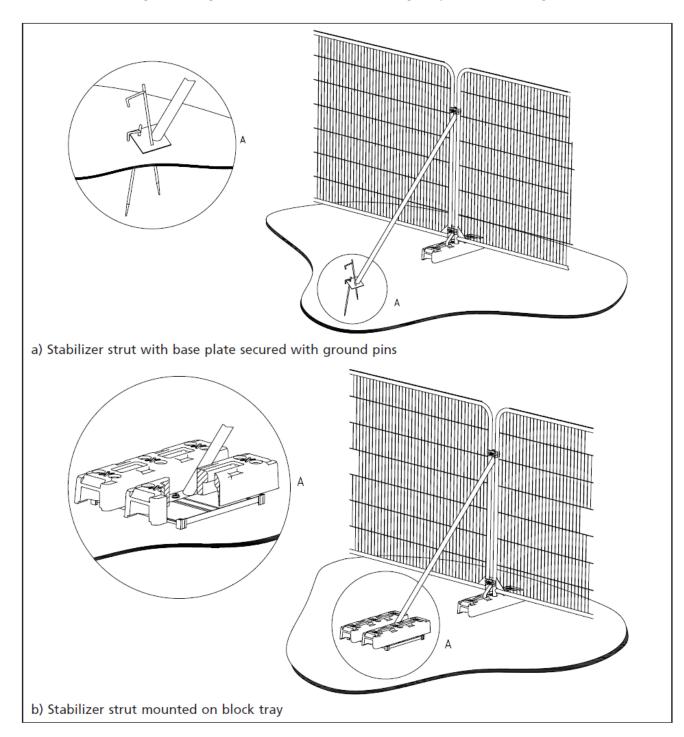
Figure 3. Diagram to illustrate alternative design of protective fencing

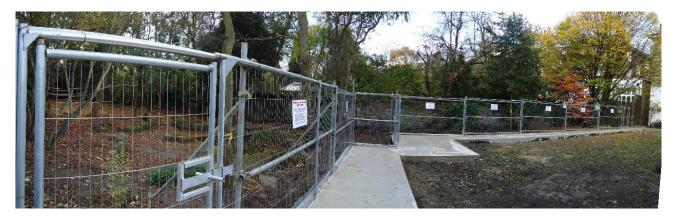
Figure 4. Photograph to illustrate installed protective fencing

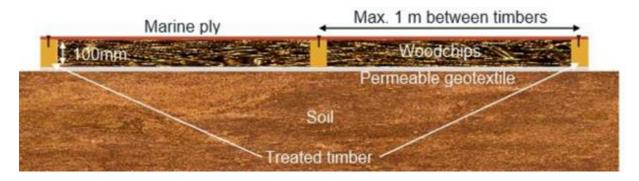
Figure 6. Specification for ground protection

5.5 In order to allow access for construction workers at the front of the development it is proposed that part of the RPA of T1 will be protected by ground protection. This area, shaded orange on the tree protection plan (**MD4**), will be covered by a permeable geotextile such as Terram. Onto this will be placed treated timber (100 mm x 80 mm) at spacings of no more than 1 m. The area between the timber bearers will be filled with a compressible material such as woodchips and will then be covered by 20 mm thick marine ply which will be screwed down onto the timber (Figures 6 and 7). The plywood may need to be coated with a non-slip paint.

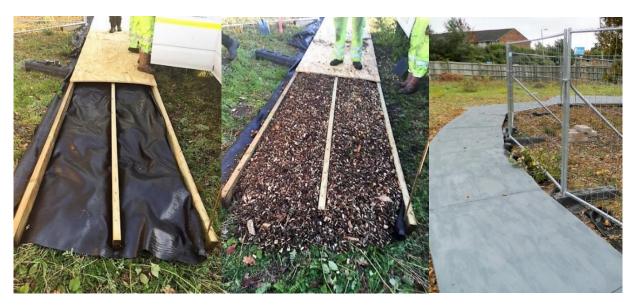
Figure 7. Plywood sheeting supported by timber bearers with woodchip infill used as ground protection for parts of the RPA outside fencing.

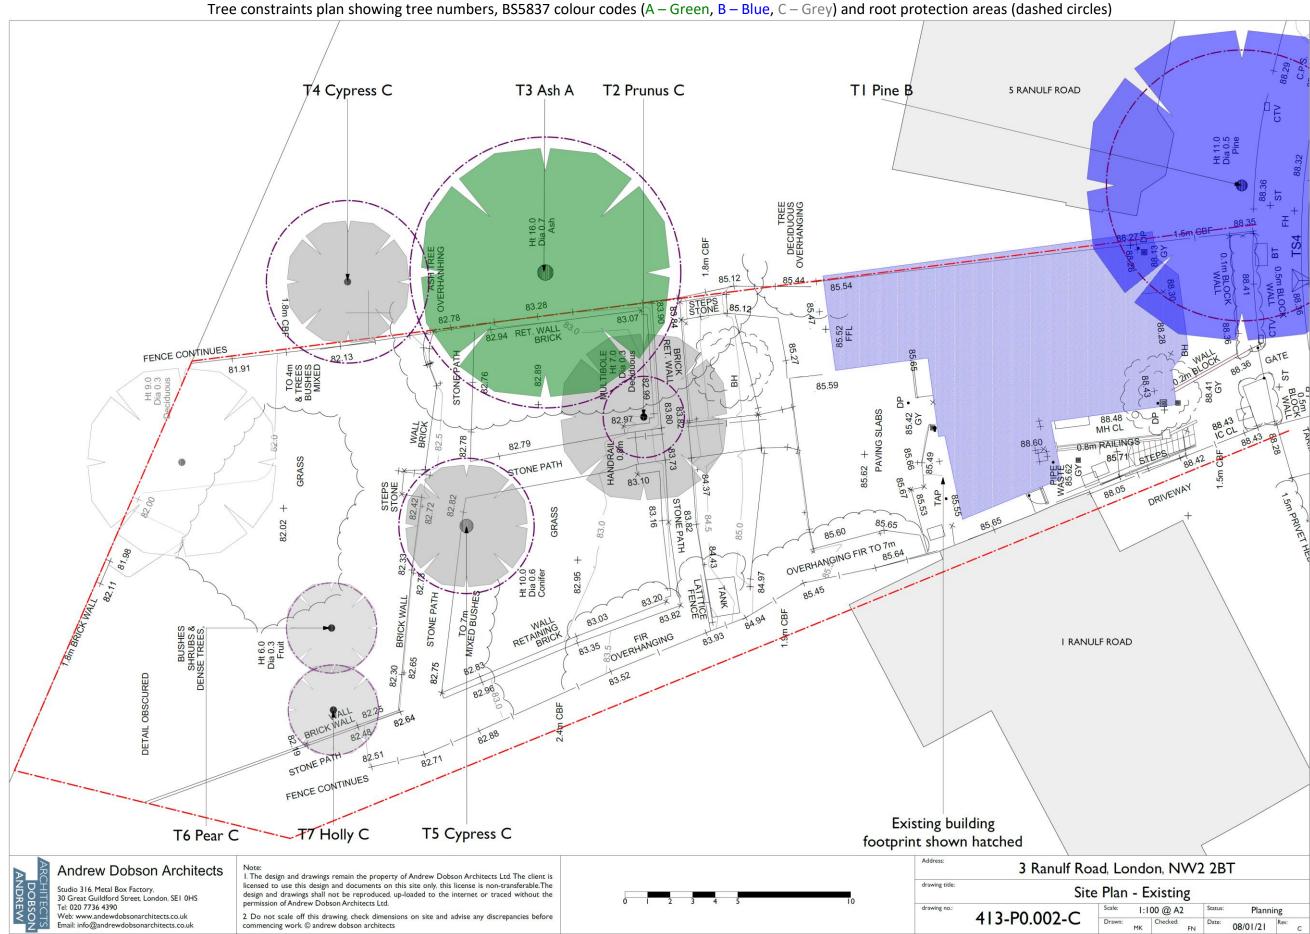
APPENDIX MD2 Tree constraints plan showing tree numbers, BS5837 colour codes (A – Green, B – Blue, C – Grey) and root protection areas (dashed ci

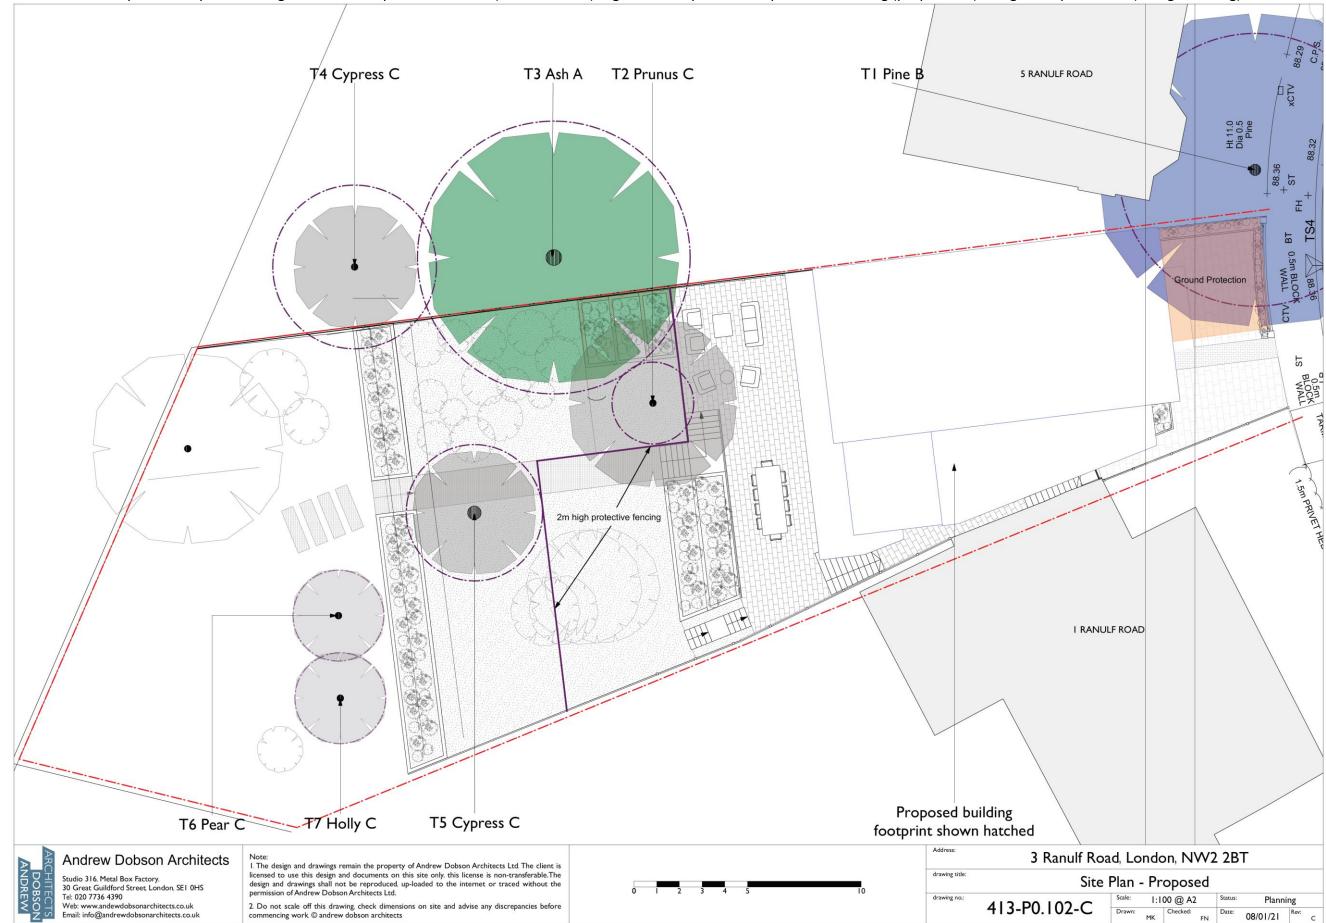
APPENDIX MD4

Tree protection plan showing extent of root protection areas (dashed circles) together with positions of protective fencing (purple lines) and ground protection (orange shading).
