Deliveroo Editions, Swiss Cottage

Review of adopted Operational Management Plan

Firstplan Ref: 17232/MM/TH

Date: April 2020

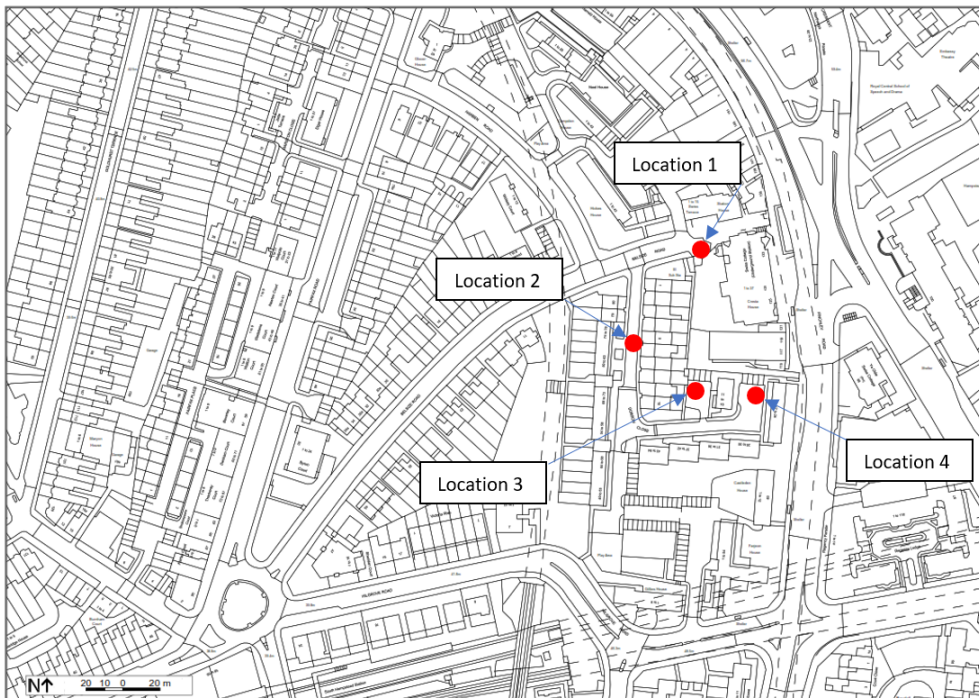
Figure 3. Map showing the locations used for the off-Site monitoring

3.16 The monitoring around the Site was carried out by both Surveyors and this allowed for an agreement on the matters being observed, in order to improve consistency. The locations used are set out below and shown at figure 3 below.

- Location 1: Outside Cresta House car park
- Location 2: Outside No. 6 Dobson Close
- Location 3: Lower car park, Dobson Close
- Location 4: Higher car park, Dobson Close
