# The Grove, Highgate Pool Construction Structural Engineering Report for Planning (CMS)

| <b>PROJECT NAME</b> | The Grove | | |
| <b>PROJECT ADDRESS</b> | 5 The Grove, London, N6 6JU | | |
| <b>DOCUMENT TITLE</b> | Structural Report for Planning (CMS) - Pool Construction | | |

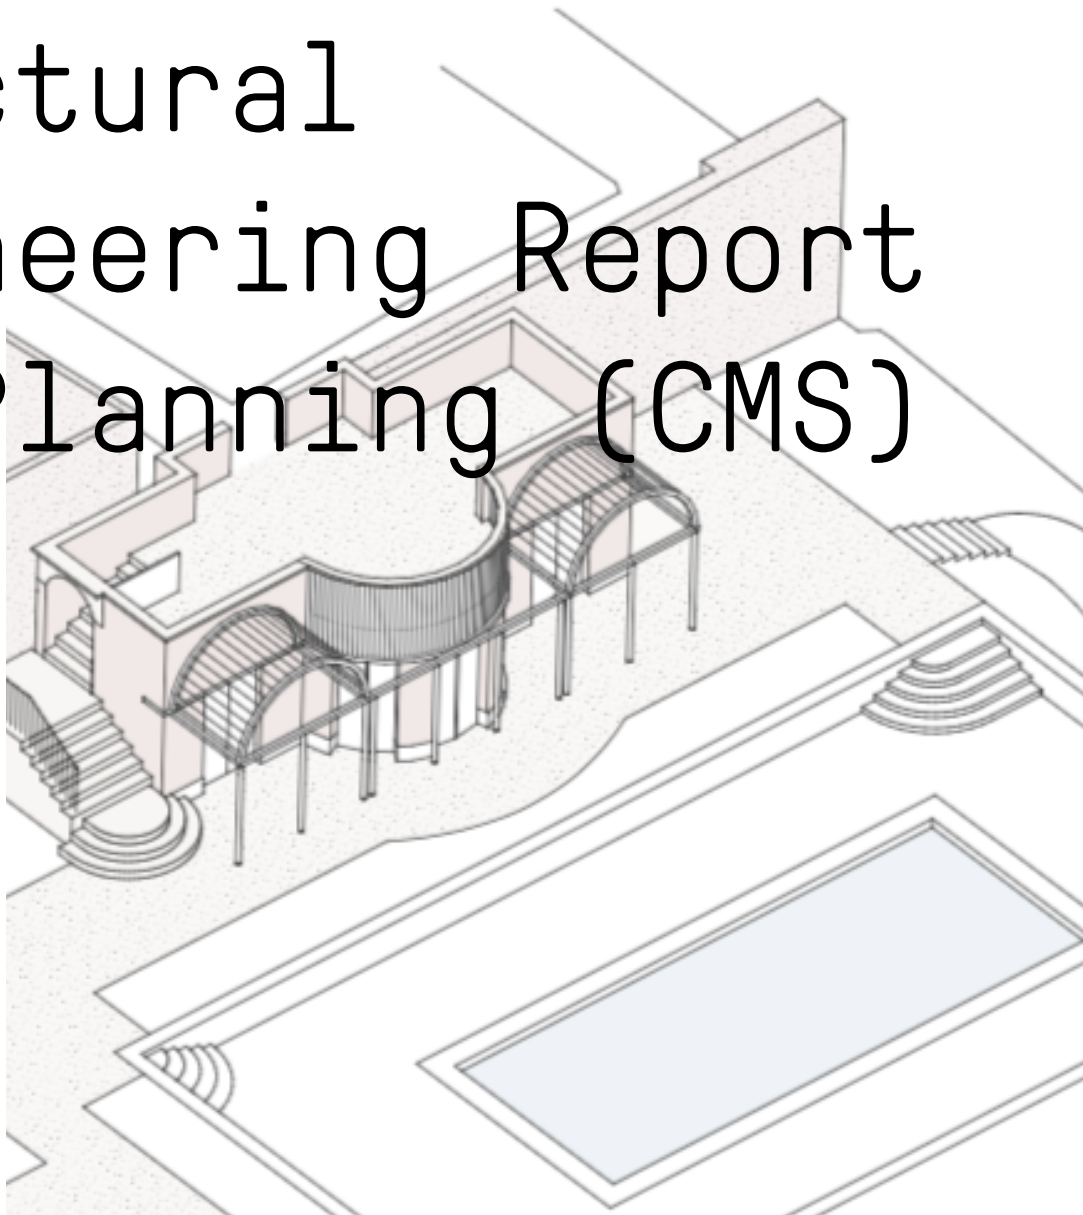
An architectural cutaway diagram showing a multi-level building structure with a central curved section and a large rectangular pool area in the foreground. The diagram illustrates the structural layout, including walls, floors, and stairs, with some areas highlighted in light blue to represent water or specific structural components.
