Sweeper application

ARCHER HUMPHRYES ARCHITECTS

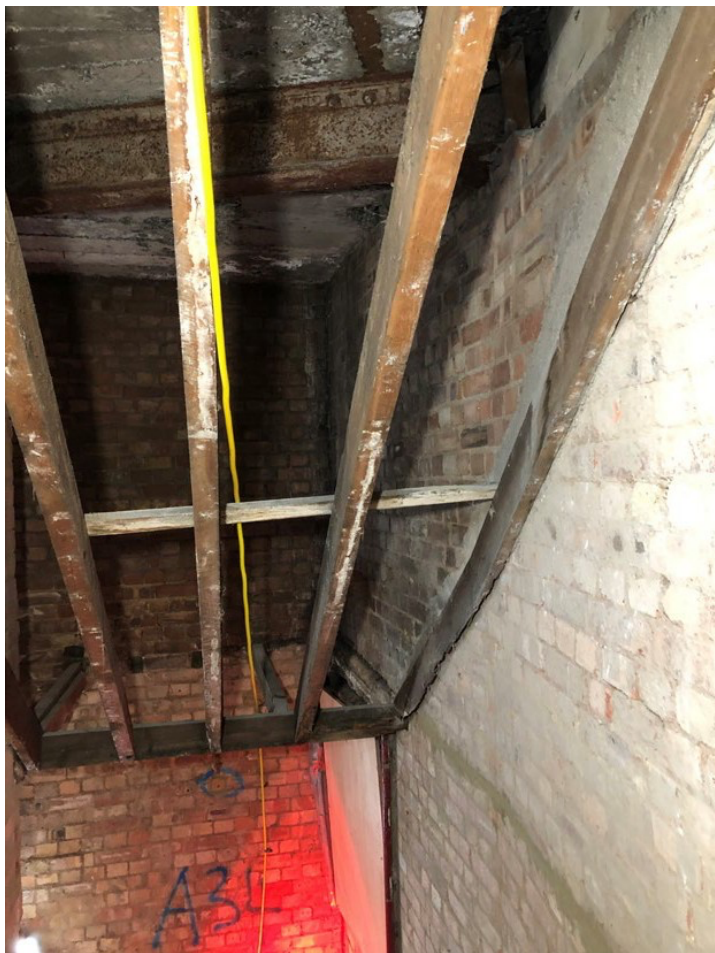
Existing photo of timber frame

Ceilings- 2nd floor timber framework to be replaced where possible, ceiling level to be replaced tight up to the existing slab.

2nd floor timber framework to suspended ceiling RM.2-22 damaged due to wet rot. The client would like to remove the ceiling tight up against the existing slab to integrate a chandelier as an experience within this staircase and entrance to the second-floor bar.

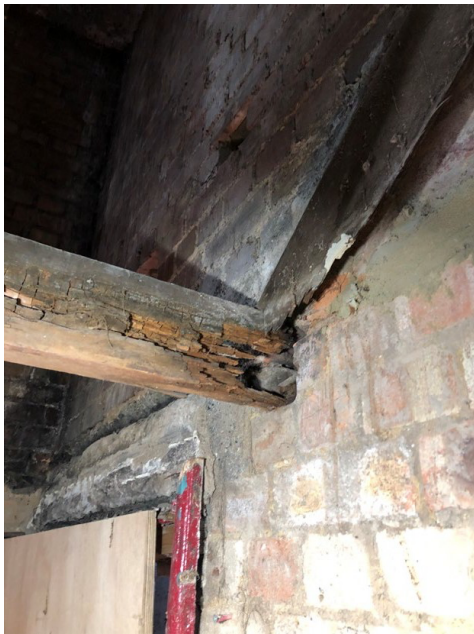
Rotten damaged timber frame

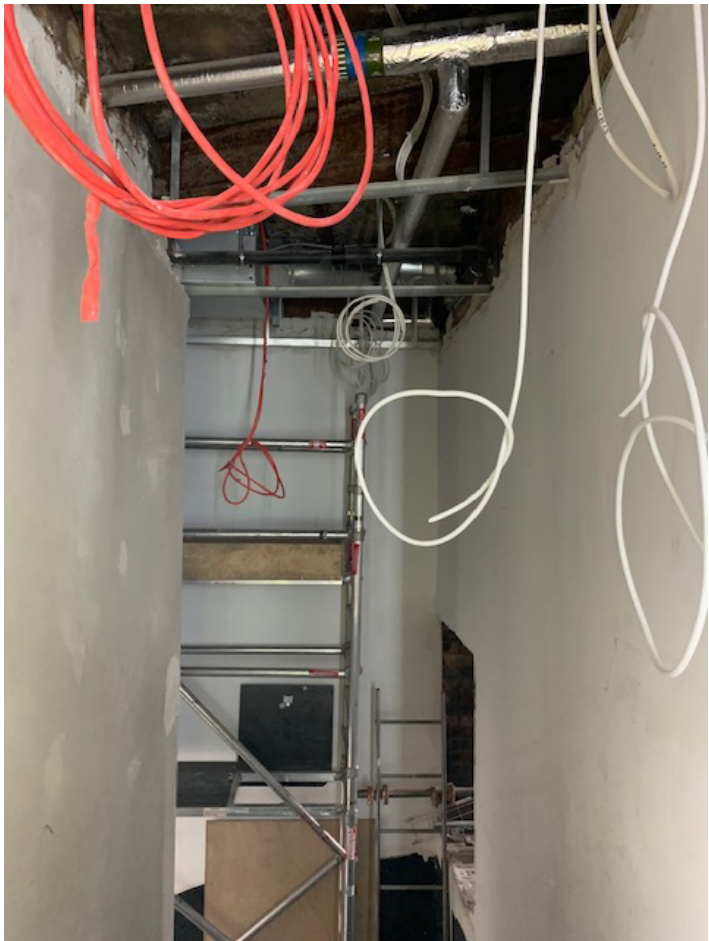
Proposed Metal Frame tight against services

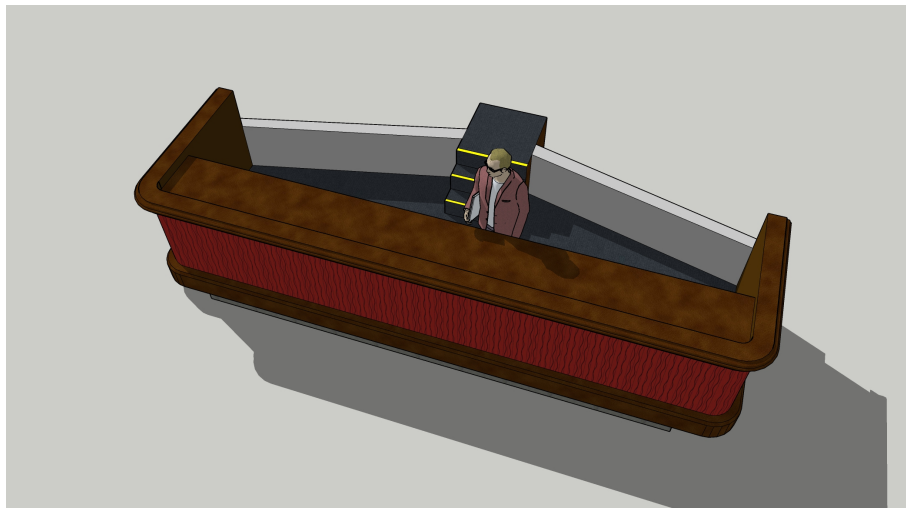
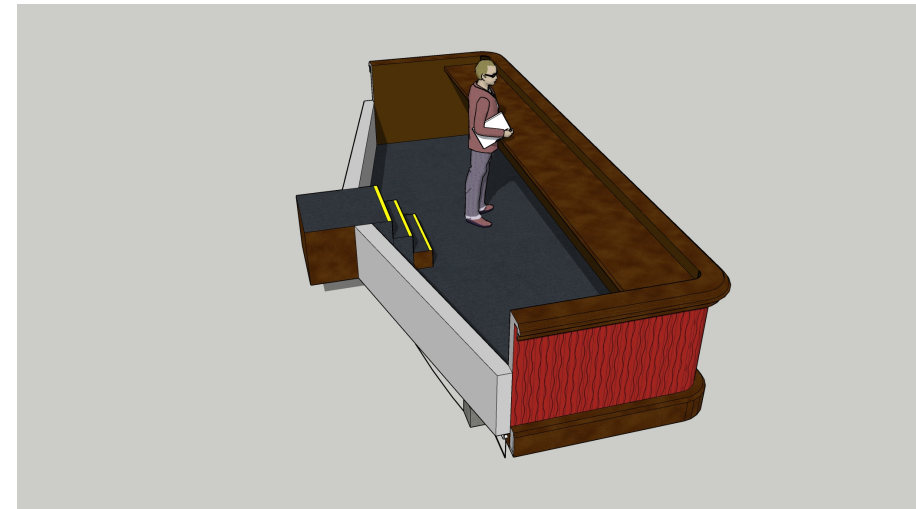
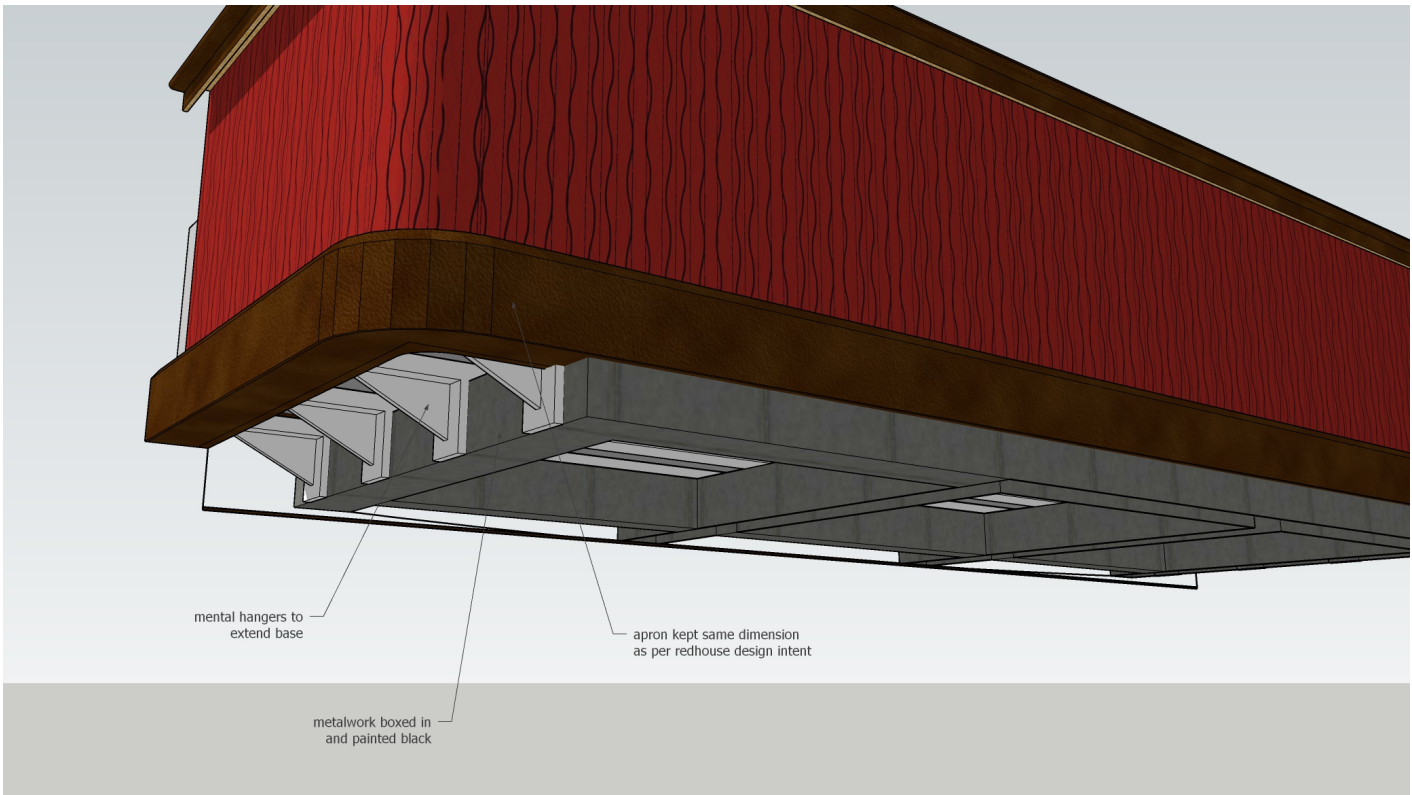
Extension of balcony to DJ / Sound booth.

It has been required to extend the DJ / Sound booth for current specification of equipment that will be required in this area. The light gray bracket has been designed with the structural engineer and can be attached to the existing metal frame seen above in dark gray.

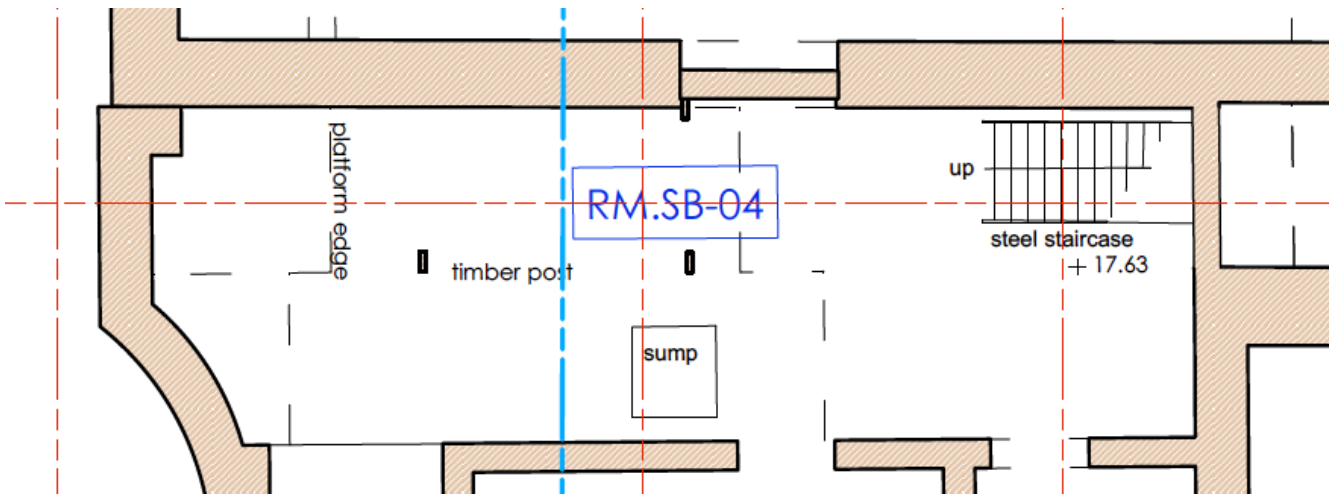
Image: Existing plan

New opening / and reinstatement of an existing stair in basement areas. It is a statutory requirement to have two exists in an electrical switch room, we are therefore asking for permission to open a second door into the switch room. The opening will be below the existing steel stair highlighted below in yellow. The steel stair will be kept and relocated.

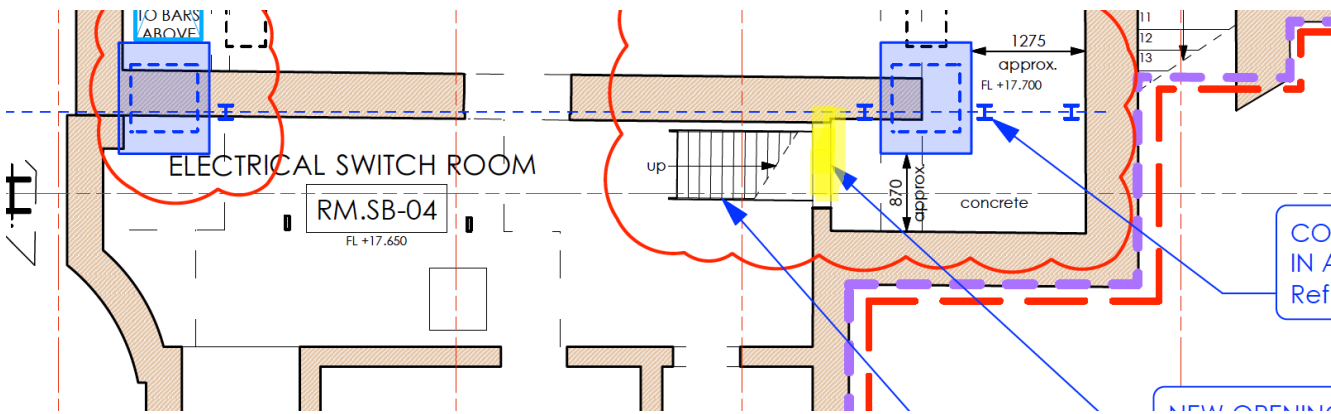
Image: Proposed plan
