Camden Geographical, Hydrogeological and Hydrological Study
Hampstead Heath Surface Water Catchments and Drainage
Report: J1 1891
Site: 93 Hillway, London N6
Figure: 5

Site Investigation Report

Site: 93 Hillway, Highgate, London N6 6AB

The site comprises an existing terraced property No 93 Hillway, London, N6 6AB. It is proposed to construct a new replacement below ground swimming pool with simple pool pavilion over.

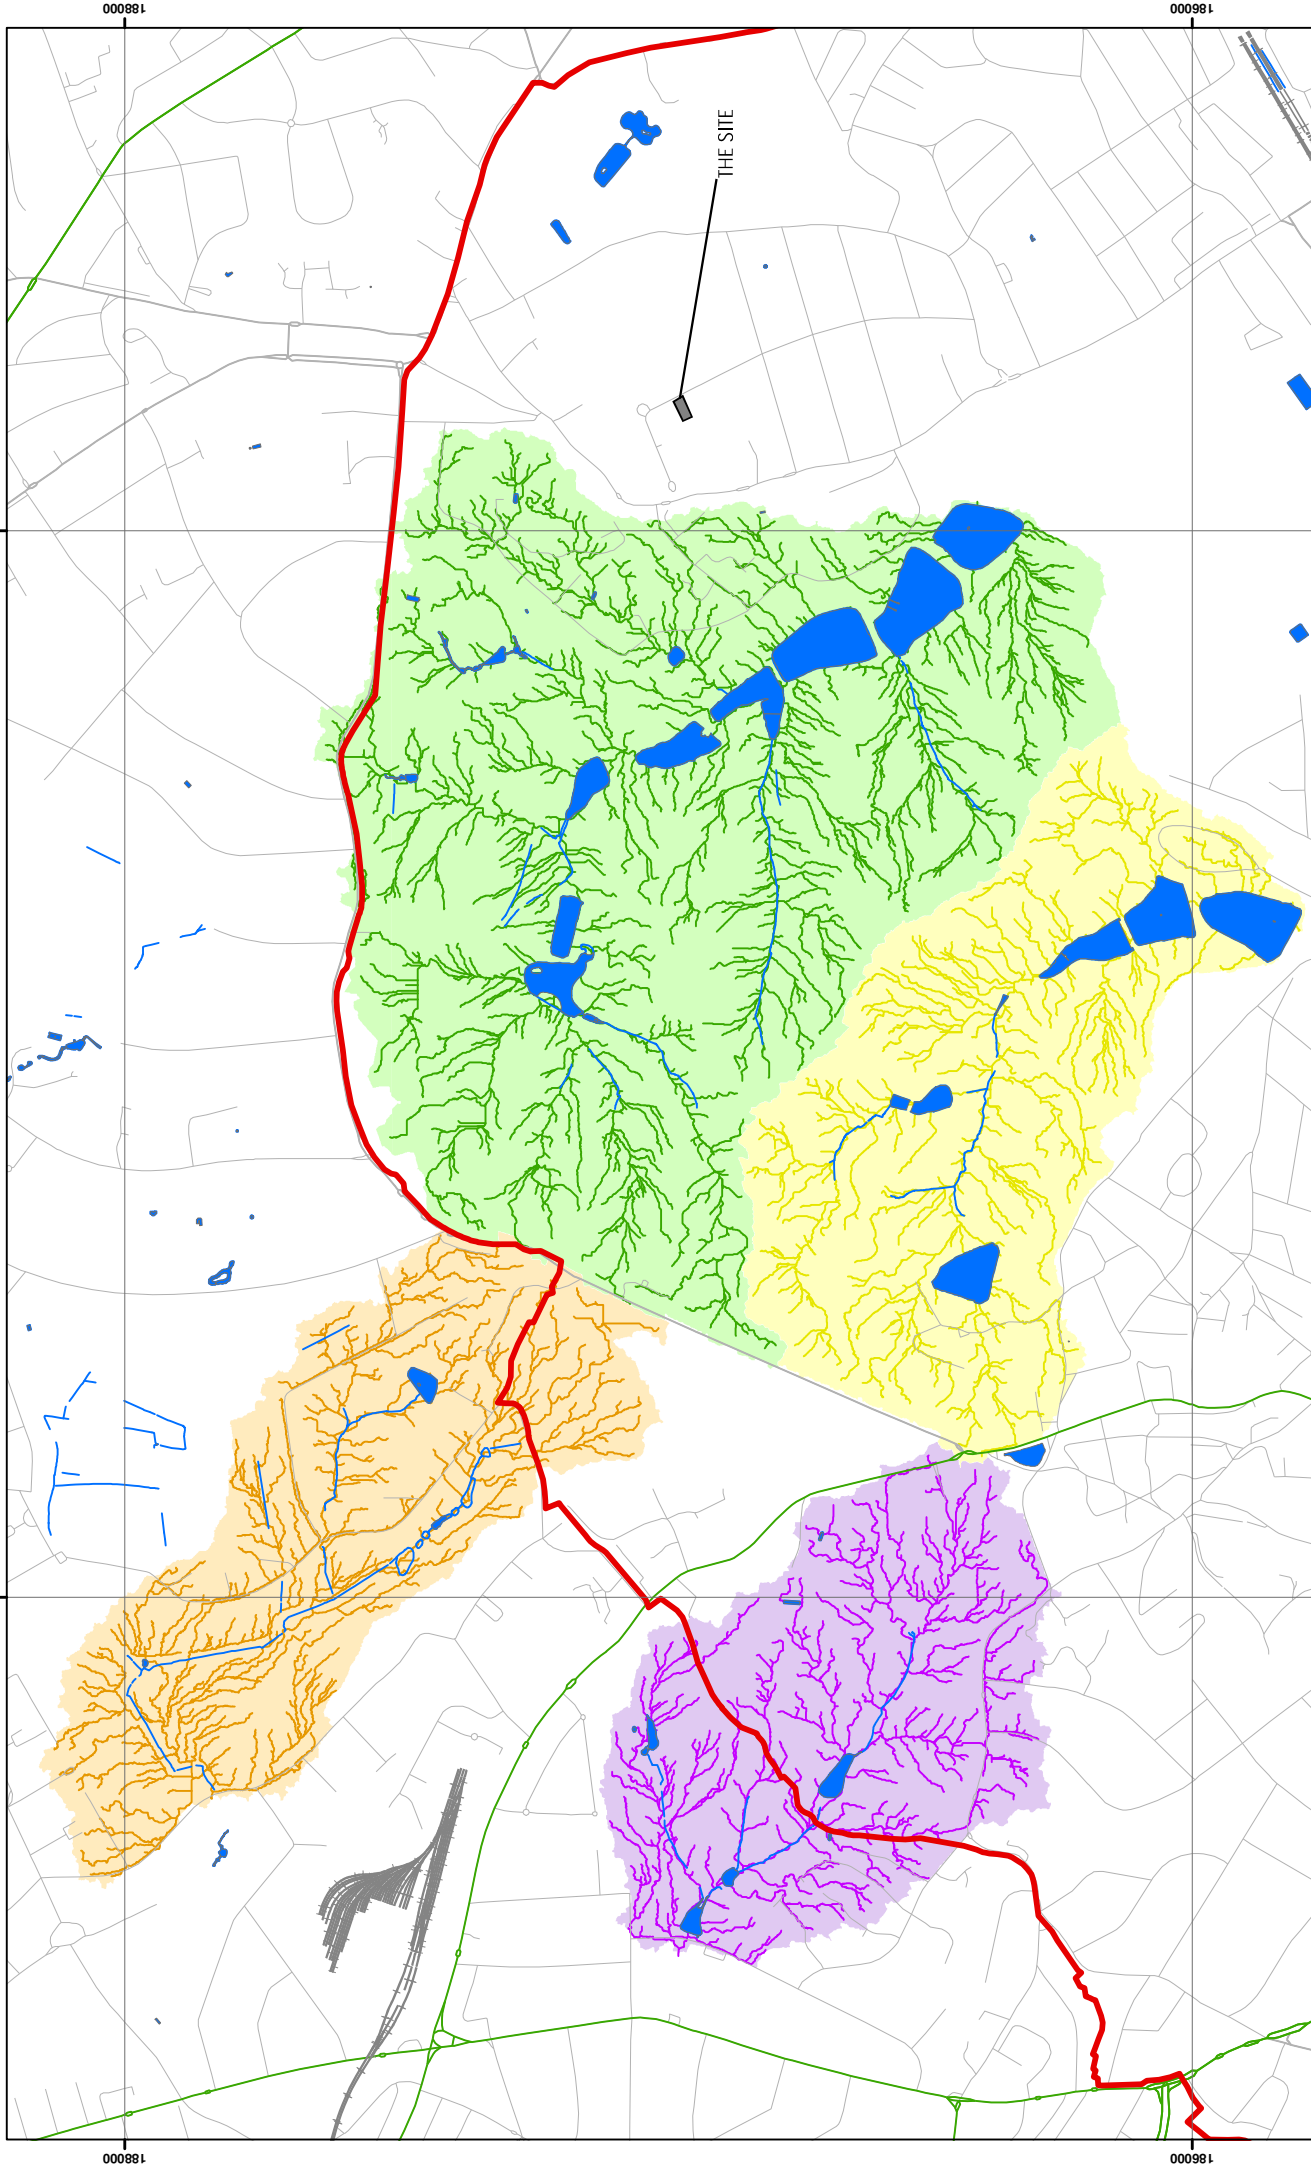
Catchments and Drainage after Haycock, 2010

Surface Water
Highgate Chain Catchment
Golders Hill Chain Catchment
Hampstead Chain Catchment
Hampstead Heath Extension Chain Catchment
