3 EVALUATION

3.1 RESPONSE TO HERITAGE APPRAISAL

3.2 DESIGN DEVELOPMENT

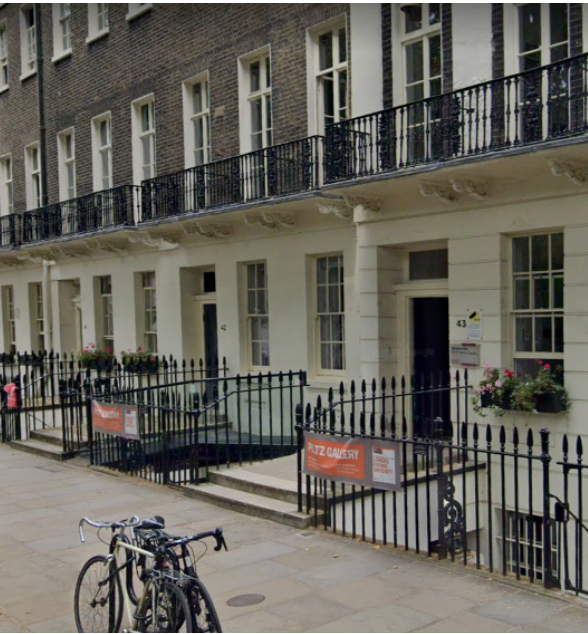
CURRENT MAIN ENTRANCE SIGNAGE

The current signage to the main entrance is comprised of fabric banners to the front railings and a small metal sign to the main facade. Neither of these are considered sufficient by Birkbeck, in addition these signs are not sympathetic with the architecture and Conservation Area.

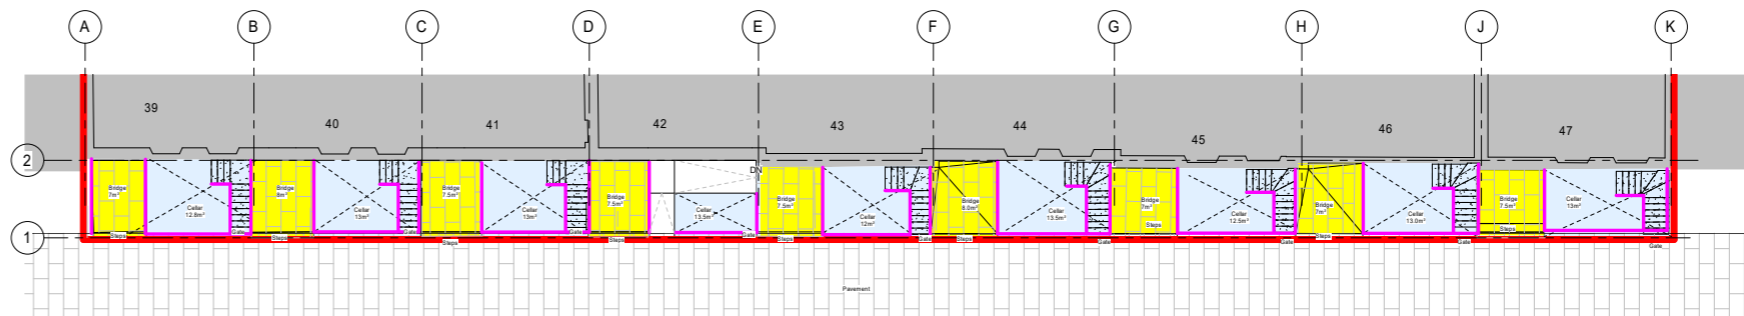
1. Planning - Proposed External Works Plan
1 : 100

- Notes:**
All areas, lengths and dimensions are accurate to the survey model.
Site measurements are required to determine extent of accuracy
- Cellar Bridge:** Repave stone tiles, heritage team to advise on detailed method/works

- Cellar Area:** Clean stone floor tiles, relay where necessary and replace where missing or broken (Area includes steps)
 - Localised render repairs where required - Paint finishes to be removed, stucco render to be repaired with a lime based mortar to improve ventilation. Area to be repainted with a breathable paint finish.

We have also taken the opportunity to improve the appearance of the bridges to the ground floor with the re-instatement of missing and the repair of existing stone paving slabs.

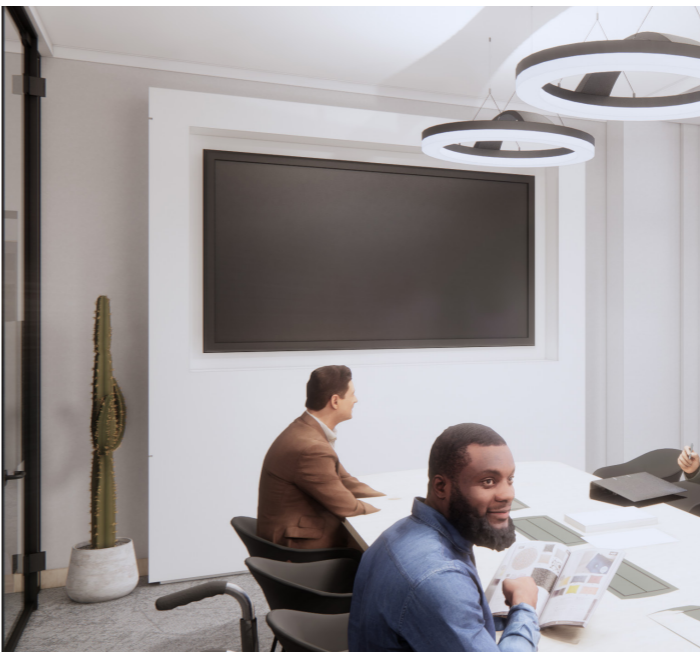
Left; Illustration of free-standing AV unit

The below options were developed and discussed with the client to enable a final approach to be chosen. The key consideration being the heritage asset be respected and not harmed. As an example of this was the suggested use of free-standing units containing screens and AV equipment instead of overhead projectors and wall mounted AV to prevent damage to walls, ceilings, and corncoring from surface fixings and cable routing.

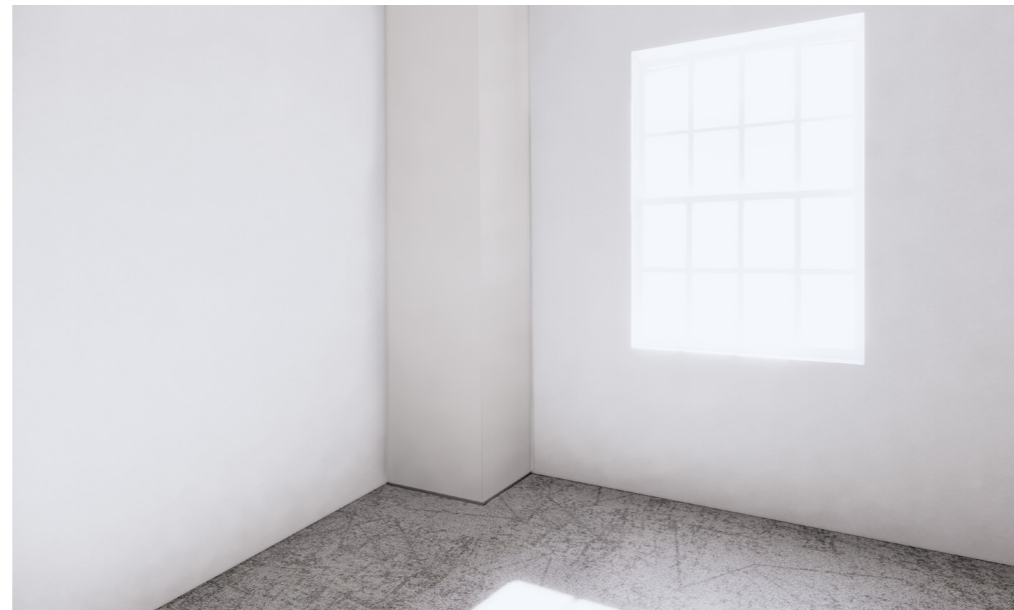
Above; Existing boxed in services are in poor condition with poor quantity junctions to existing fabric and poor access

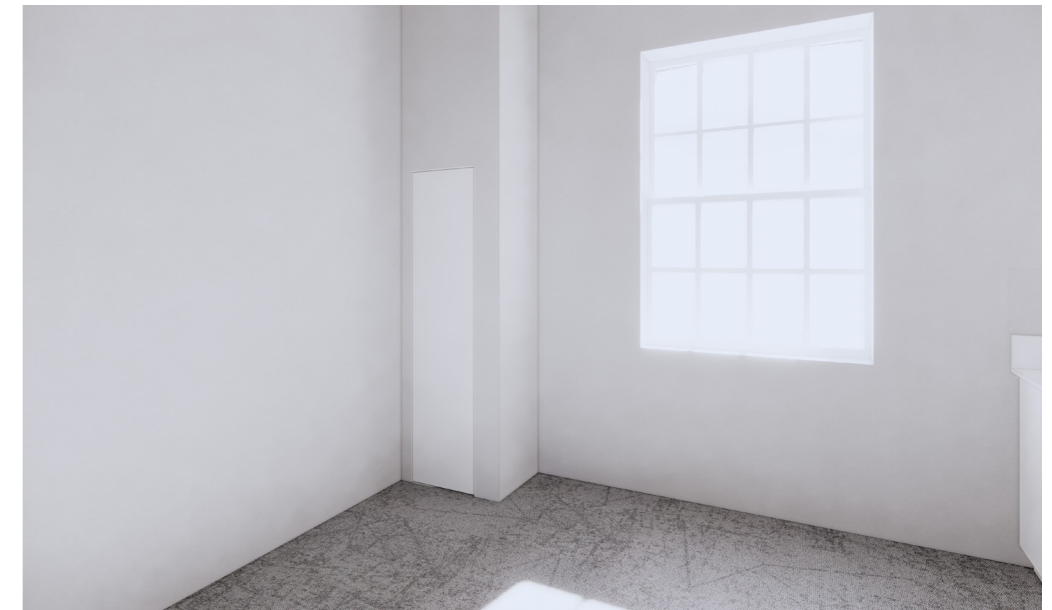
Above; Where size and shape of service enclosures has been adjusted new fire rated risers are to be formed. These will be finished to match the adjoining walls and have neat junctions to the existing fabric. Flush access doors will provide access.

There has been the need to enlarge these remaining risers slightly in order to accommodate the services in one location and contain them in the fire-rated enclosure required by Building Regulations. Please refer to the Heritage Impact Plans that show existing riser extents alongside proposed. The design team have worked carefully to ensure this increase has been minimal and enlargements have been made in rooms without ornate heritage assets.

Access is provided to the risers via discreet flush metal doors and lift off access panels. It is anticipated that access will be required infrequently once services are initially installed.

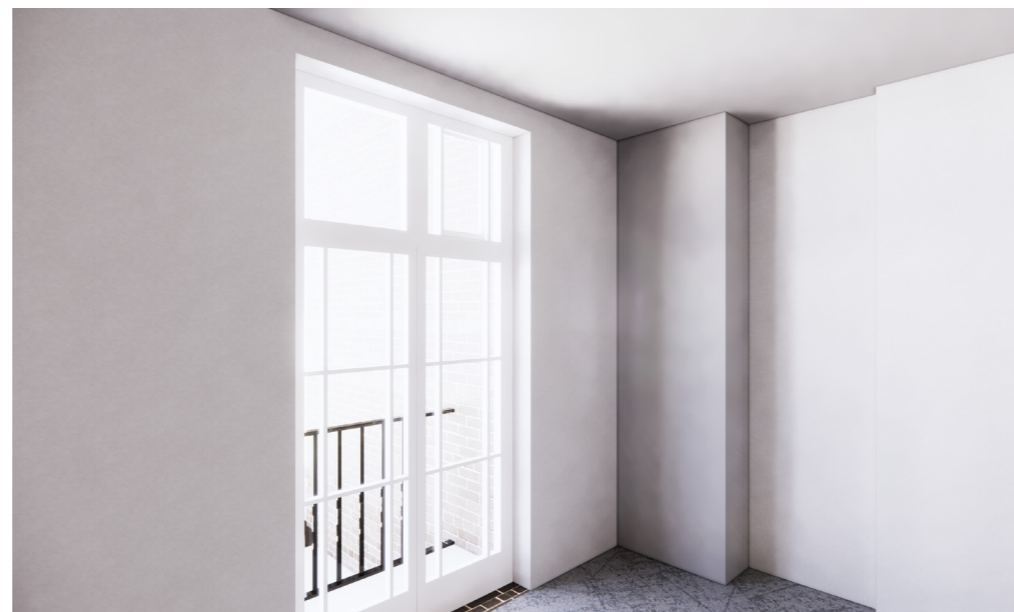
Above; Existing boxed in services are in poor condition with poor quantity junctions to existing fabric and poor access

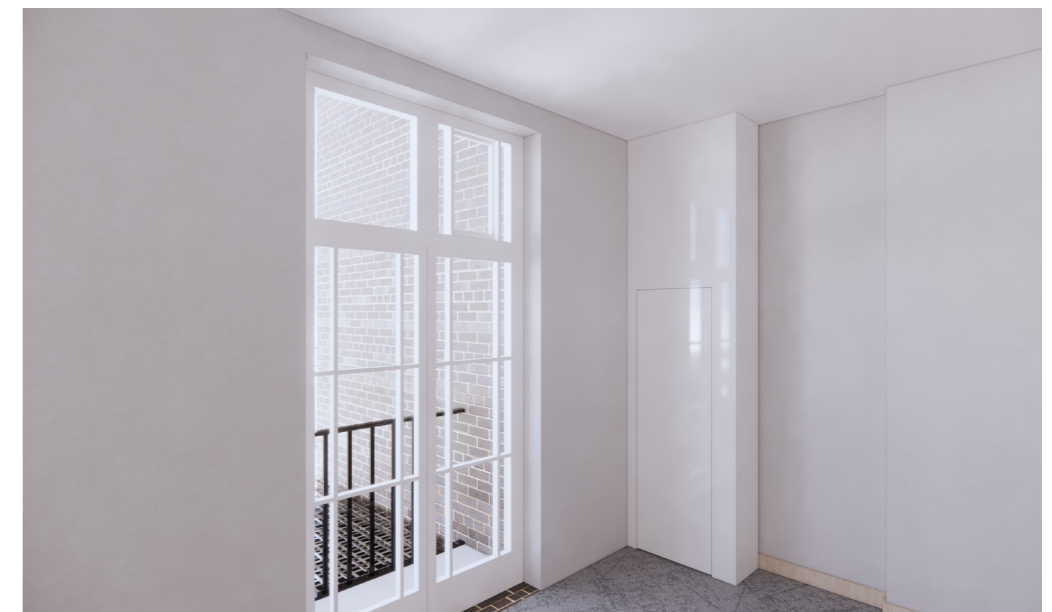
Above; Where risers remain the same size replacement services enclosures are to be high quality joinery items finished to match the adjoining walls. Enclosures will have neat junctions to the existing fabric and demountable panels to provide access.

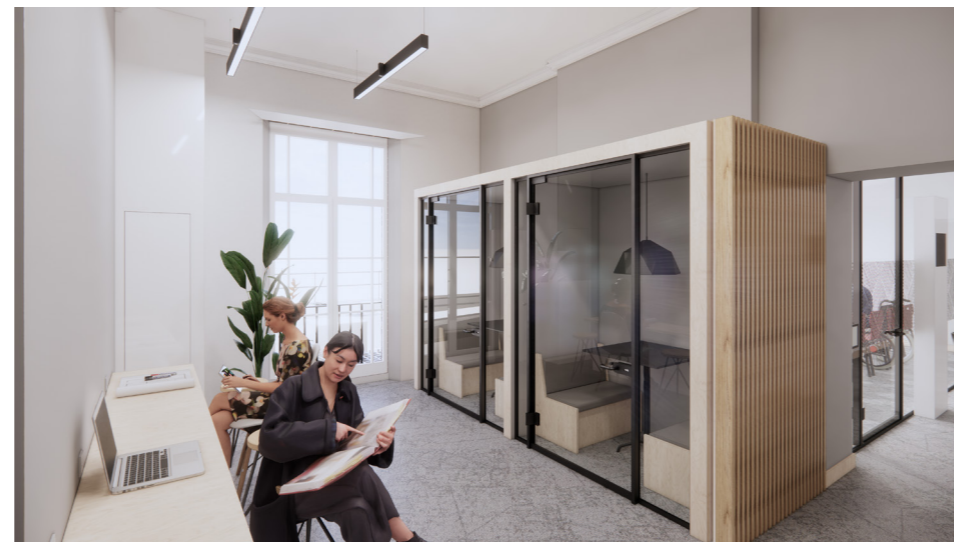
ARTISTS IMAGE OF OPEN TUTORIAL PODS AND MEETING SPACE

There are two locations on the first floor where existing cornicing is intact to the full rear room. In these locations the space is left open as a social breakout area with free standing 'meeting pod' furniture items to provide the privacy required for one to one meetings and tutorials. This allows the client brief to be achieved whilst ensuring no harm is caused to the heritage asset through further subdivision.

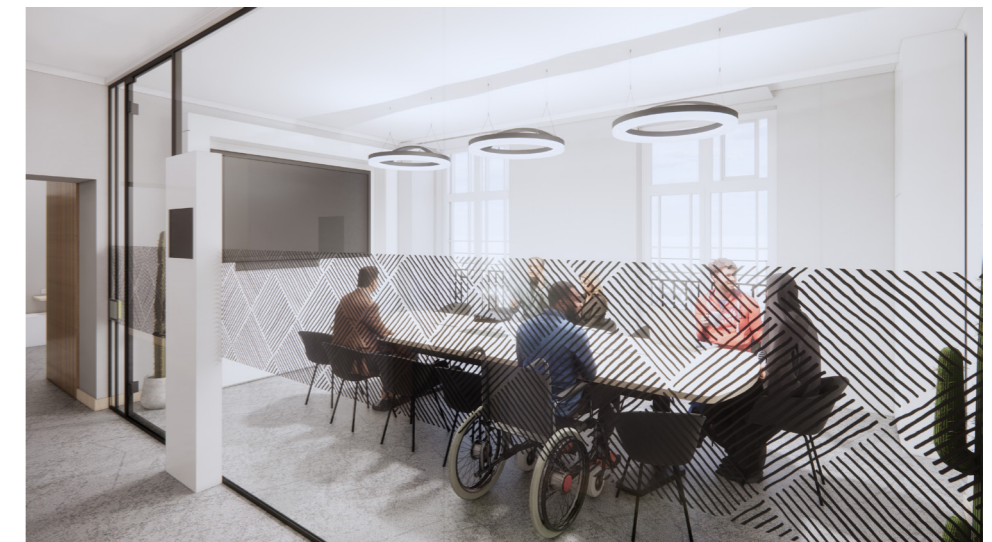
ARTISTS IMAGE OF GLAZED PARTITION TO MEETING ROOM

Whilst undertaking the exercise to realign the horizontal circulation the design team have taken the opportunity to remove the existing stud partitioning to the rear rooms of the building, replacing in some instances with full height glass partitioning. This is proposed for two reasons:

- To allow for the existing cornicing to be seen from both within the room and within the corridor and still be appreciated as being formally one whole room. Visually re-instating the original plan form.
- To improve way-finding and allow views to the external windows. This allows for greater opportunity for people to orientate themselves in the terrace.
