## 5. STRUCTURAL ENGINEERING PROPOSALS

Project  
**BIRKBECK**

Title  
**Basement plan with Ground Floor structures shown reflected above. Opening up works**

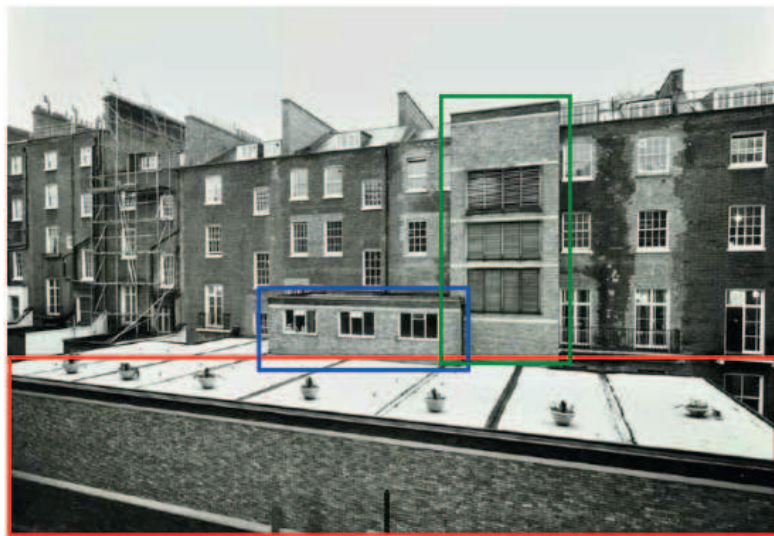
Figure 5: Full-width, two-storey extension (in red), single-storey extension at first-floor level to the rears of No. 43-44 (in blue), cooling tower to the third floor behind No. 43 (in green)

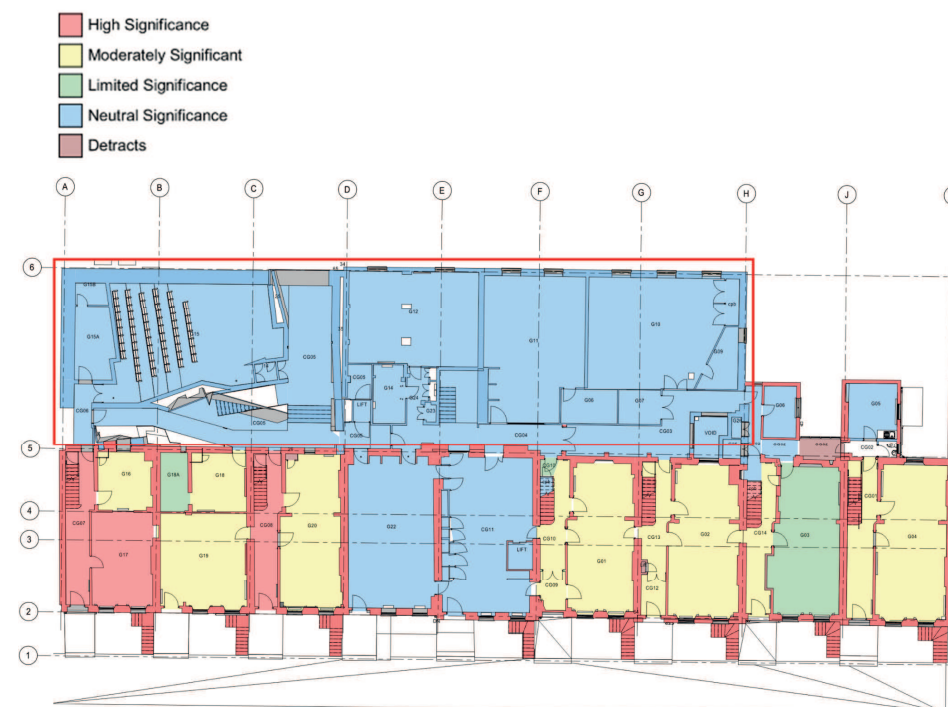
- » Foundations – Foundations are believed to be strip footing under load bearing walls.
- » Rear Extension – The rear extension is believed to comprise of concrete floors on steel frame (highlighted in the image below). During the visual inspections, concrete columns and beams have been noted in the basement but they are believed to be made of steel with concrete encasement rather than reinforced concrete structure

Figure 7: Level 00 - Existing Significance Plan with extension highlighted in red

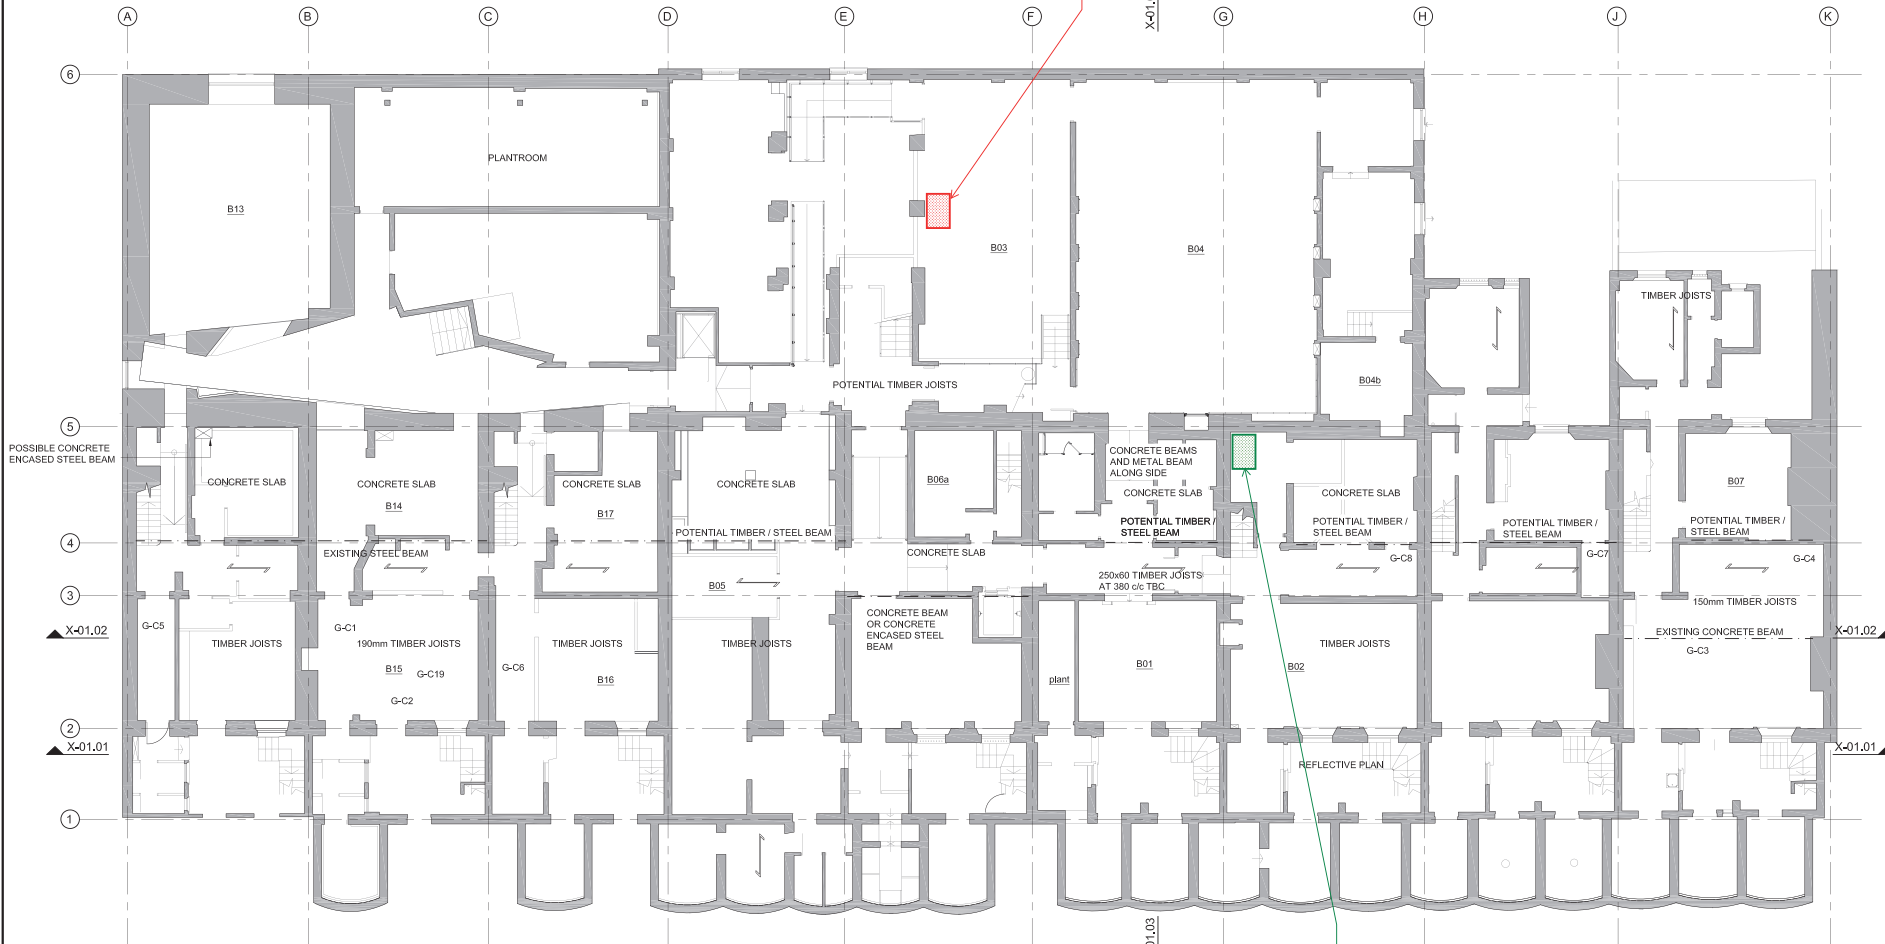
Please note that plans are reflected (show floor structure above)  
Please refer to architect plans for correct room numbering

TP\_L-1\_2 - Trial pit to investigate ground bearing pressure for new pad footings

KEY - INVESTIGATION TAGS				
Location	W=Wall	F=Floor	TP=Trial Pit	C=Ceiling
Level	-1=Basement	0=Ground Floor	1=First Floor	2=Second
Unique reference	1	2	3	4
Importance in regards to cost risk	Most severe	Severe	Least Severe

OPENING UP WORKS TABLE				
Reference	Room reference	Reason	Description	Importance in regards to cost risk
F_L-1_1	New accessible shower. Gridline G5	To investigate screed and concrete slab depth. New accessible shower need screed to fall. Useful also to determine maximum line load that can be applied with temporary propping	Form 250x250mm hole or 150mm diameter core. Once inspected by Hydrock make good with proprietary concrete repair such as Fosroc Paveroc in 100mm layers or concrete C32/40 to reinstate slab	Least Severe
TP_L-1_2	B03	Trial pit to investigate ground bearing pressure for new pad footings	1000x1000mm square trial pit to expose underside of existing foundation and provide space for bearing capacity check by geotechnical engineer. Once inspected by Hydrock make good with proprietary concrete repair such as Fosroc Paveroc in 100mm layers or concrete C32/40 to reinstate slab	Most severe
