## SITE INVESTIGATION FACTUAL REPORT

Report No: [REDACTED]  
Client: Crawford Claims Management  
Site: 52 ST ALBANS ROAD, LONDON  
Client Ref: [REDACTED]  
Date of Visit: 01/02/2021

Home Emergency Response - Subsidence Investigation - Drainage Services – Crack & Level Monitoring – Property Video Surveys

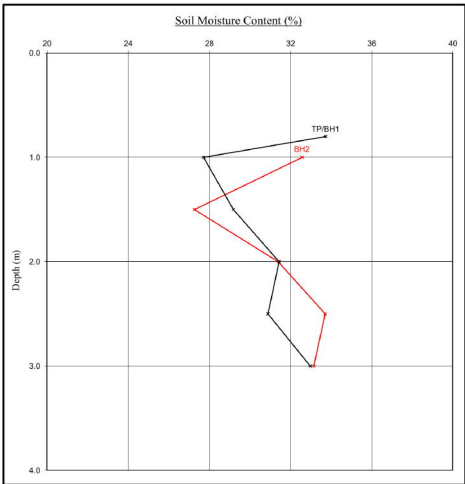
Moisture Content Profiles

Notes  
1. If plotted,  $0.4 LL$  and  $PI-2$  (after Driscoll, 1983) should only be applied to London Clay (and similarly overconsolidated clay) at shallow depths.  
2. Unless specifically noted the profiles have not been related to a site datum.
