### 3. Existing Structure

Norfolk house was originally constructed in 1904 and extends from basement to Level 4. The structure is load bearing masonry with concrete filler joisted floor structure, approximately 190mm deep.

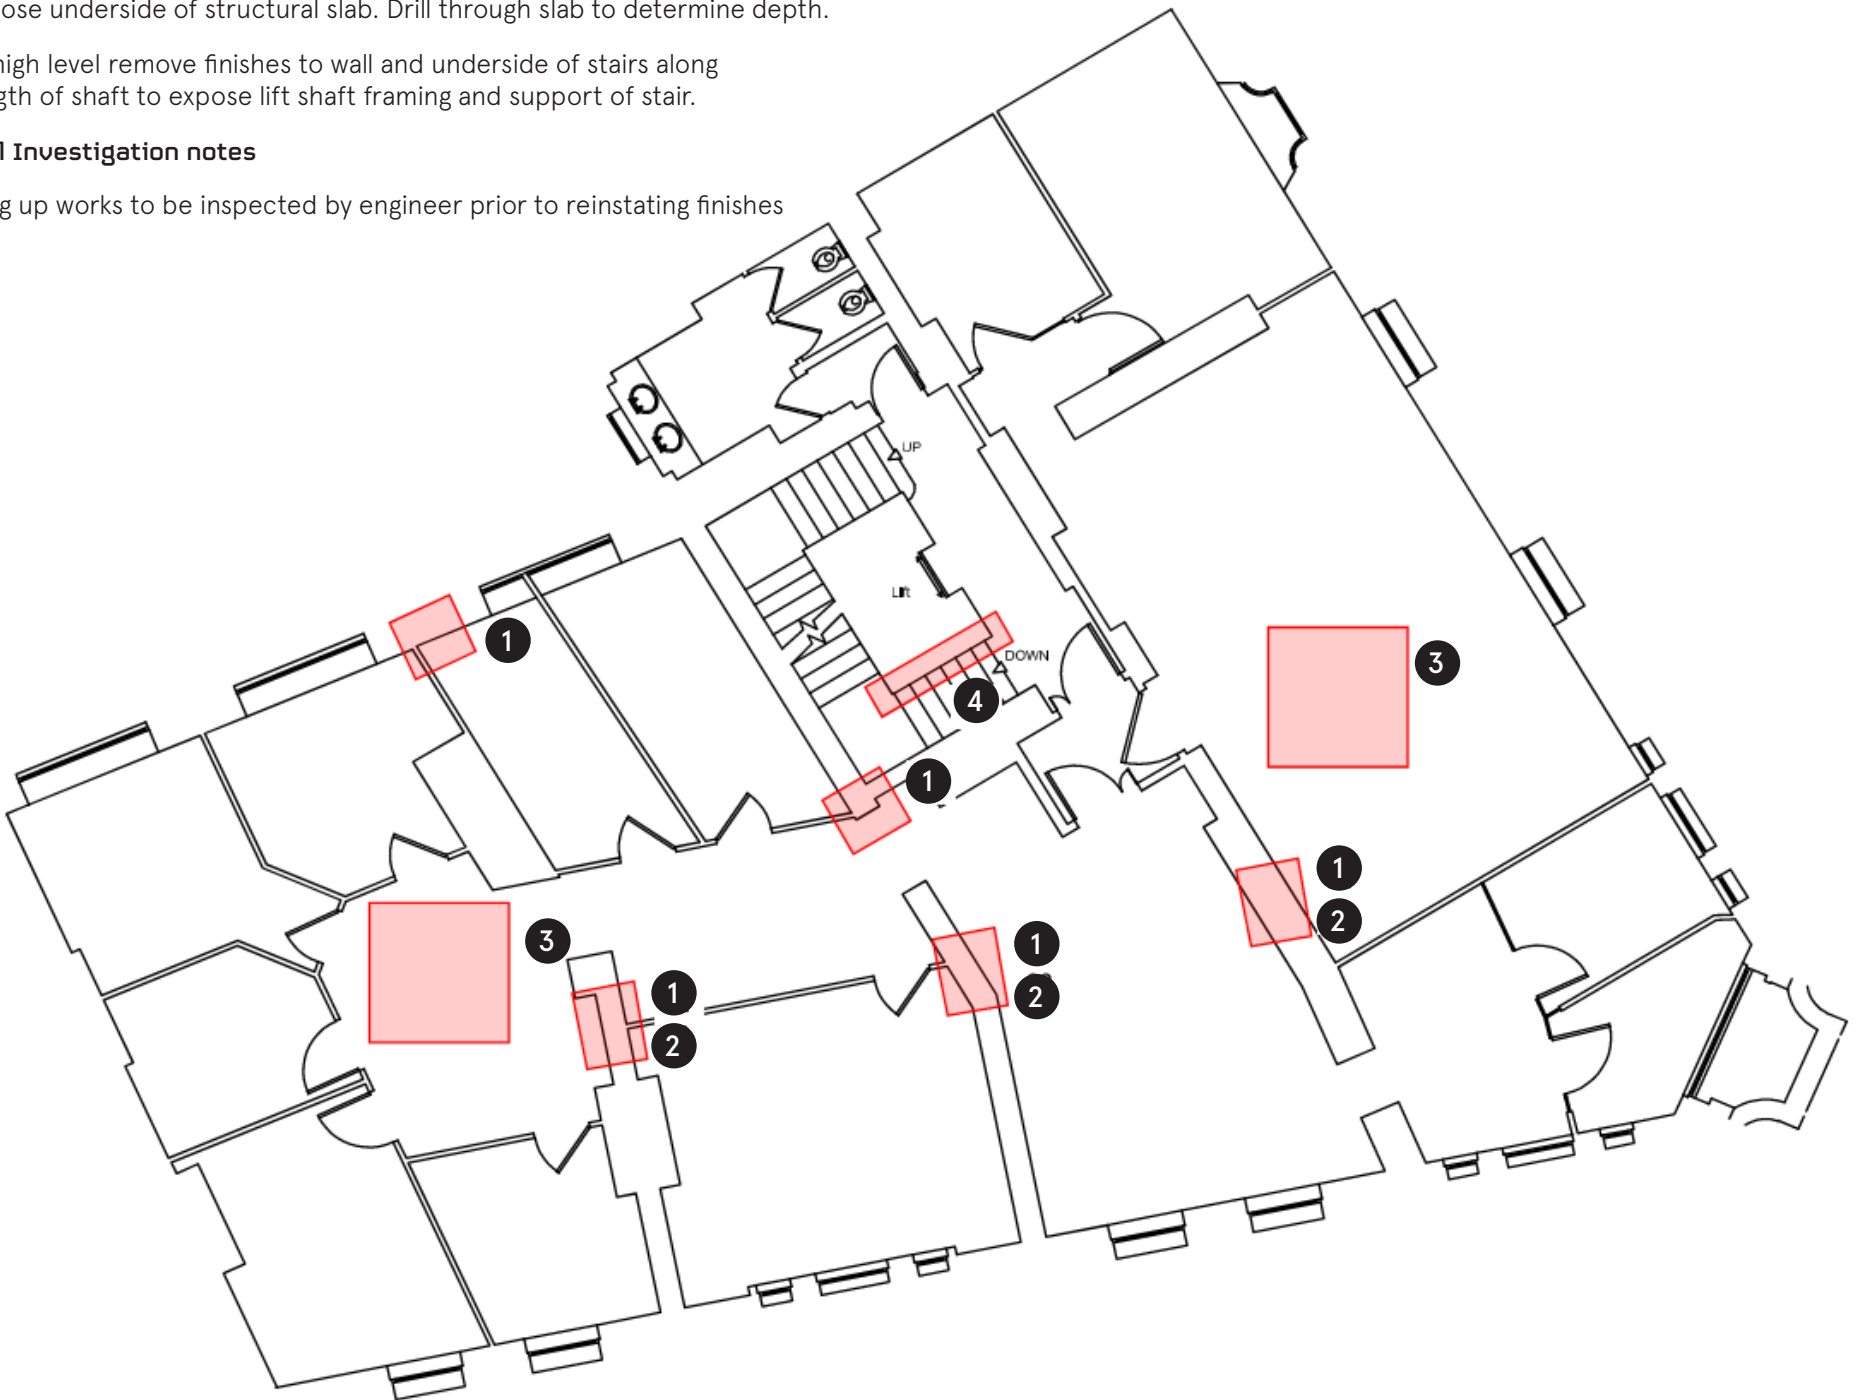
IMAGE 14 - LEVEL 1 INVESTIGATIONS PLAN

- 1 At high level remove ceiling and all finishes on both sides of wall along length of 2m by at least 500mm width. Expose underside of steel beam and slab structure
- 2 At low level remove floor finish and any architectural floor build up over area of approximately 2m x 500mm either side of the wall. Expose top face of slab and connection into masonry wall.
- 3 At high level remove ceiling and all finishes over area of 2m x 2m to expose underside of structural slab. Drill through slab to determine depth.
- 4 At high level remove finishes to wall and underside of stairs along length of shaft to expose lift shaft framing and support of stair.

All opening up works to be inspected by engineer prior to reinstating finishes

Structural opening up works to confirm size, framing and condition of structural elements.

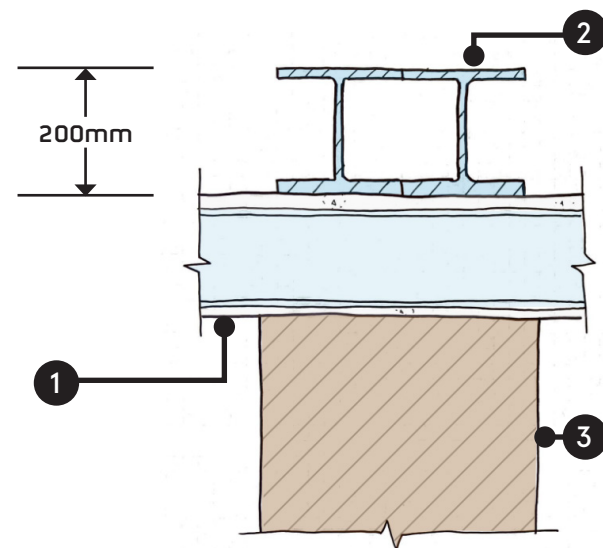
IMAGE 15 - SECTION THROUGH PROPOSED SPREADER BEAM OPTION 1

- 1 Concrete filler joist floor
- 2 203 UC spreader beams
- 3 Load bearing wall at Ground
- 4 150mm deep fabricated sections
- 5 New steel box frames at Level 1
- 6 Existing timber stairs retained
- 7 Existing timber lift shaft retained. Lit to be refurbished to specialist specification
- 8 Allow for propping from L01-Roof

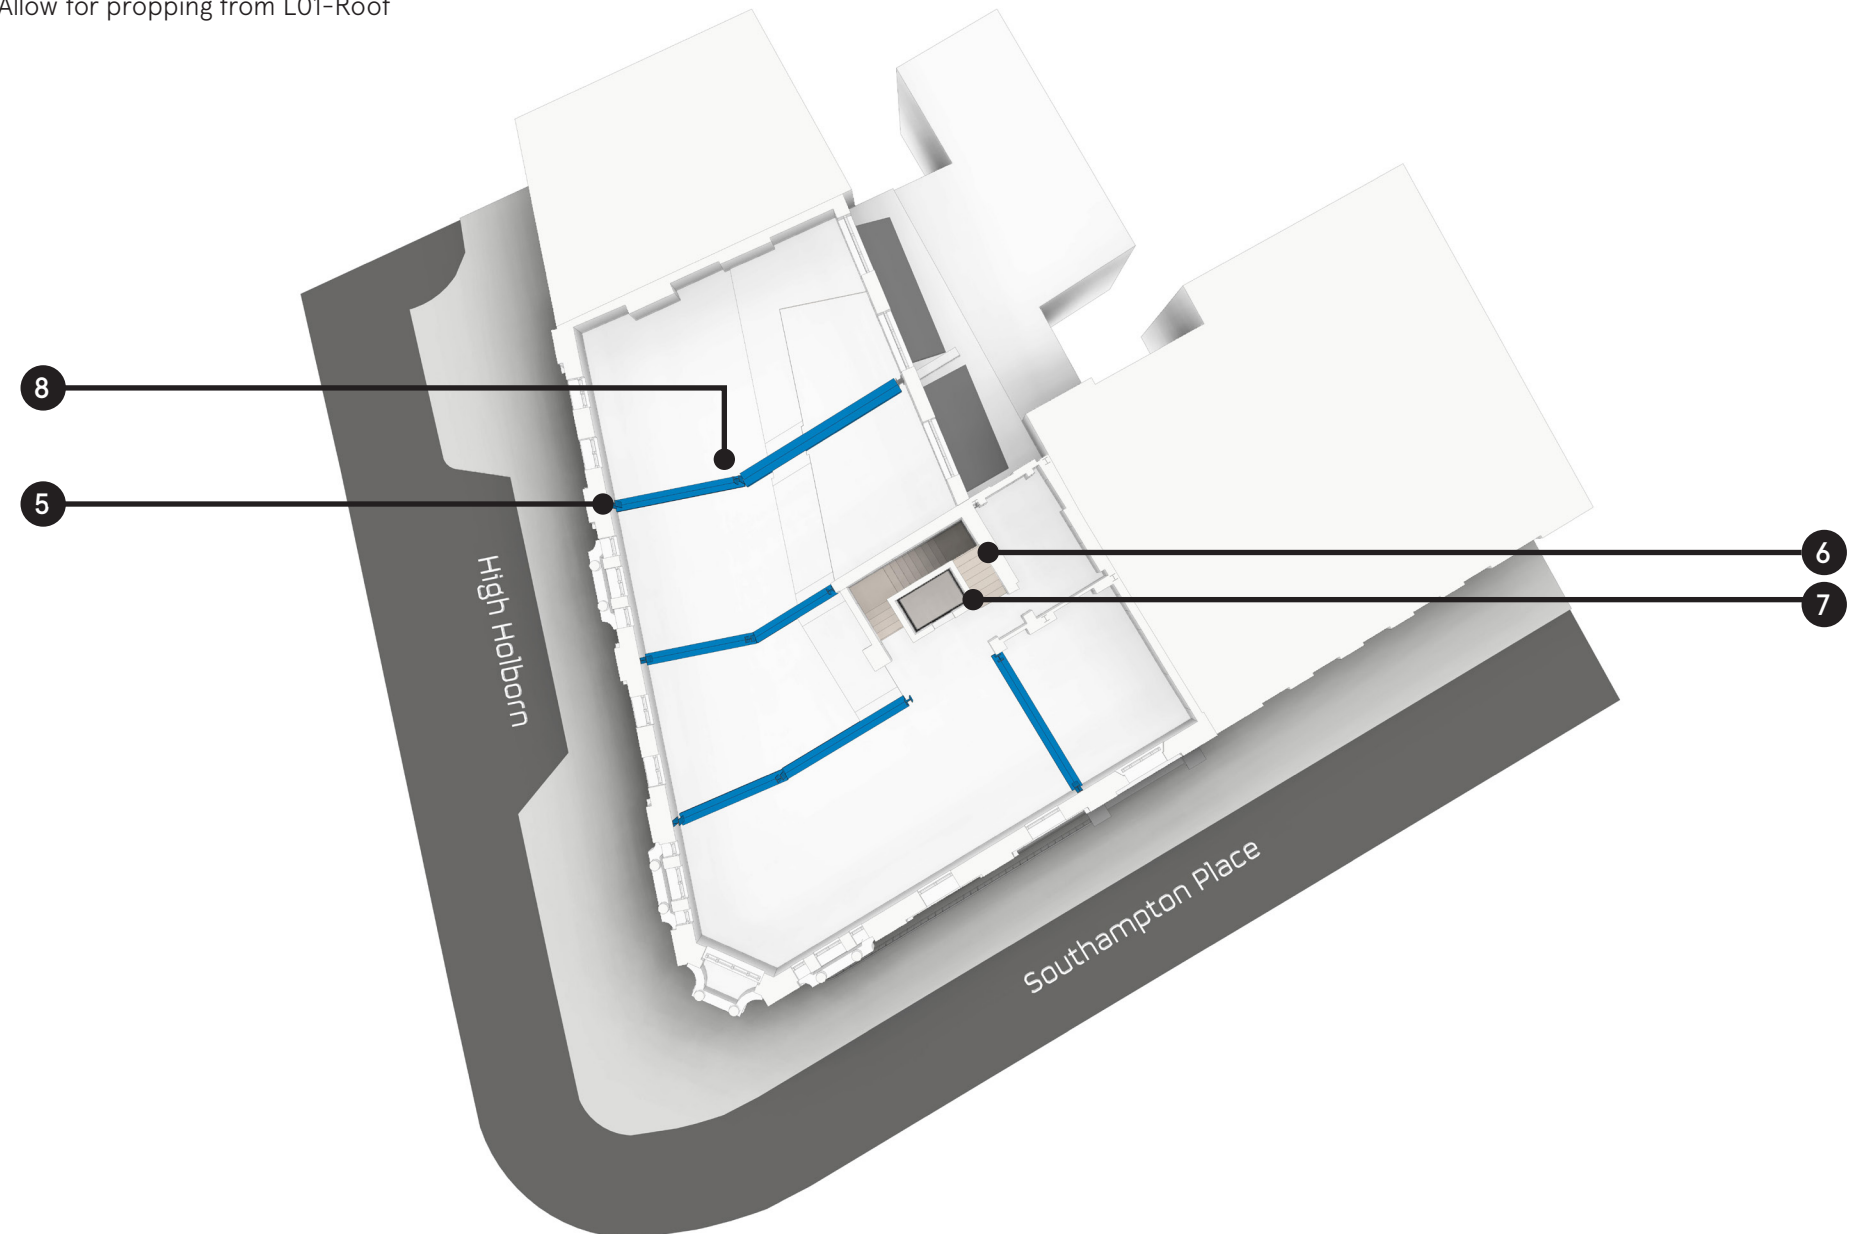
IMAGE 17 - PROPOSED LEVEL 1 STRUCTURAL PLAN

- + Existing load bearing masonry walls on office floor plate to be demolished and replaced with steel box frame supported on masonry walls below

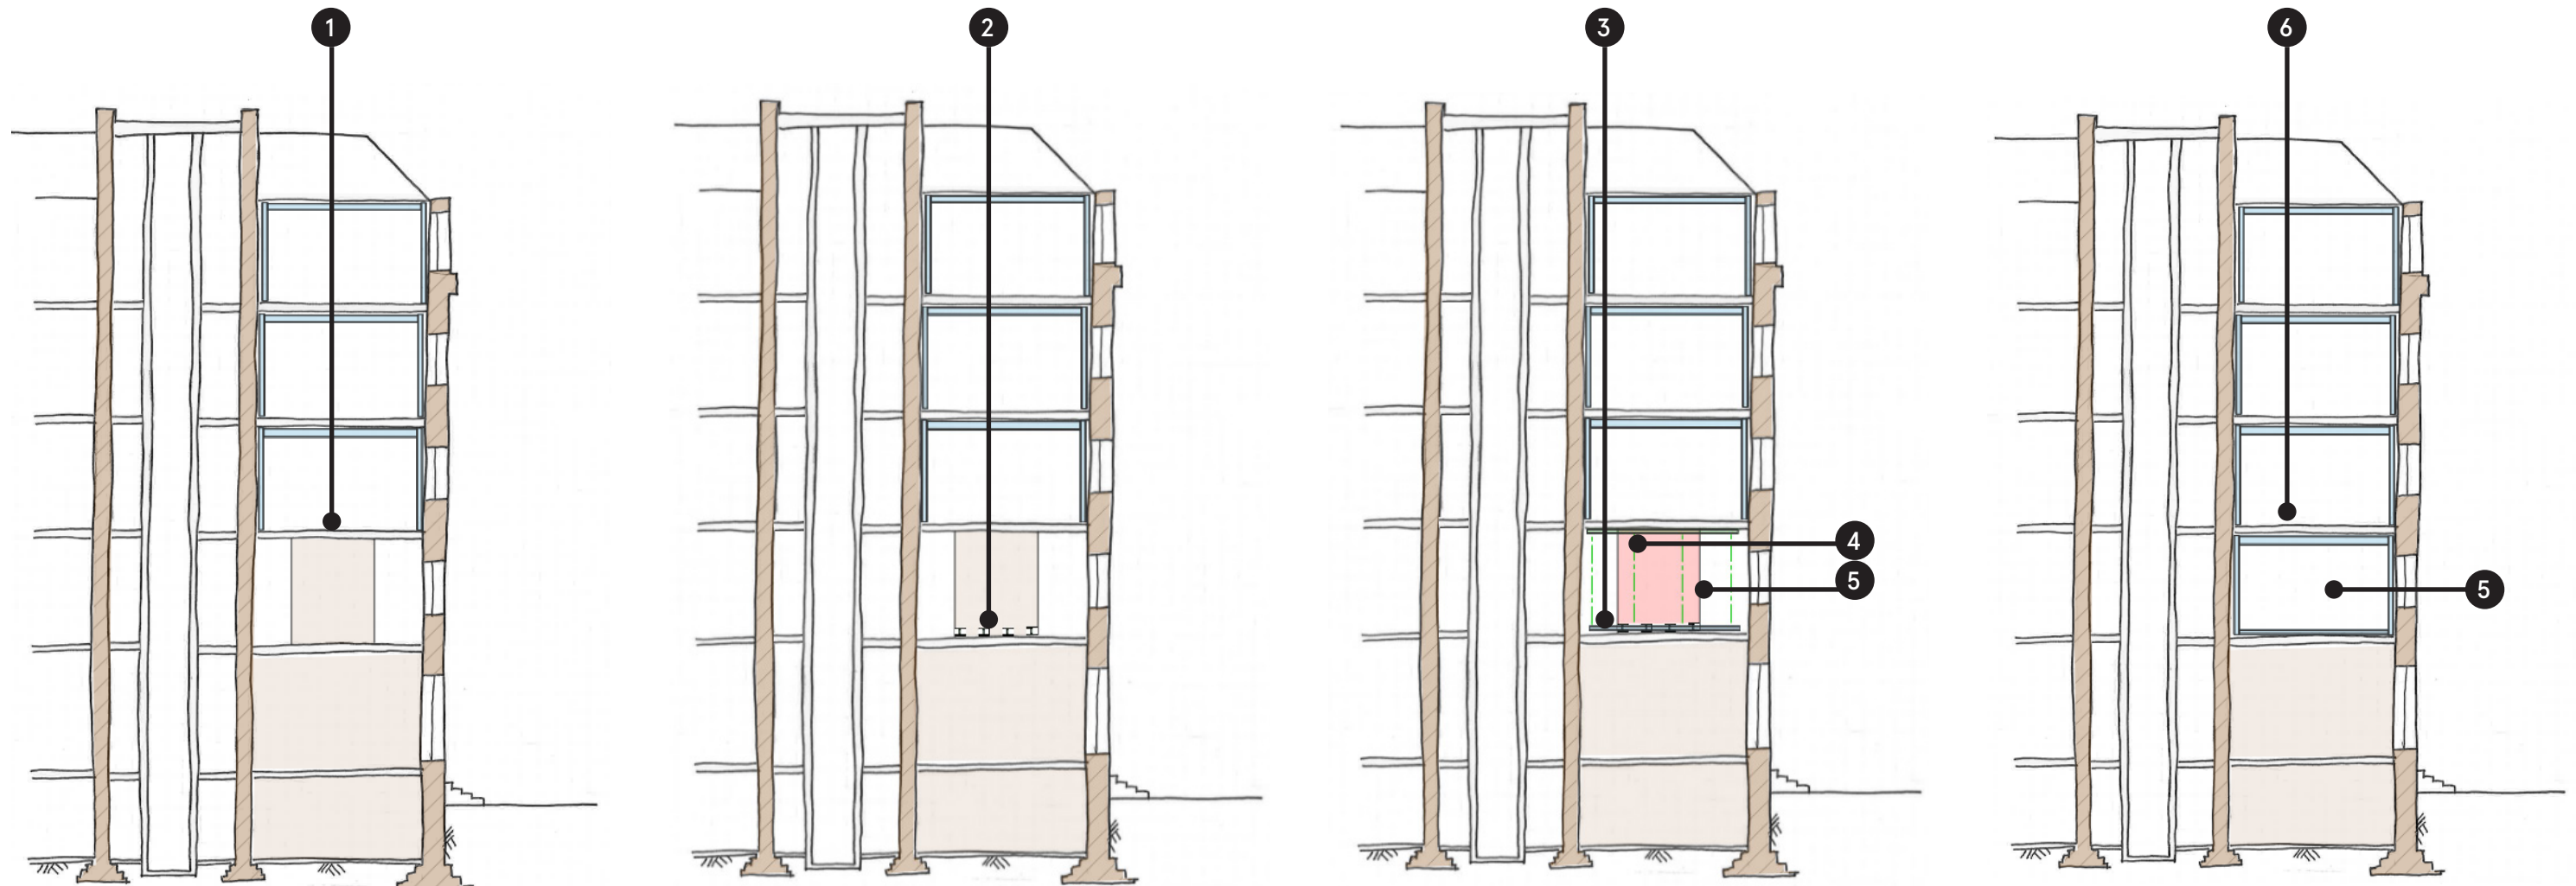
IMAGE 20 - INDICATIVE CONSTRUCTION SEQUENCE

- 1 Existing wall at Level 01
- 2 Install stools at low level
- 3 Install permanent steel spreader beam
- 4 Install propping to level 02 structure
- 5 Demolish wall at level 01
- 6 Install proposed steel columns and high level beam

Extensive temporary works will be required to prop the structure above level 1 to allow the installation of the steel frames.
