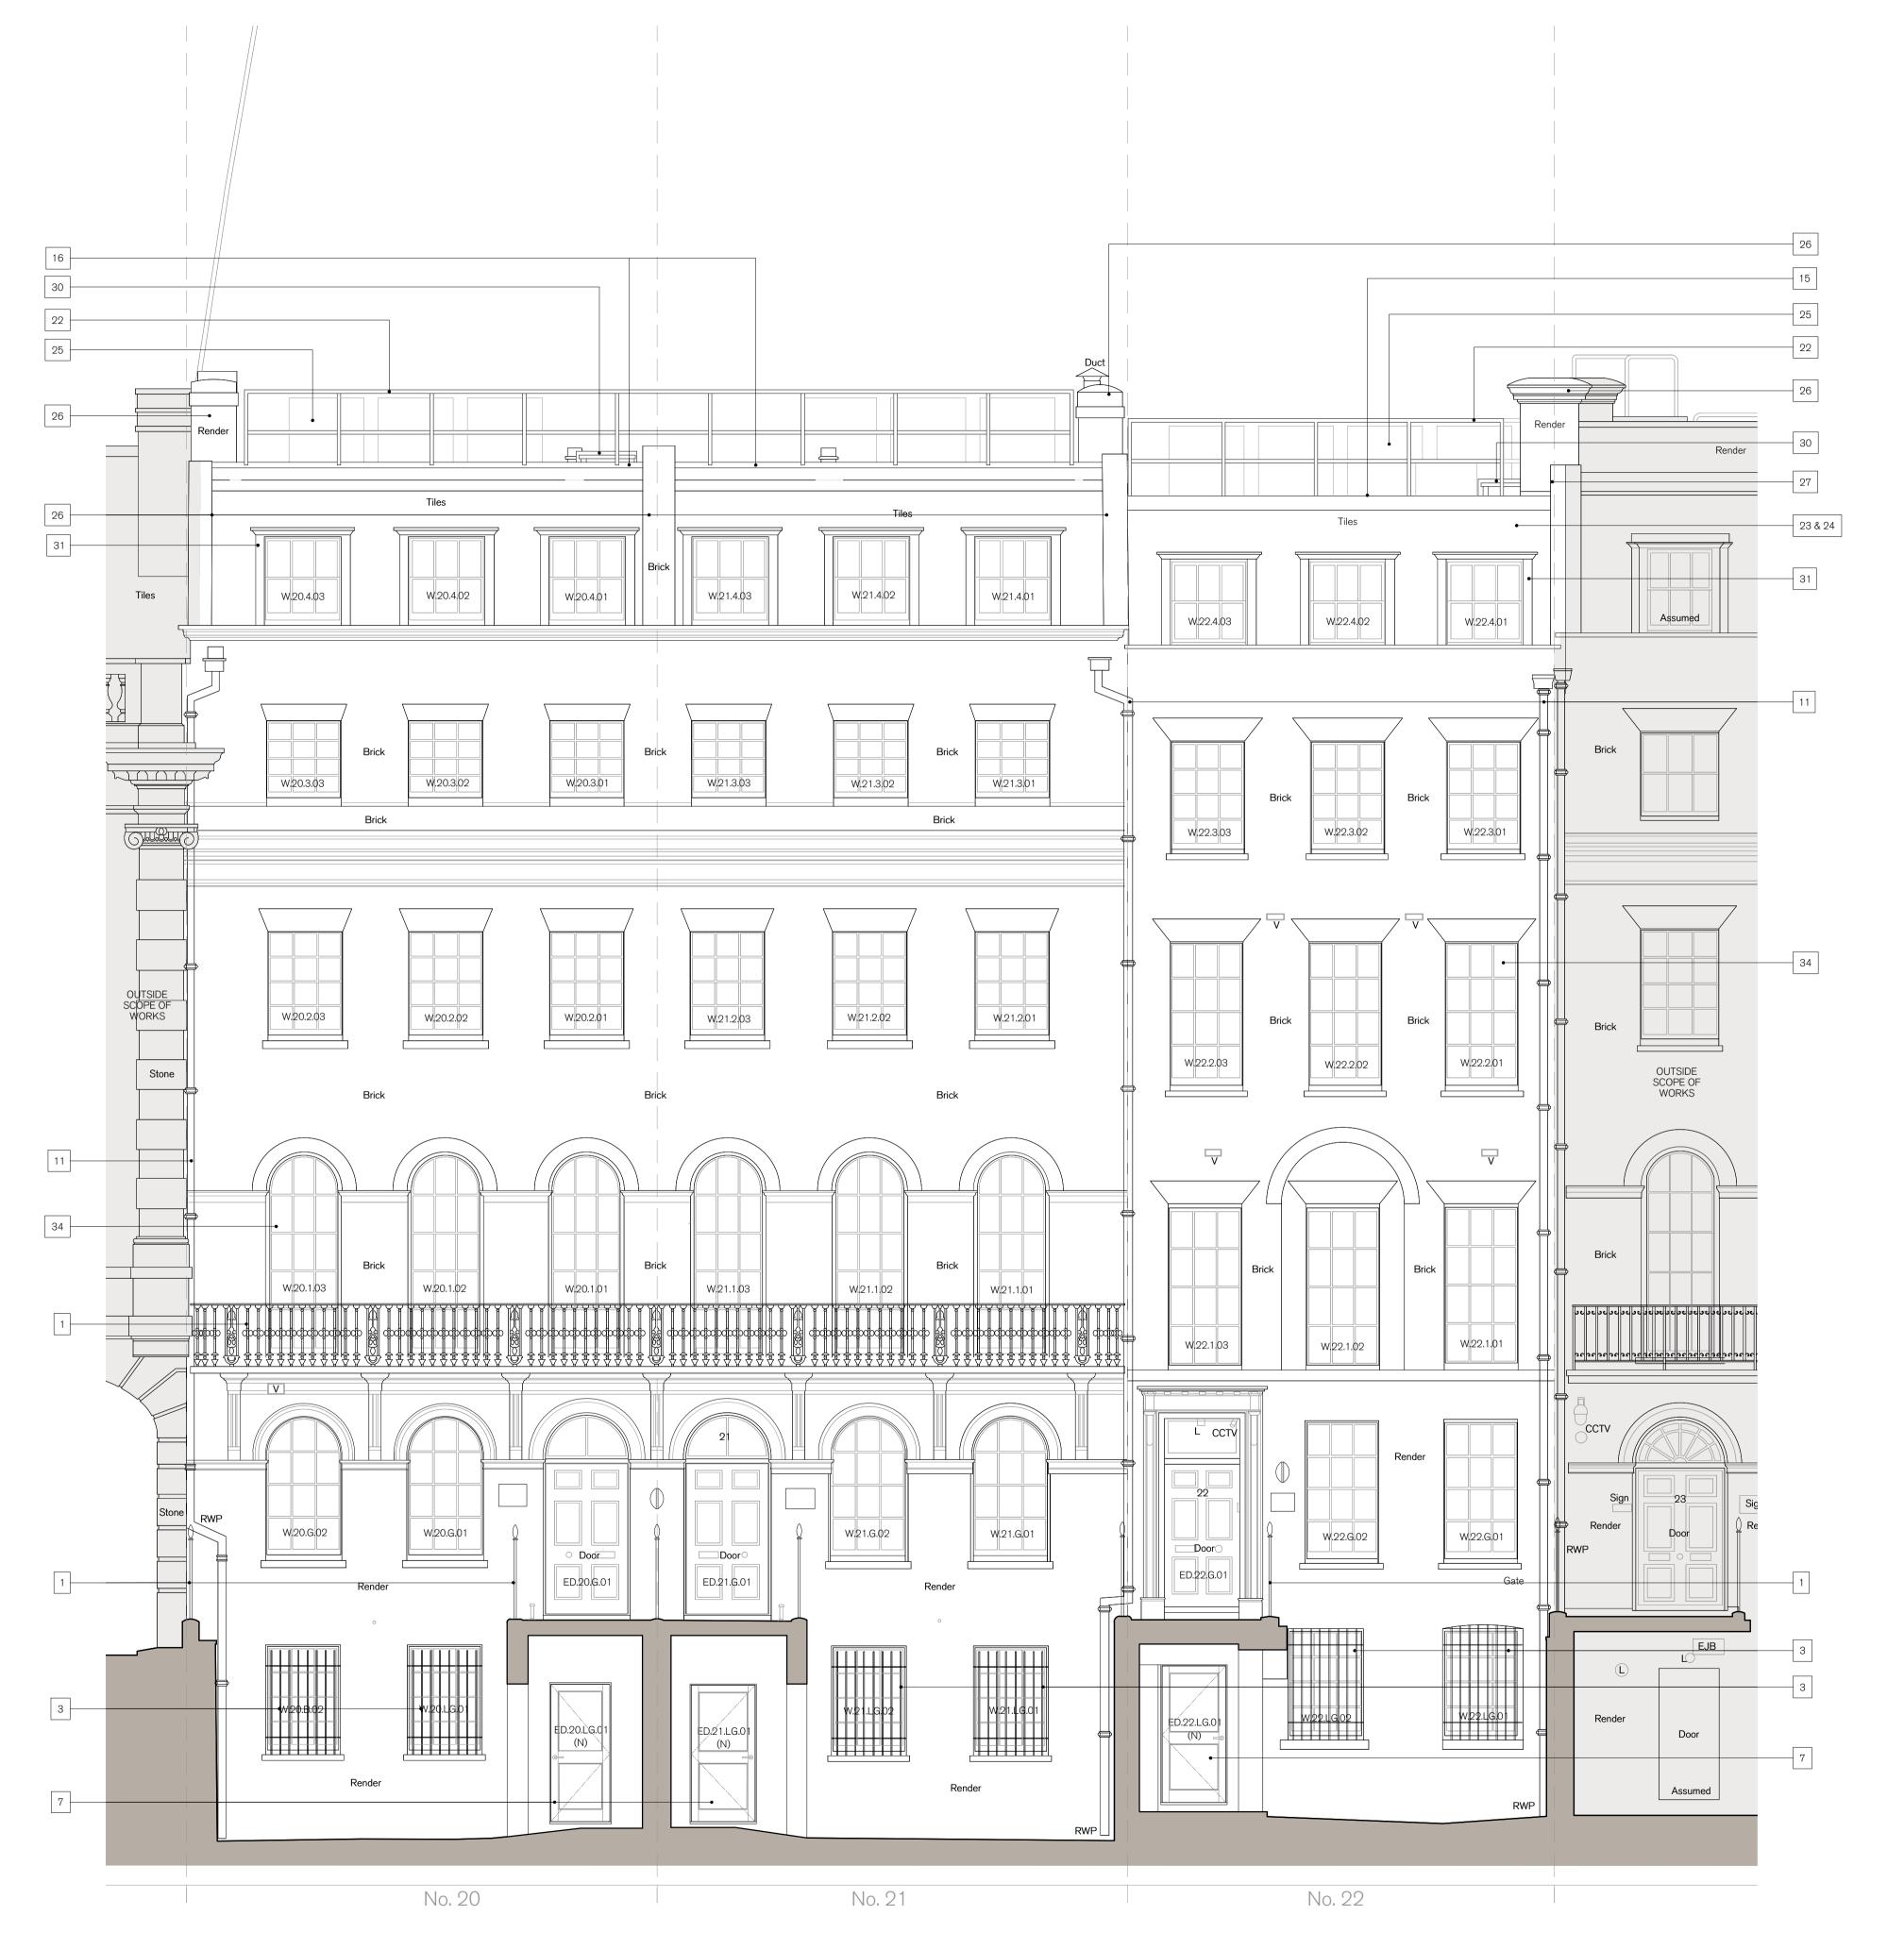
Grey hatch indicates adjacent buildings.

- 1. Existing painted metal railings and balustrade redecorated.
- 2. New mechanical equipment and service runs to roofs. Refer to MEP information for details on services and structural engineers information for roof strengthening works.

- 3. Existing painted metal bars redecorated white. 4. New glazing to replace exiting top panels modified for plant vent.
- 5. New sash window.
- 6. New wall mounted external lights.

- 7. New external door. 8. Existing metal gangway retained and re-supported to structural engineers
- details. Existing painted metalwork redecorated black. 9. New wall mounted cycle stands.

- 10. New metal bars installed externally to existing window to match existing.
- 11. Existing rain water goods cleaned and redecorated black. Damaged or

- poorly installed components repaired and replaced. 12. New external building signage.
- 13. New metal balustrade painted black.
- 14. New plant screen and door.

- New roof membrane overlaid onto existing asphalt roof on 22 Southampton Place and 46-47 Bloomsbury Square.
- 16. New roof membrane overlaid onto existing asphalt roof on 20-21 Southampton Place.

- 17. New 150mm louvre for shower and toilet.
- 18. New 100mm kitchenette extract wall fan. 19. New 100mm toilet extract wall fan.
- 20. New 100mm louvre for shower.

- 21. New 100mm louvre for future tea point fan connection.
- 22. New free standing roof edge protection to flat roof perimeter.
- 23. Existing mansard roofs retained and missing/damaged slates replaced 24. Damaged, slipped or missing slates to mansards to be replaced to match

- 25. New mechanical equipment located on roofs. Refer to MEP information for
- details on services and structural engineers information for roof strengthening works or raised kerbs.

- 26. Existing chimney render and flashing's repaired. 27. Existing parapet and party walls repaired.
- 28. New extended external stairs to match existing.

- 29. Condenser units in rear courtyard, refer to MEP information for details.
- 30. New roof access hatches. 31. Existing dormers leadwork, roofs and flashings to be repaired.

- 32. New decking to rear external courtyards.
- 33. Boosted cold water service to serve bib tap, refer to MEP drawings and schedules for details.
- 34. All existing windows refurbished.
