**BLOOMSBURY
CONSERVATION AREAS**
Advisory Committee | Est. 1968

Formal Objection to application 2021/5128/P and 2021/5707/L regarding works to 5 Denmark Street, including replacement of windows, roof extension, and associated alterations.

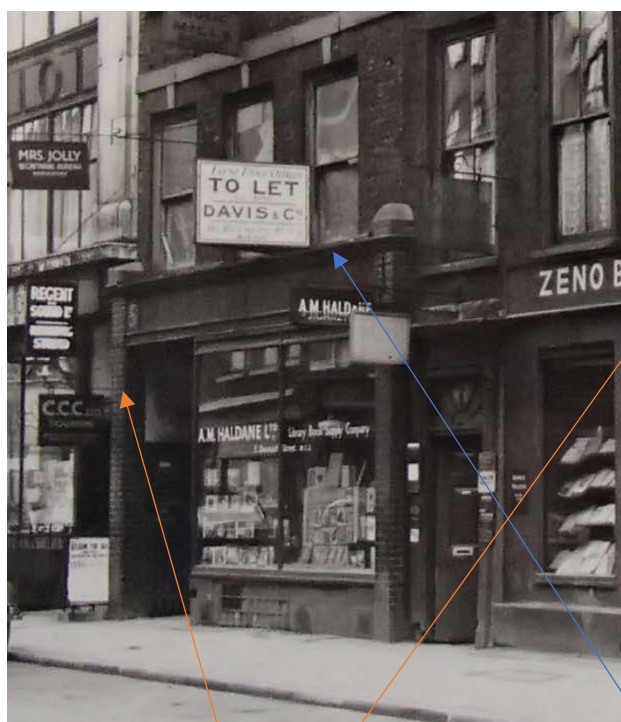
Columns

There is the further important point that the ground floor façade benefits from a shopfront which retains at least some historic detailing and fabric. While the existing fascia board, stall riser, and glazing are modern, there are historic columns and a cornice retained which are clearly visible. Removal of the fascia board may reveal an historic timber fascia behind. The existing window sill rests upon the top of the historic cornice, meaning that lowering of the sill would necessitate demolition of the cornice and subsequent loss of the significance of this historic shopfront.

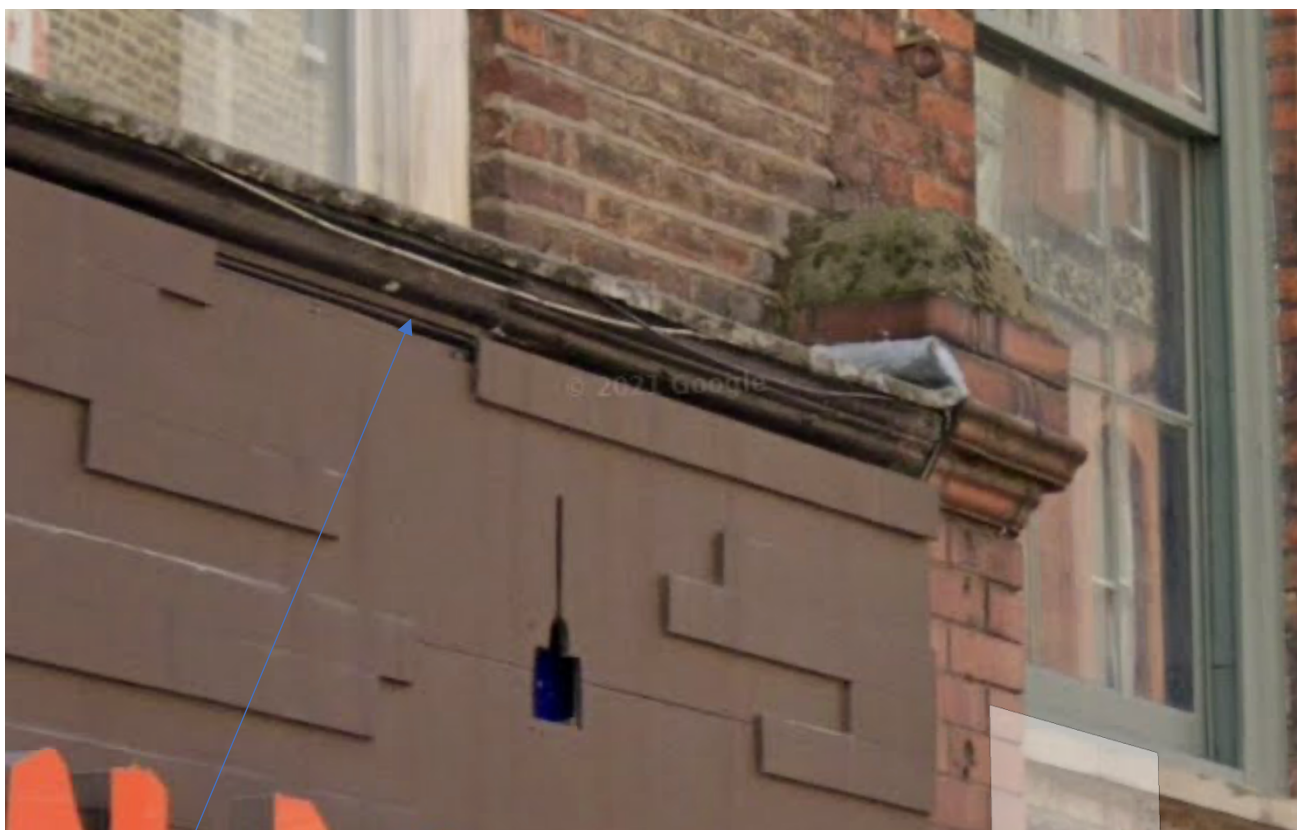
Cornice detail visible

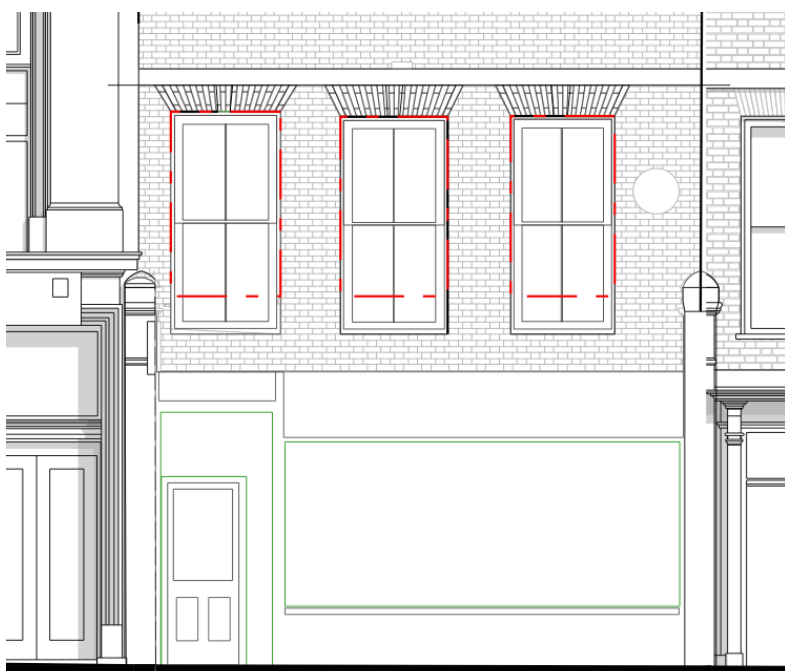
The drawings are unclear but appear to propose simply 'building down' in brick to replace this area of shopfront, while retaining the rest of the shopfront below and allowing the columns to rise to the previous level. This is in our view, poor design, and would erode the architectural and historic significance of the building and lead to a loss of historic shopfront detailing.

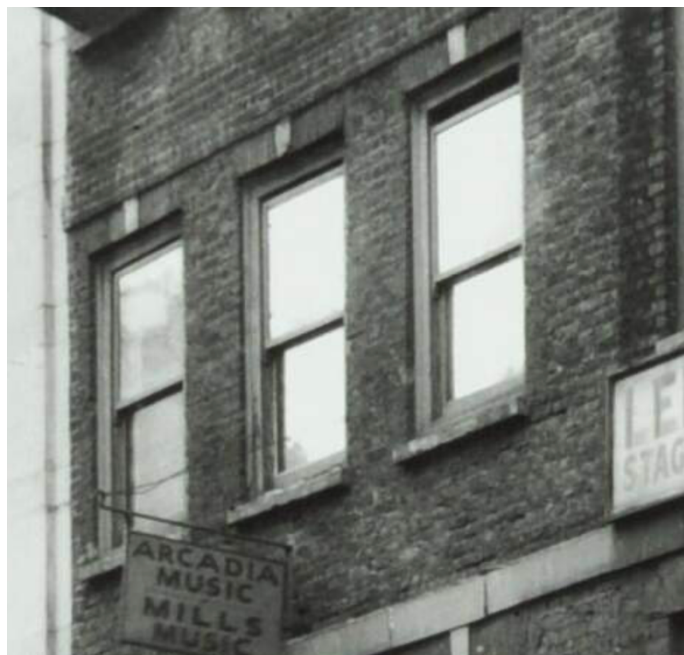
1951 photograph of 5
Denmark Street

The existing windows are clearly not original to the building, and we agree with the applicant that the non-matching windows between floors is harmful to the significance of the building. The heritage statement however asserts that the windows are modern, which is highly unlikely. The image supplied as part of the heritage statement and found as part of record number 70713 of the London Picture Archive shows what appears to be the same windows in place in 1953. From observation, the windows (apart from the top floor) appear to be Victorian, while the top floor windows appear contemporary with the early c20 extension. Nevertheless, the existing windows are historic fabric, with their replacement therefore considered generally unacceptable (para 11.1 of the Denmark Street Conservation Area Management Strategy).
