proposed plan 1:50

arts lettres techniques ARCHITECT Arts Lettres Techniques Limited 2021 copyright is retained ©

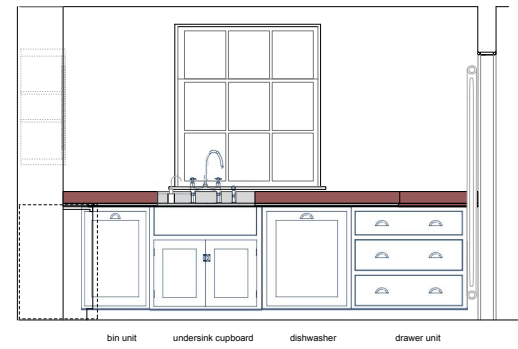
elevation C

joinery items use single panel doors following precedent  
1969 salvaged worktop material from Bennett kitchen re-used to maintain continuity of appearance and use  
original 1850's window surround restored

new masonry spine wall  
fire rated stud wall to stairway under retained steel RSJ

hardwood and Carrera marble reclaimed material from original kitchen

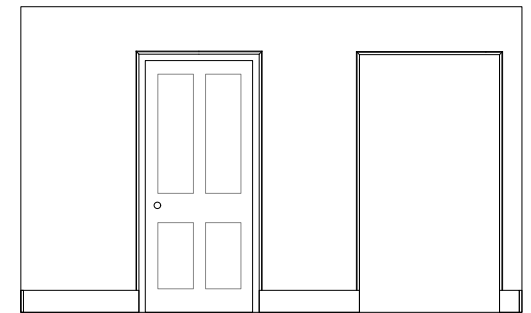
elevation D

20 diameter timber  
dowel corner detail  
to doorway and opening  
170x20mm softwood  
square edged skirting  
dowel corners run onto  
top edge of skirting  
timber linings to doorways

retained cupboard doors redecorated

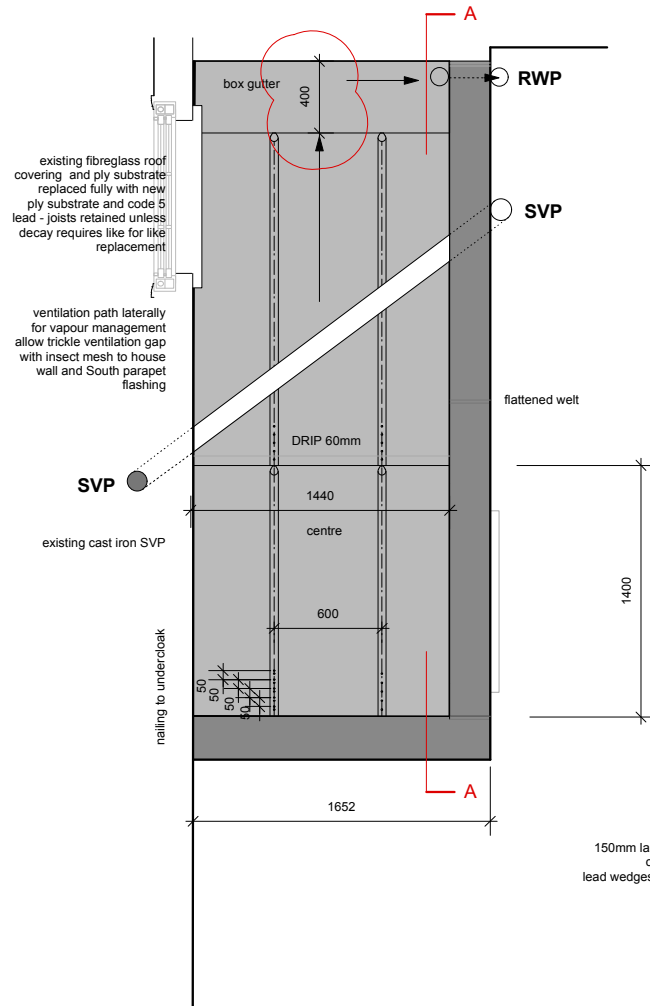
Code 5 lead sheet throughout.

Rolls set out to avoid pipe wall exit and low point above parapet gutter.

Dress lead coping around existing SVP - ensure adequate clipping.

Covering flashings to house wall 1.5m max. length between laps, lead clips at 400ctrs, 100 lap joints, upstand min 75mm.

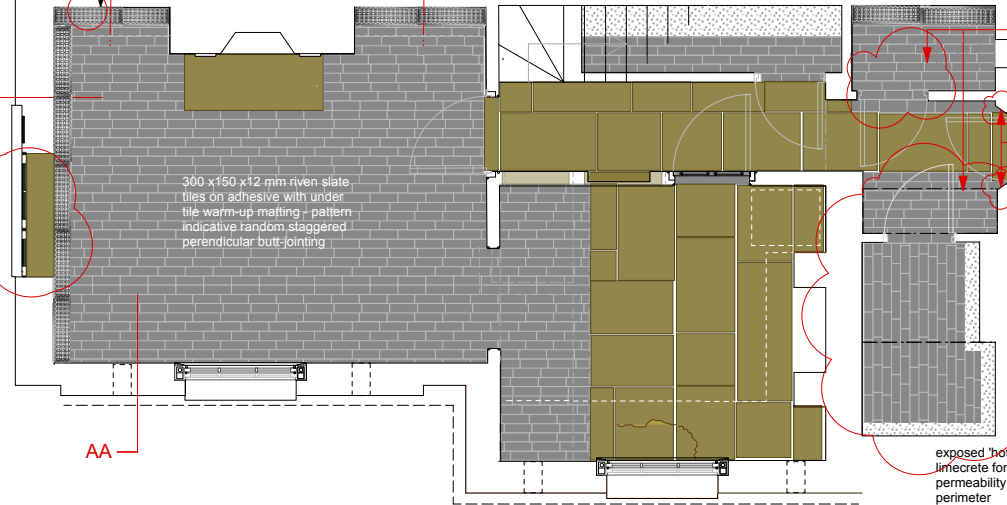
section AA 1:20

exposed 'hot lime' limecrete for vapour permeability at floor perimeter

note: 2x whole grilles with off-cut to make up wall length

note: extent of concrete flooring more extensive than originally thought - all York stone flags found are retained in situ - extent of slate tiles greater than current consent allows

external plinth - cement removed, re-rendered in Roman stucco clay tile supports retained where intact - replaced with matching clay tiles. The existing vent holes cleaned and mesh fitted, with a 50mm clear gap between external wall and new limecrete 'lung' to facilitate moisture evaporation through the original vented cavity.

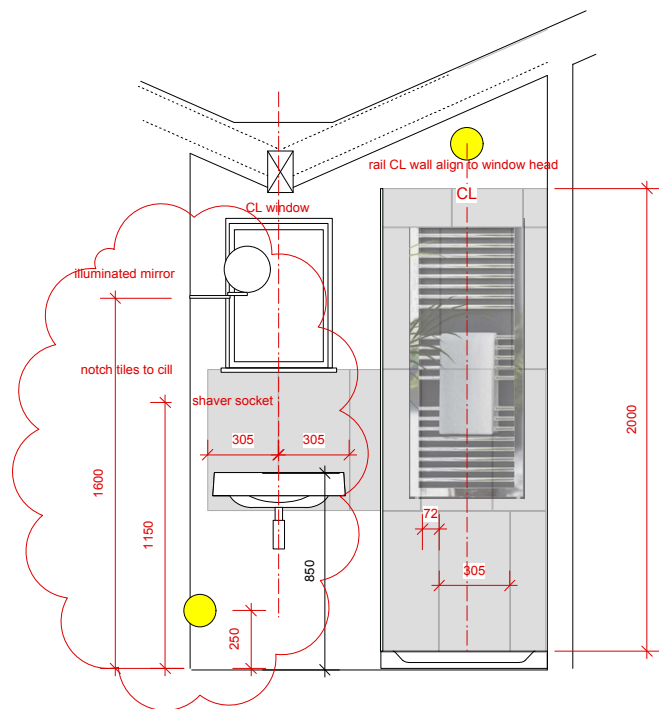
section AA

tiles 610 x 305mm

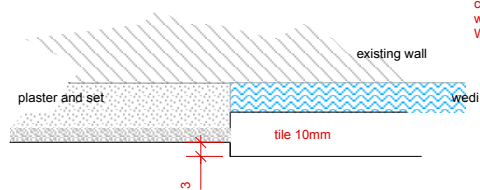
general plaster - tile detail 1:1

single tile recessed 100mm to create shelf - cut tile on 4 sides whole tile to rear supported on WBP ply and wedi
