Space House

Planning Condition Discharge Report

Conditions 3LBC f)

For Seaforth Land

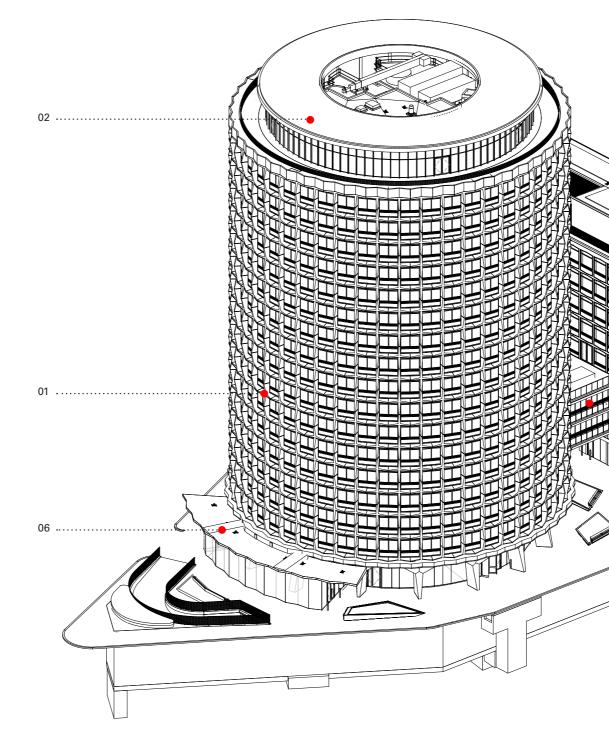
Fig. 1.0.1 Space House Axonometric

Key:

- 02. Tower extension 03. Kingsway building
- 04. Kingsway extension
- 06. Western Canopy (Filling Station)

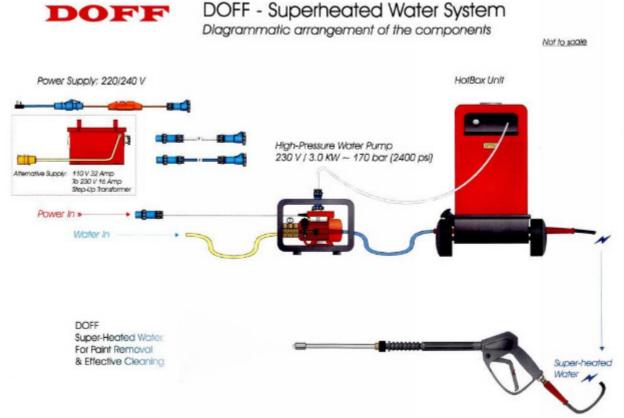
Fig. 2.1.1 Superheated water cleaning equipment

Superheated water cleaning methodology (refer to Fig. 2.0.1)

• Operatives located the machine and cables on the scaffold adjacent to the work area.

• Temperature was set at 140 Centigrade and pressure was kept to a 'safe' level to prevent any abrasion or other disruptions to the substrate.

Nozzle distance to the surface was set at 400mm – 500mm
Operating temperature, nozzle pressure and distances to the substrate were controlled and monitored by the cleaning operative throughout the works. Minor alterations were made at the cleaner's discretion to ensure no damage or abrasion occurred.

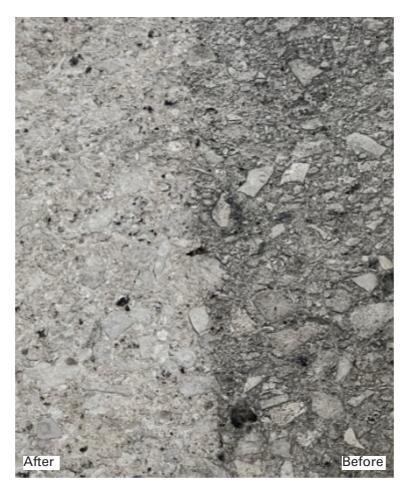
Fig. 2.1.2 Concrete surface before and after cleaning

Fig. 2.0.2 demonstrates close up the eroded texture of the concrete surface and the before and after appearance of the cleaned surface.

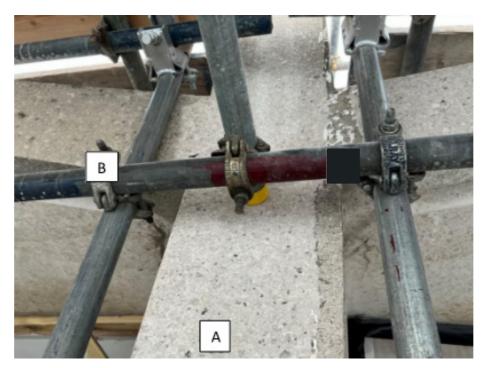
Fig. 2.1.3 Cleaned front face

Fig. 2.0.3 shows the cleaned front face of the column 'A', the still dirty face of the spandrel cill 'B'.

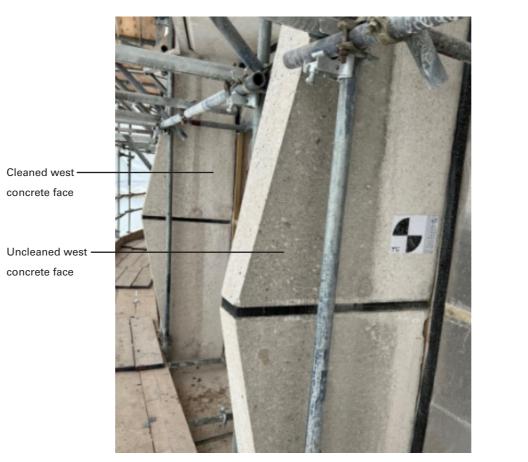
Fig. 2.1.4 West concrete faces (cleaned and uncleaned)

Fig. 2.0.4 and 2.0.5 show the West and East cleaned column faces in comparison to the uncleaned adjacent columns.
