Project Title:	Alexandra Ainsworth Estate - ID1717
-----------------------	-------------------------------------

Type of Work:	SDU/MDU/Estate
----------------------	----------------

Short Description of Works					
<p>This is a proposed fibre design to connect Rowley Way to the CFL existing Fibre network, utilising the Open-reach duct network that has been installed around the Borough.</p> <p>This MDU Design pack is a proposal based on survey work carried within the Camden borough. It is from this information gather that our design team came up with the proposed solution on how best to feed fibre to this MDU in a most cost effective way.</p>					
Ver. N.	Author	Details	Date	Verify By	Date
1	PN	First Issue	29/04/2020

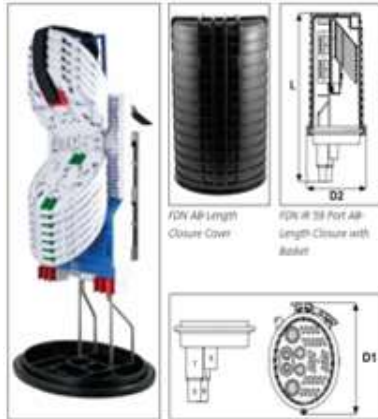
Underground Joint (AUX Joint)

Dimension (LxDxH): 312x222x561 mm

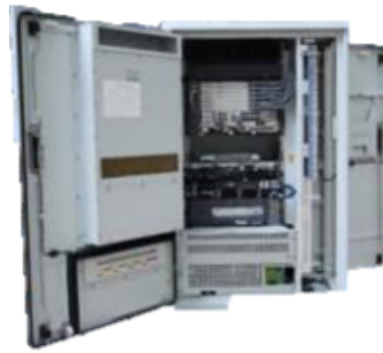
Optical Line Terminal (OLT) Cabinet

Dimension (LxDxH): 850x450x1350 mm

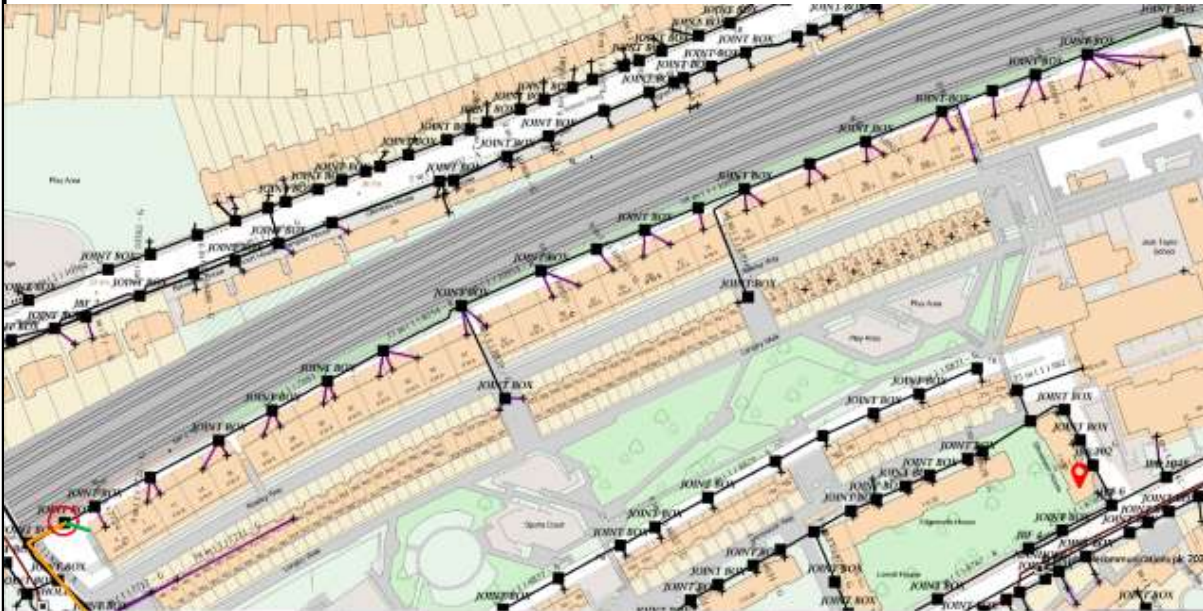
Alexandra Ainsworth Estate - ID1717		NW8 OSF																											
			ID 611																											
	Description of work: 4-119 Rowley way																													
	External Solution																													
	Some civils required.																													
346 Premise's total. 5 MDU Blocks Block 1 Apt.4-18 - 50 premise's Block 2 Apt.23-47 - 80 premise's Block 3 Apt.51-75 - 80 premise's Block 4 Apt.79-103 - 80 premise's Block 5 Apt.113-119 - 56 premise's

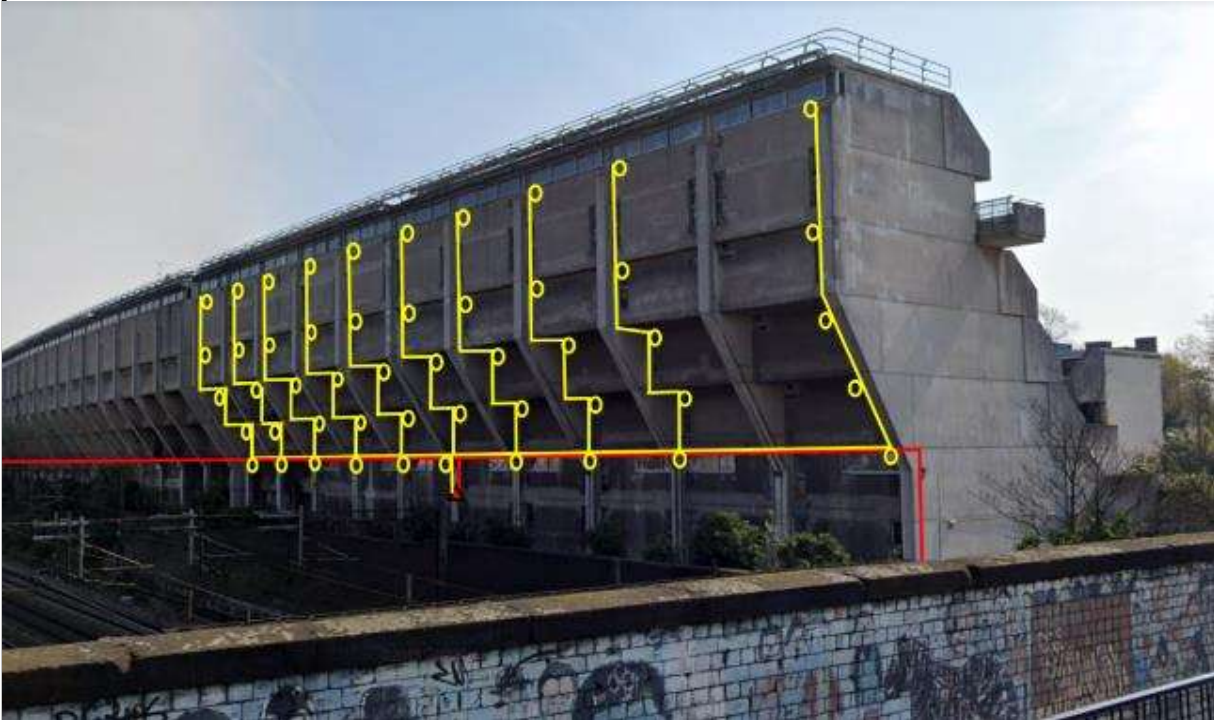
Alexandra Ainsworth Estate - ID1717		NW8 OSF																											
			ID 611																											
	Description of work: 4-119 Rowley way																													
	1x64 Splitter required to feed the 50 premise's within this MDU - Apt.4-18 2x12F feed cables to be forward fed in a Daisy chain design																													
	From the distribution point, run twin core subscriber feed cables using cantenary wire along the wall following existing cable routes where possible. Subscriber feeds to be left in neat 5m length coil neatly affixed to the wall next to each flat living room window.																													
Drop coil design/layout to be duplicated for each of the MDU's

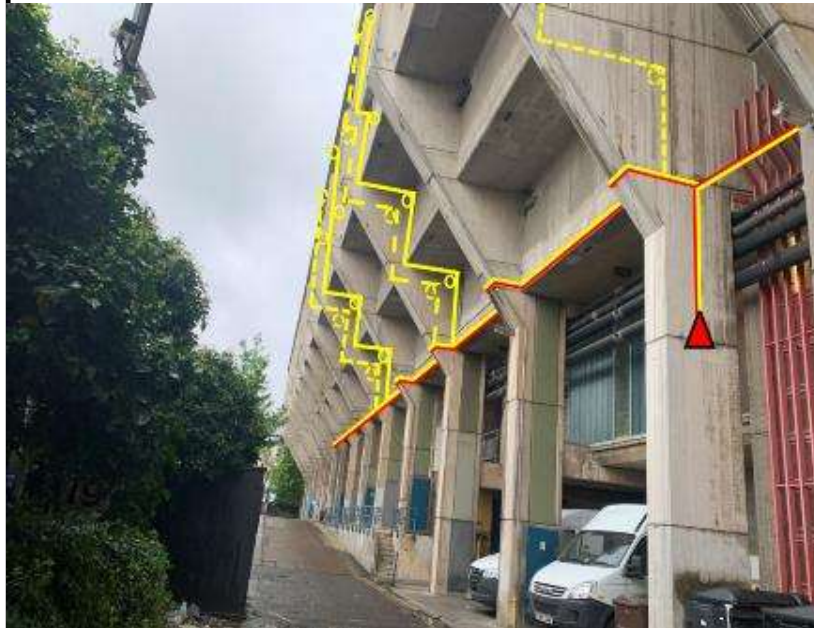
Cabling Detail-Work Points (Pg1)

From the distribution point, run twin core subscriber feed cables using cantenary wire along the wall following existing cable routes where possible. Subscriber feeds to be left in neat 5m length coil neatly affixed to the wall next to each flat living room window.

Drop Coils are in the same position for each MDU Block Mirror design along the back of these Units
