<b>Project Title:</b>	Alexandra Ainsworth Estate - ID1717
-----------------------	-------------------------------------

<b>Type of Work:</b>	SDU/MDU/Estate
----------------------	----------------

**Short Description of Works**

This is a proposed fibre design to connect Alexandra Place & Langtry Walk to the CFL existing Fibre network, utilising the Open-reach duct network that has been installed around the Borough.

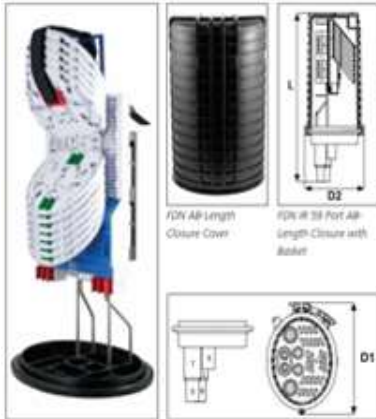
**Underground Joint (AUX Joint)**

Dimension (LxDxH): 312x222x561 mm

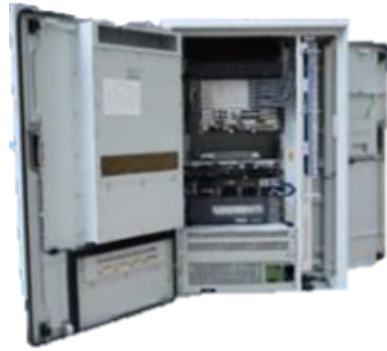
**Optical Line Terminal (OLT) Cabinet**

Dimension (LxDxH): 850x450x1350 mm

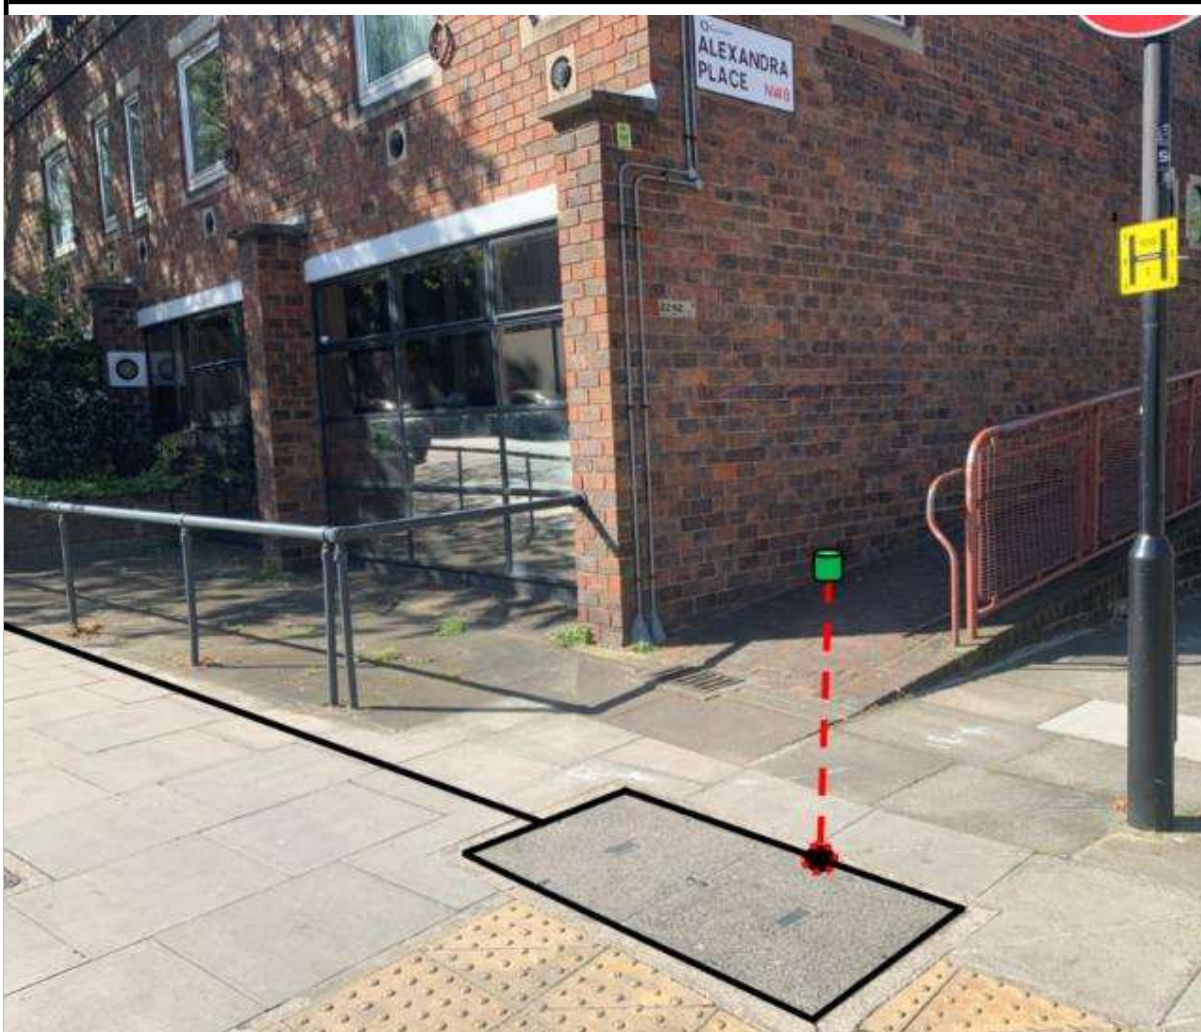
**Description of work:** Alexandra place

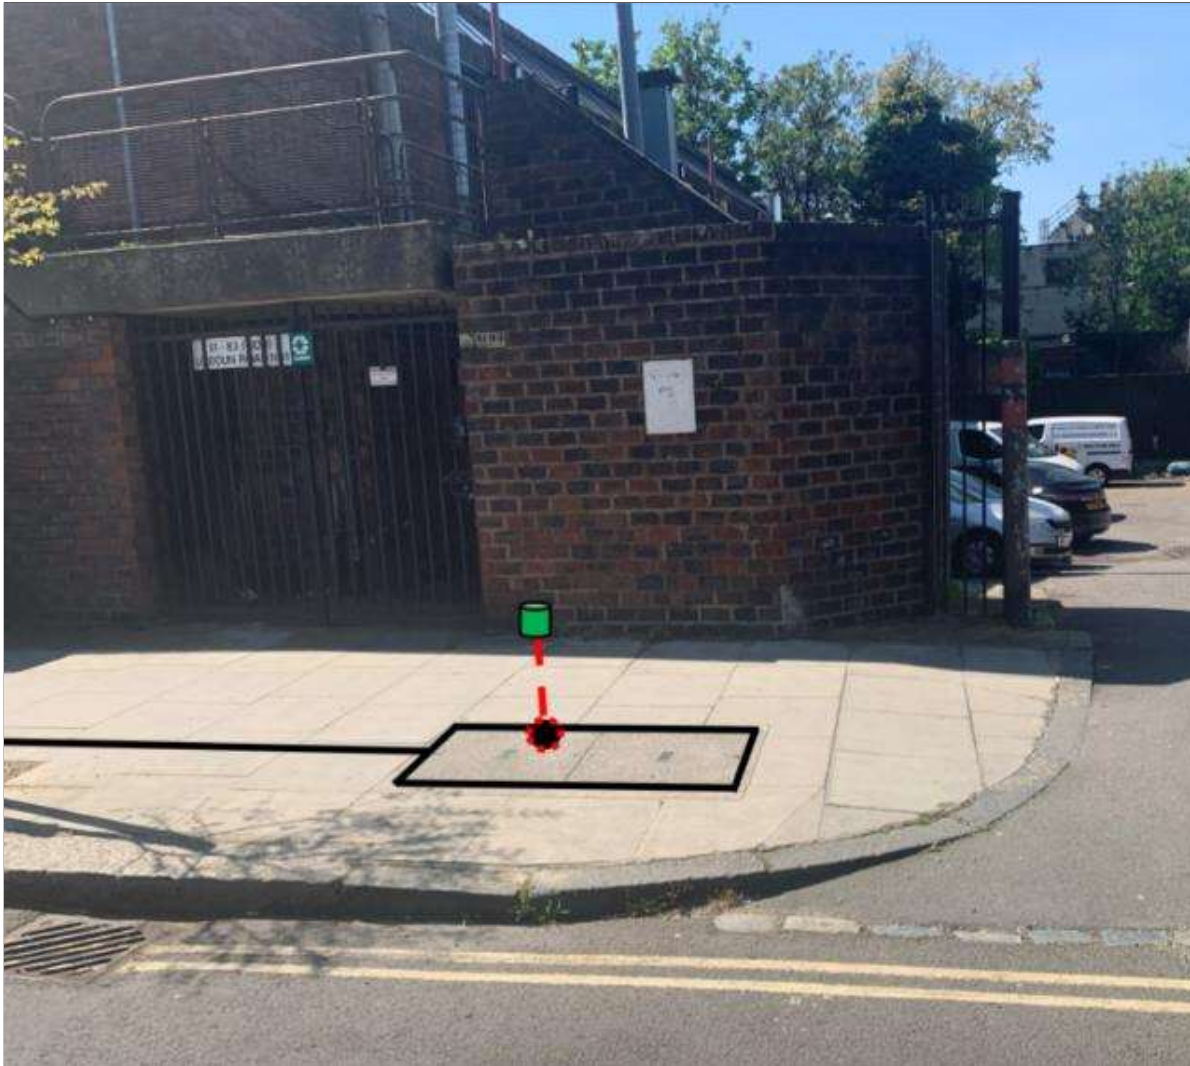
**Description of work: 1-8 Langtry Walk**

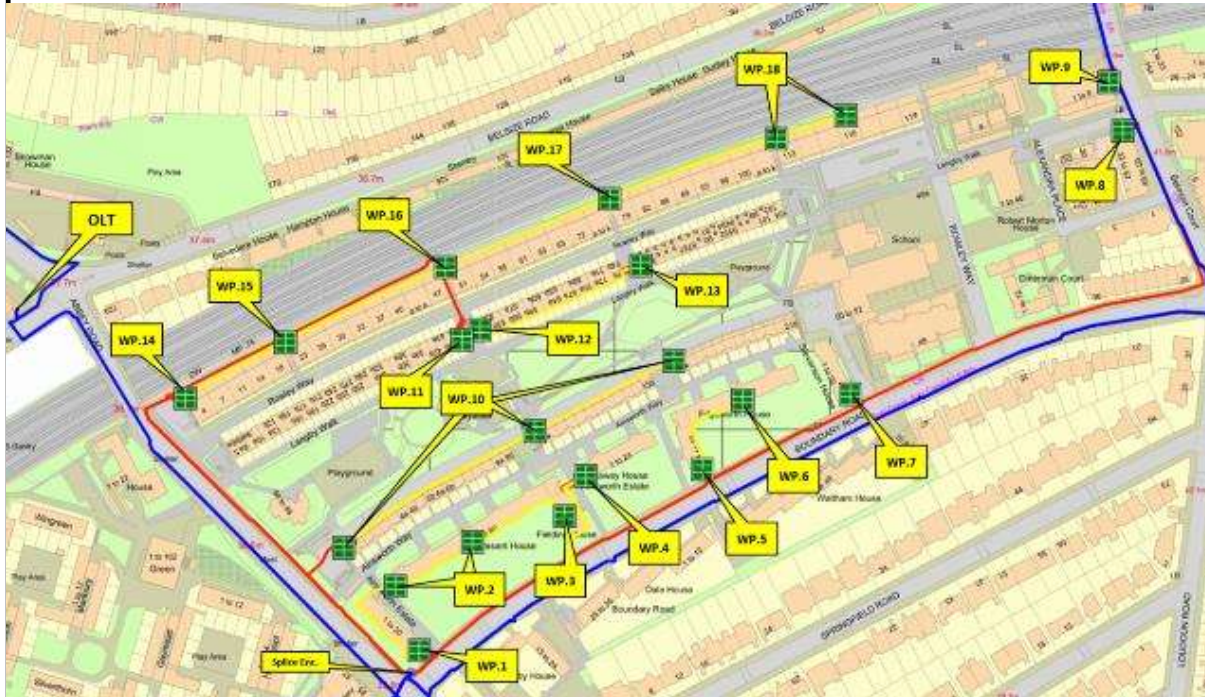
**Cabling Overview (map)**

**Description of work:**

Overview of cable distribution from the AUX to the the splitter box on the MDU

Key	Planned	As built
Drop Fibre		
Feed/Distribution Fibre		
Fibre Enclosure		
Drill/Core Hole		
CFL Chamber		
Third Party Trench/Duct		
Third Party Chamber		
Splitter Wall-Box
