Project Title:	Alexandra Ainsworth Estate - ID1717
-----------------------	-------------------------------------

Type of Work:	SDU/MDU/Estate
----------------------	----------------

Short Description of Works					
<p>This is a proposed fibre design to connect Langtry Walk to the CFL existing Fibre network, utilising the Open-reach duct network that has been installed around the Borough.</p> <p>This MDU Design pack is a proposal based on survey work carried within the Camden borough. It is from this information gather that our design team came up with the proposed solution on how best to feed fibre to this MDU in a most cost effective way.</p>					
Ver. N.	Author	Details	Date	Verify By	Date
1	PN	First Issue	06/05/2020

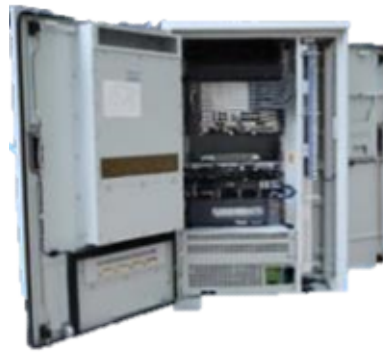
Optical Line Terminal (OLT) Cabinet

Dimension (LxDxH): 850x450x1350 mm

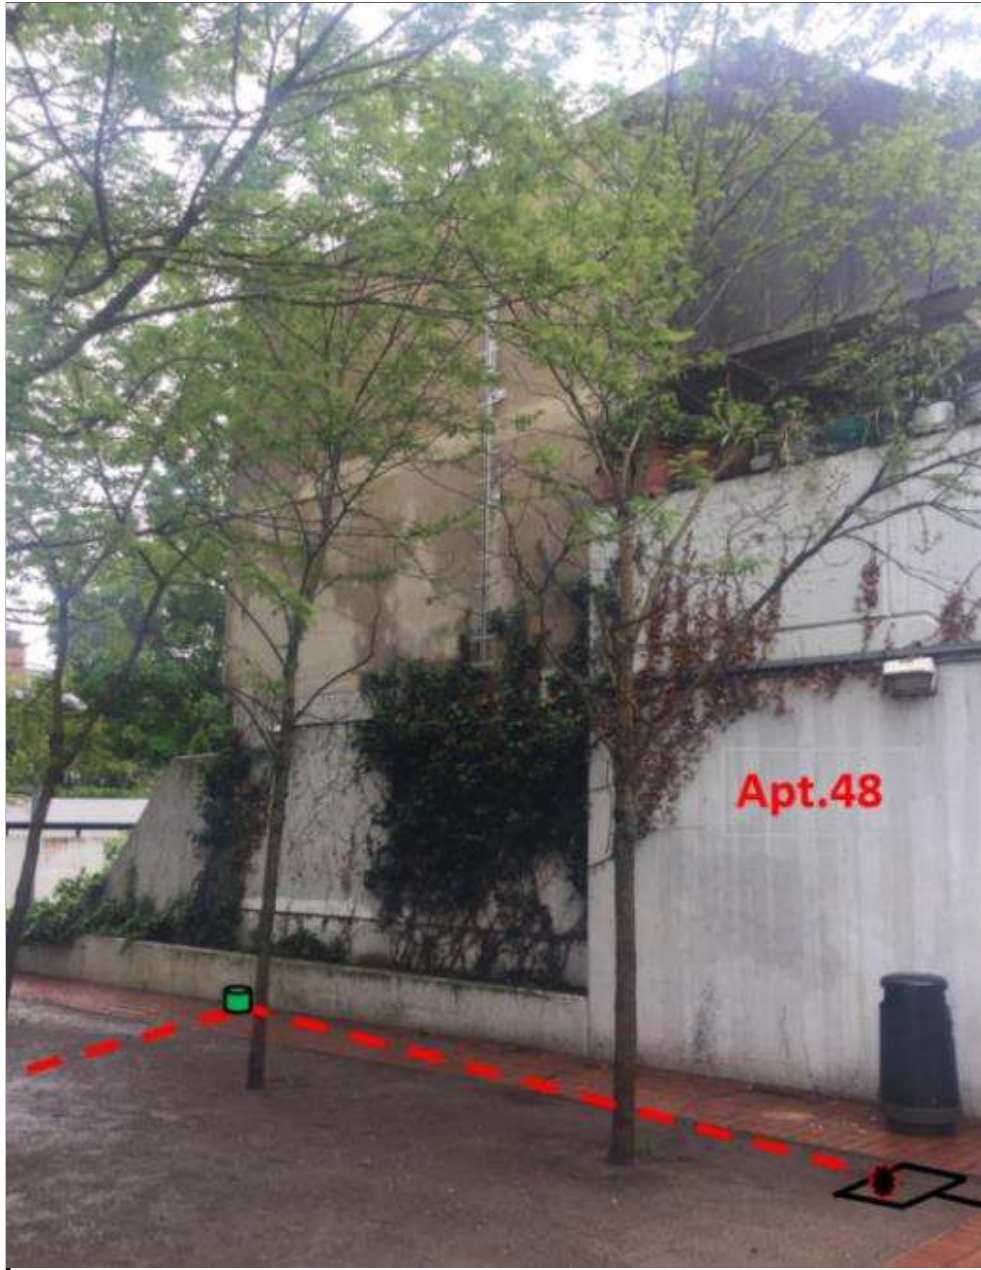
Use existing BT PIA ducting & structures to the existing BT chamber shown in the image.

Core drill from existing BT chamber and lay a 54mm 1 way ducting to the proposed breakout points indicated by the green 90° upturn cylinder shown in the images provided. From the Upturn shown, new civils are required to lay a new 54mm one way duct to Apt.50

Approx. 3.5m of civils required.
Galvanised conduit to be installed at the breakout point of the upturn duct.

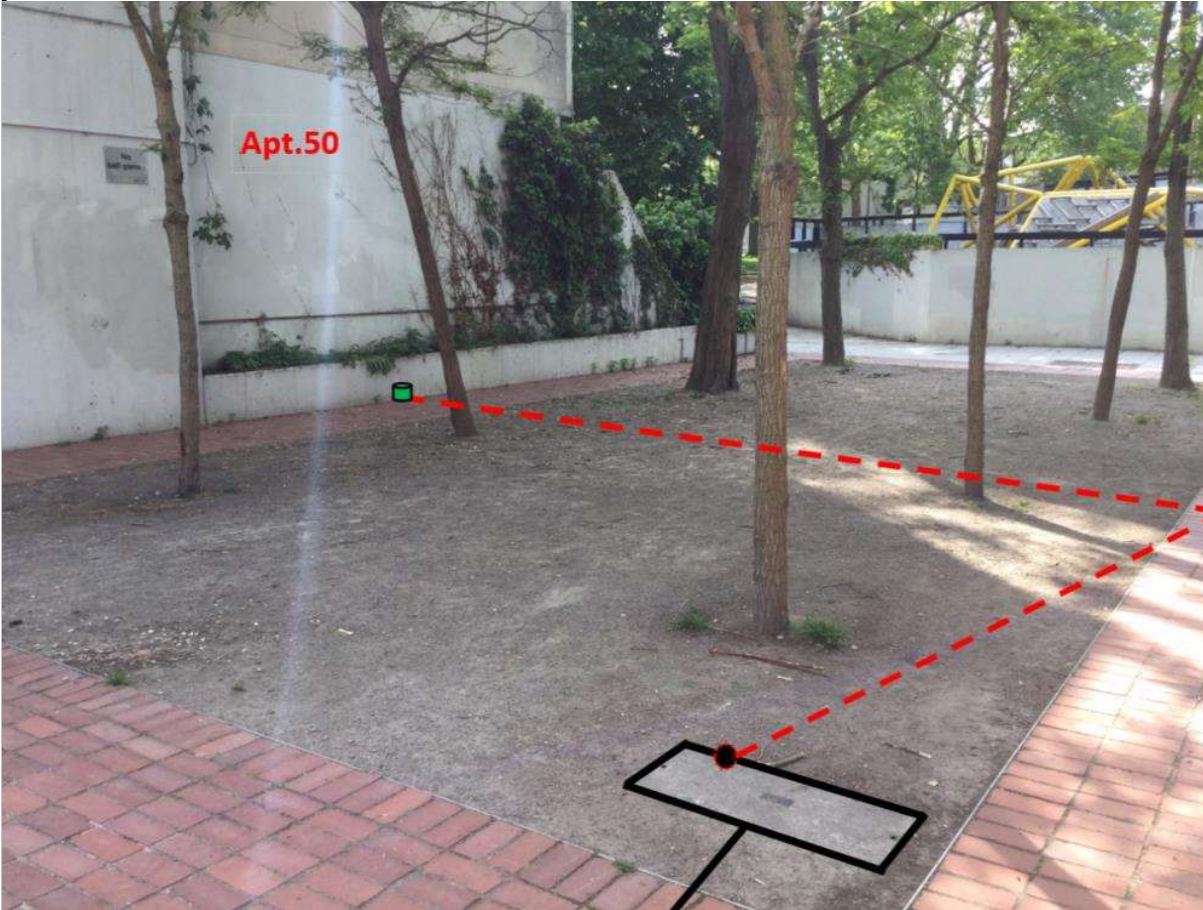
Alexandra Ainsworth Estate - ID1717		NW8 OSH																											
				ID 611																											
Description of work: 5-104 Rowley way																															
1		Catenary wire not a viable solution due to the tree canopy.																													
2		From the Upturn beside Apt.48 - New civils are required to lay a new one way 54mm duct with an upturn to be place beside Apt.50 as shown in the accompanying image.																													
3		Approx. 5m of civils required. Galvanised conduit to be installed at the breakout point of the upturn duct.

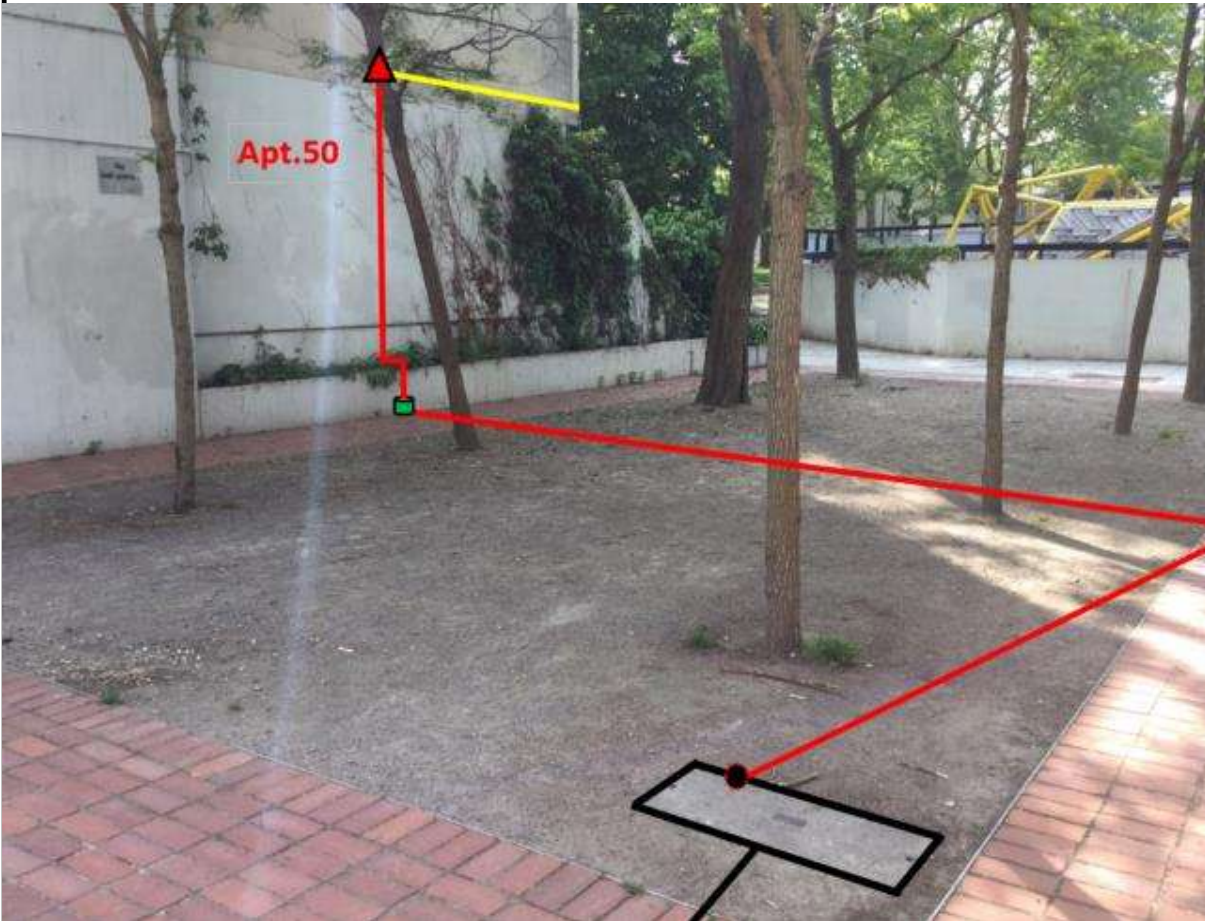
Alexandra Ainsworth Estate - ID1717		NW8 OSH			
		ID 611			
Description of work: 5-104 Rowley way					
	1x64 Splitter required to feed the 36 premise's within this MDU				
	From the distribution point, run twin core subscriber feed cables using cantenary wire along the wall following existing cable routes where possible. Subscriber feeds to be left in neat 5m length coil neatly affixed to the wall next to each flat living room window.				
	12F feed cable to run in parallel with distribution using a cantenary wire along the wall following existing cable routes.

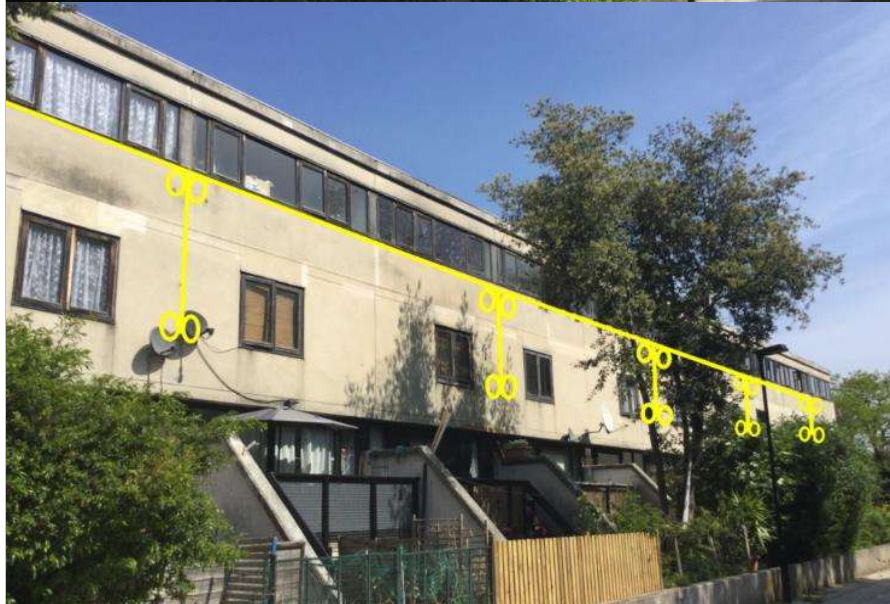
4

From the distribution point, run twin core subscriber feed cables using cantenary wire along the wall following existing cable routes where possible. Subscriber feeds to be left in neat 5m length coil neatly affixed to the wall next to each flat living room window.
