# 2673 - 52 Avenue Road, Structural Method Statement - 12 Unit Scheme

# 1. Introduction

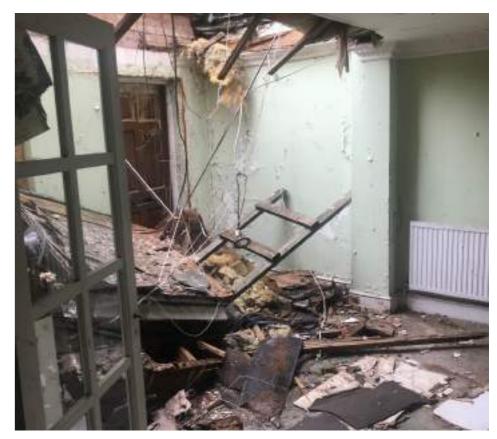
Image 10 - Collapsed Roof

Multiple elements of the existing structure are in poor or unusable condition, including roof and wall external elements, as well as corrosion of structural steel elements. Several original elements have seen total failure with collapse of roofs and ceilings observed.

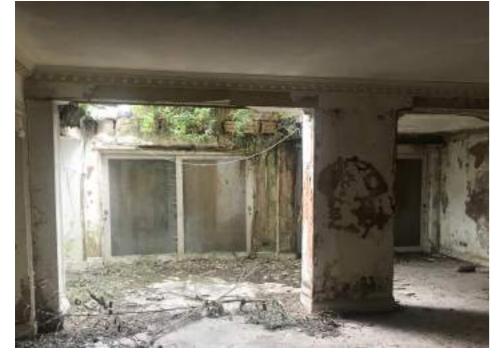
Image 11 - Condition of Internal Elements

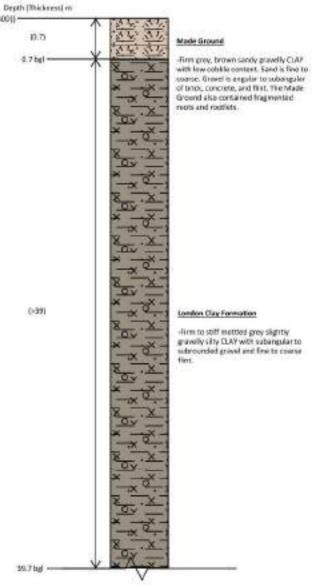
#### Image 18 - Assumed Existing Ground Conditions

- + Made Ground (depth to 0.7m below ground (+46.0mAOD to 45.3mAOD))
  - + Firm grey, brown sandy gravelly CLAY with low cobble content. Sand is fine to coarse. Gravel is angular to subangular of brick, concrete, and flint. The Made Ground also contained fragmented roots and rootlets.
  - + Three zones contained a layer of concrete and/or brickwork ranging between 0.1 and 0.9m in thickness, and some contained a thin layer of topsoil.

- + London Clay Formation underlying soil strata (+45.3mAOD to +6.0mAOD))
  - + Firm to stiff mottled grey slightly gravelly silty CLAY with subangular to subrounded gravel and fine to coarse flint.

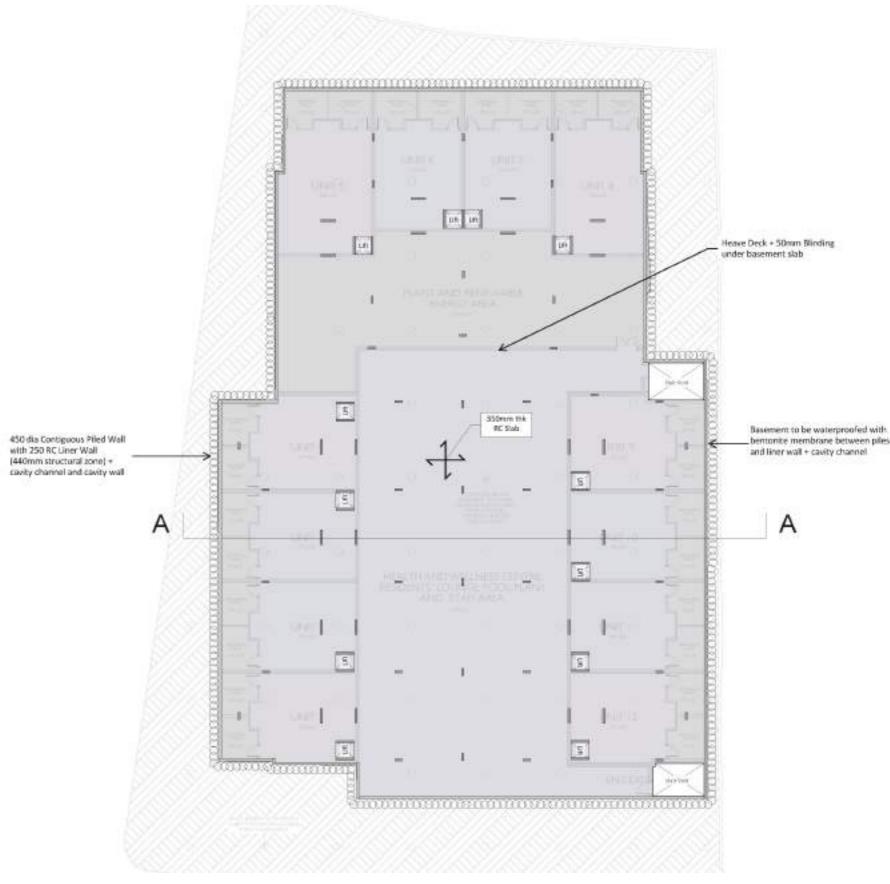
Image 20 - Proposed Basement Plan

The proposed basement will be designed to achieve a Grade 3 level of waterproofing protection as outlined in BS 8102:2009. A bentonite lining (or similar) will be provided between the reinforced concrete liner. An internal drained cavity system will act as a secondary barrier. As part of this system, any water seepage will be collected in a sump and be pumped up to a high level where it will drain under gravity into the main drainage system.

The new 350mm thick basement slab, lower ground floor slab, ground floor slab and liner walls will be constructed using reinforced concrete to form a stiff concrete box. The reinforced liner walls will be designed to resist hydrostatic pressures while the contiguous piled wall will resist soil and surcharge pressures. The basement slab will also be designed to resist any hydrostatic or heave pressures, with heave board being introduced below the suspended slab. Tension piles may be required to ensure the basement box is not buoyant in the permanent case.

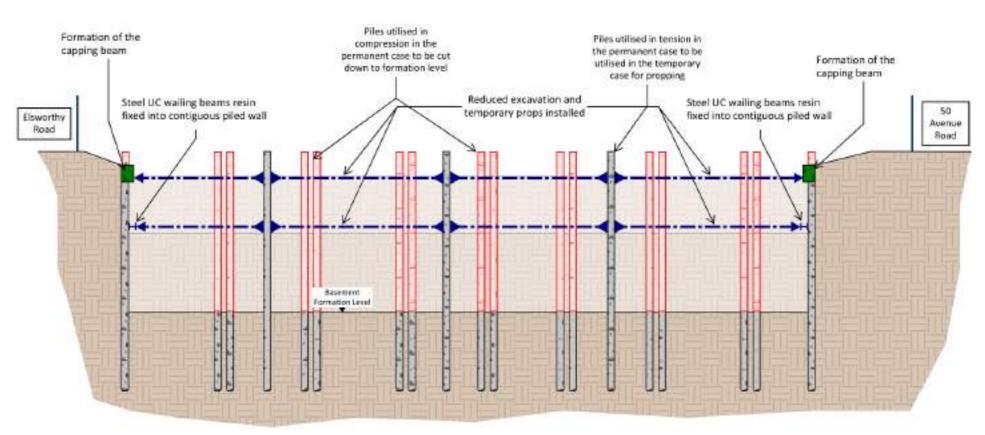
Image 22 - Excavation Sequence

The basement area is to be excavated to approximately 10m below ground floor level. As the excavation continues temporary waler beams and props will be installed close to the proposed slab levels to minimise defections of the piled wall until the permanent slab props are installed.

Once sufficient temporary works are installed the entire basement is to be excavated down to Basement Floor formation level.

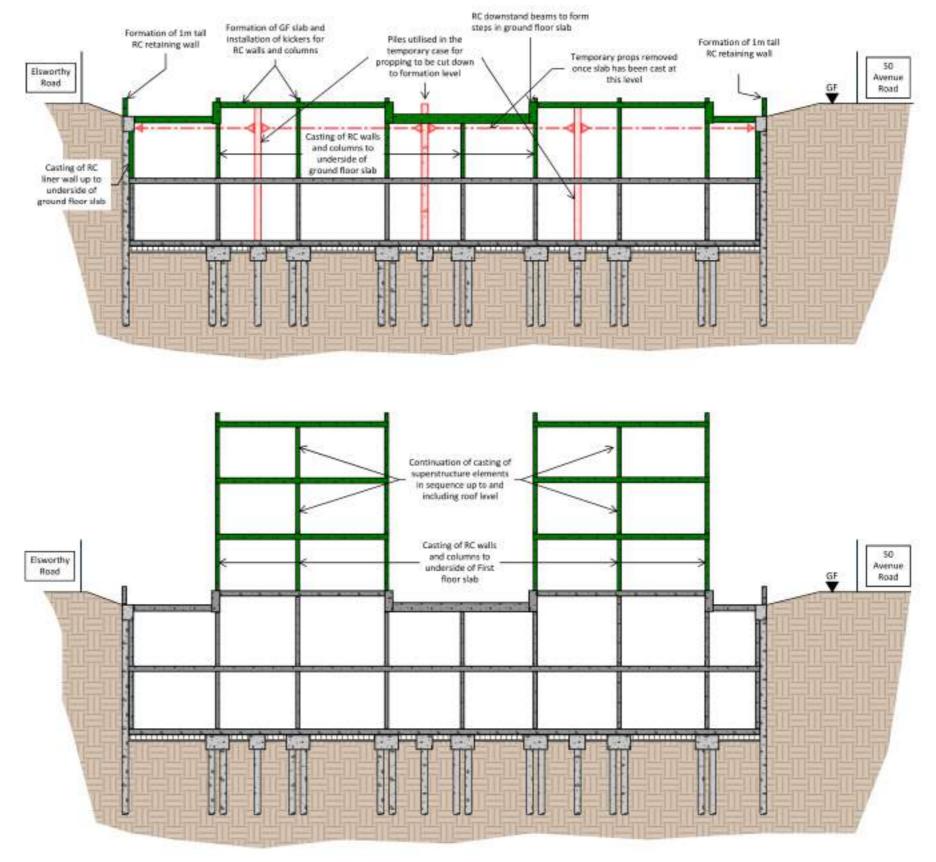
Image 23 - Basement and Superstructure Construction

Once the ground floor slab has been cast, the RC superstructure works can commence. The superstructure frame of columns walls and slabs will be cast on site in sequence. Primarily the columns and walls will be cast up to the underside of the first-floor slab. The reinforcement for the first-floor slab will be laid and the concrete poured and cured. Once the concrete has cured to a sufficient strength, the same sequence can be followed to form the second floor and the roof. The walls positioned around the stairs and lift voids provide the laterally stability for the RC structure, with the slabs acting as a diaphragm to translate any lateral loadings back to these elements where the loads will be transferred down to the foundations.

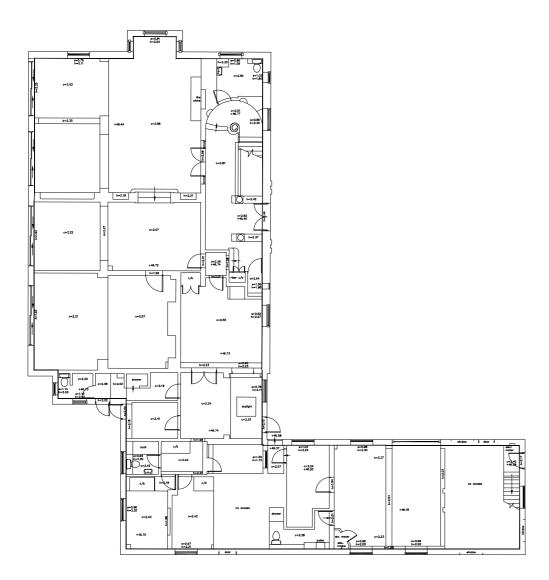
Ground Floor Gross Internal Area=384.2sqm

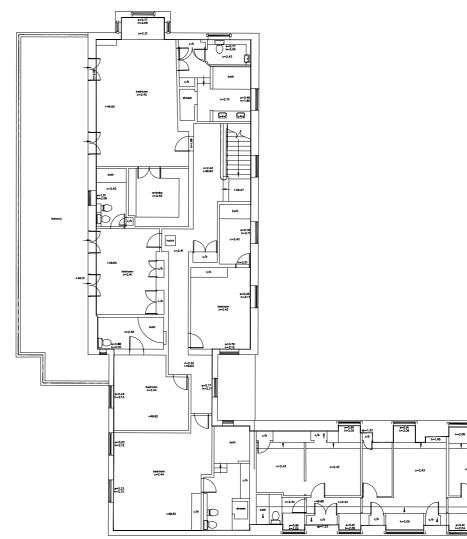
FIRST FI©©r Gross Internal Area=293.82sqm

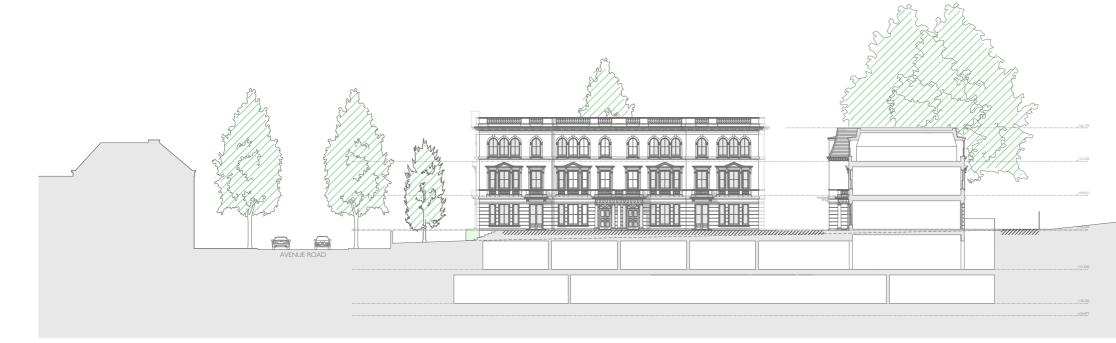
PROJECT: AVENUE GARDENS						
<u>TITLE:</u> PROPOSED SECTION A - A - 12 UNIT SCHEME						
Date:	APRIL 2022					
Scale:	1:200 @ A I	Dra	awn: SDK			
DRAWING NUMBER: 208-290A

PROPOSED SECTION A - A I:200

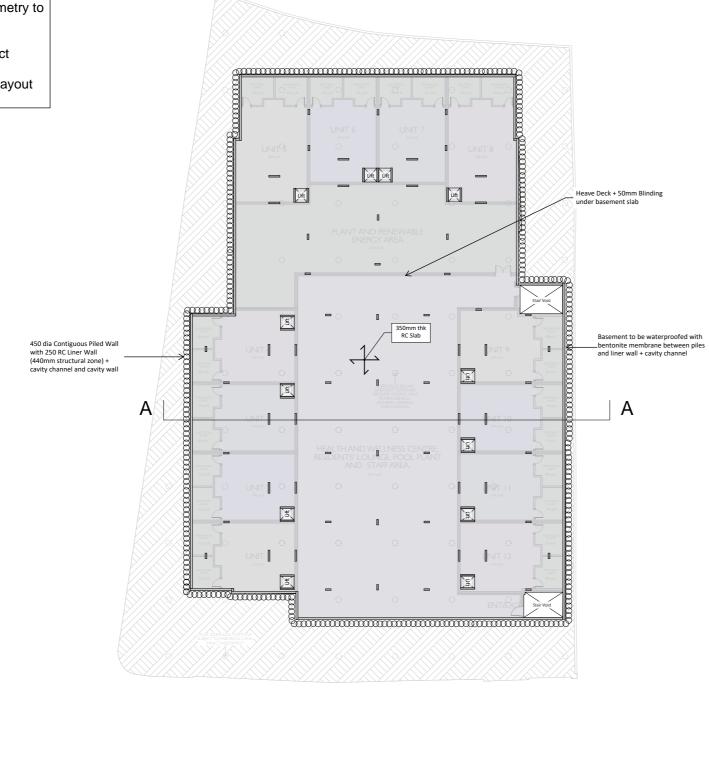
Job	52 - 54	Avenue Road		
Title	Propose	d 12 Unit Structu	ral Dra	wings - Basem
Job No.	2673		Sheet	SK006 - 2 (

Foundations: 450mm dia piles assumed in all locations Pile cap geometry TBC

Notes:		
10103.		
Slabs:	RC depth as annotated	
Columns:	200x600 RC UNO	
Walls:	Stair Core walls to be 1200x200 RC UNO Lift Core walls to be 1500x200 RC UNO	
	terial, build up and construction methodology med by architect	
Upstand and service opening positions and geometry to be confirmed by architect		
Finished Fl	oor Levels to be confirmed by architect	
1

Shear wall location(s) to be confirmed following layout freeze

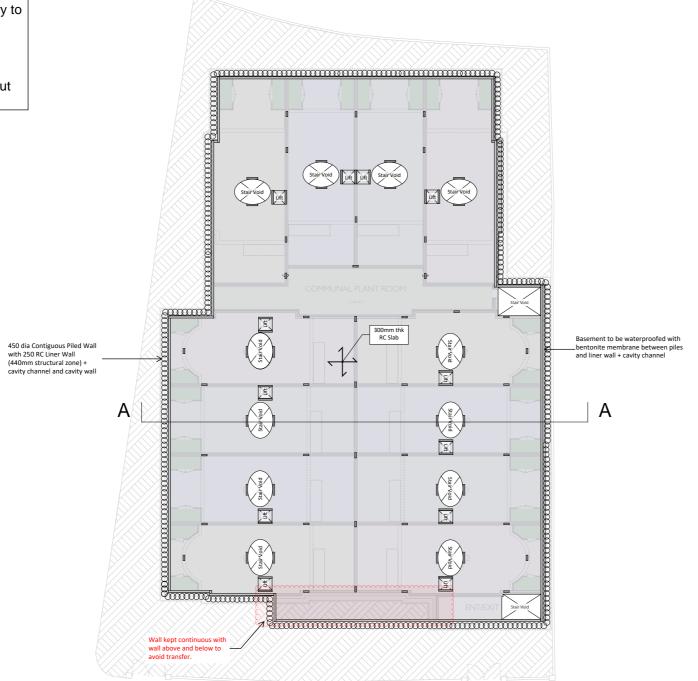
Job	52 - 54	Avenue Road	
TitleP	roposed 12	Unit Structural Drawing	gs - Lower Grou
Job N	o. <b>2673</b>	Sheet	SK006 - 3 c

Notes:		
Slabs:	RC depth as annotated	
Columns:	200x600 RC UNO	
Walls:	Stair Core walls to be 1200x200 RC UNO Lift Core walls to be 1500x200 RC UNO	
	erial, build up and construction methodology red by architect	
Upstand and service opening positions and geometry to be confirmed by architect		
Finished Floo	or Levels to be confirmed by architect	
1

Shear wall location(s) to be confirmed following layout freeze

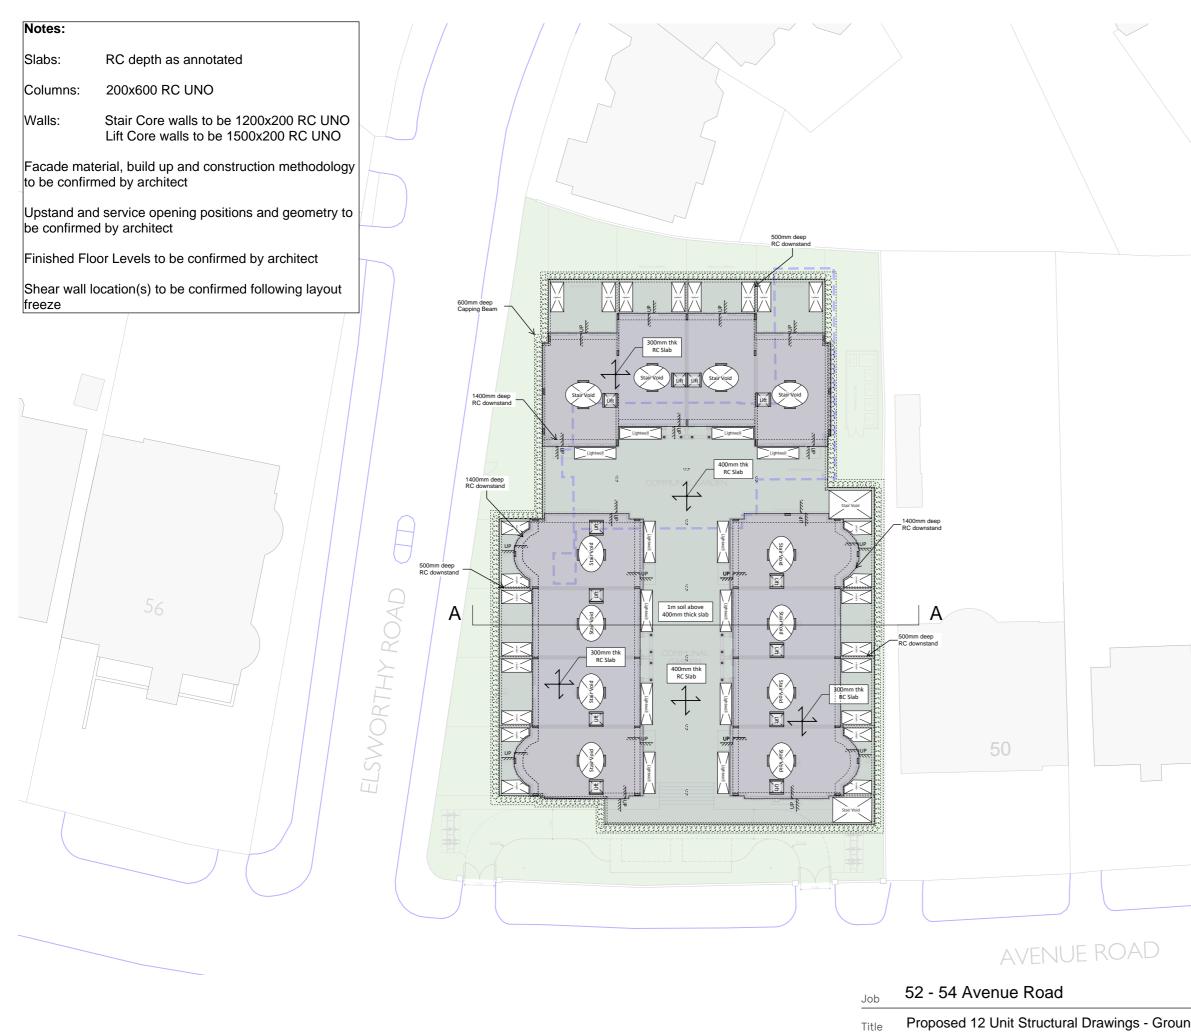
Job No.	2673	Sheet	SK006 - 4
JUD 110.	2010	311661	0.000

Date	10/05/22	
nd Floor GA	Eng.	AD	
l of 8	Rev.	P1	
			-

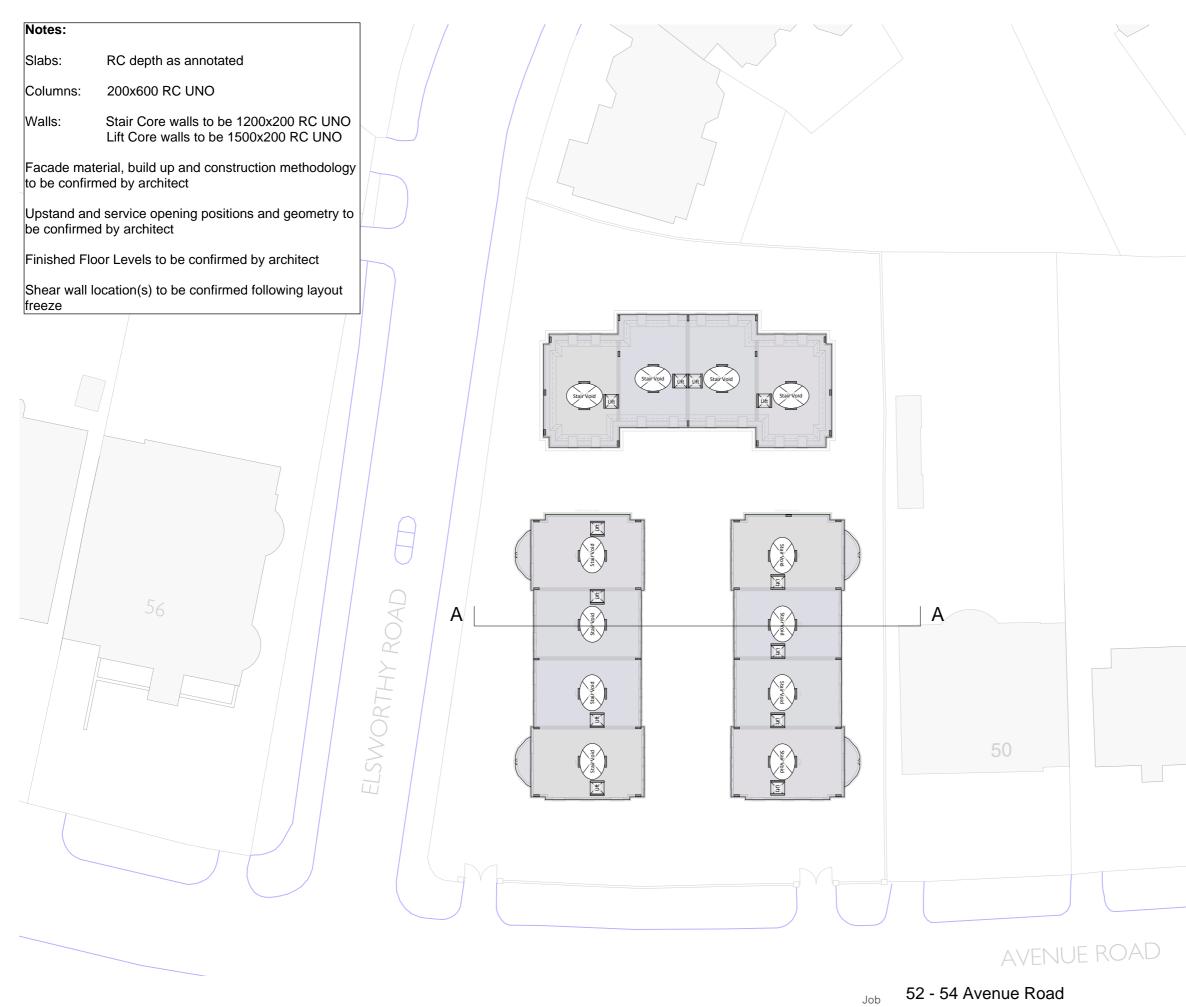
Title	Proposed 12 Unit Structural Drawings - Seco		
Job No.	2673	Sheet	SK006 - 6

Date	10/05/22
nd Floor GA	Eng.	AD
6 of 8	Rev.	P1

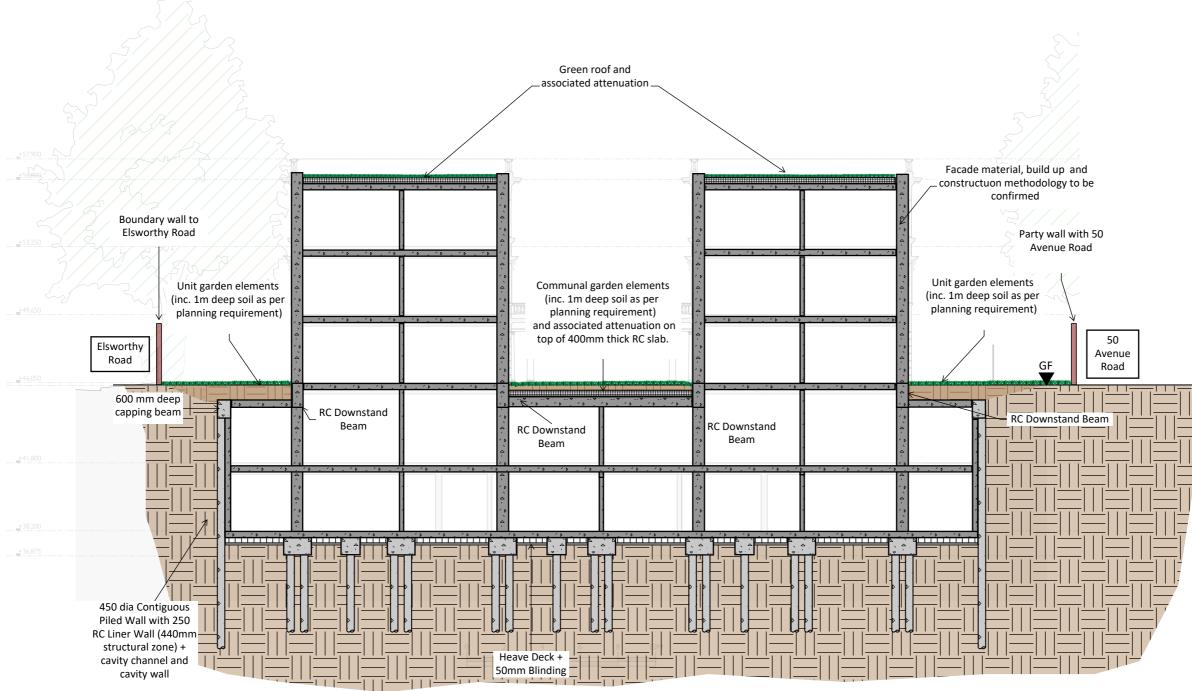
Job	52 - 54 Ave	nue Road		Date	10/05/22
Title	Proposed 12	Unit Structural Drawir	ngs - Section A-A	Eng.	AD
Job No.	2673	Sheet S	K006 - 8 of 8	Rev.	P1

PROPOSED SECTION B - B I:100
