1. Front facade renovation

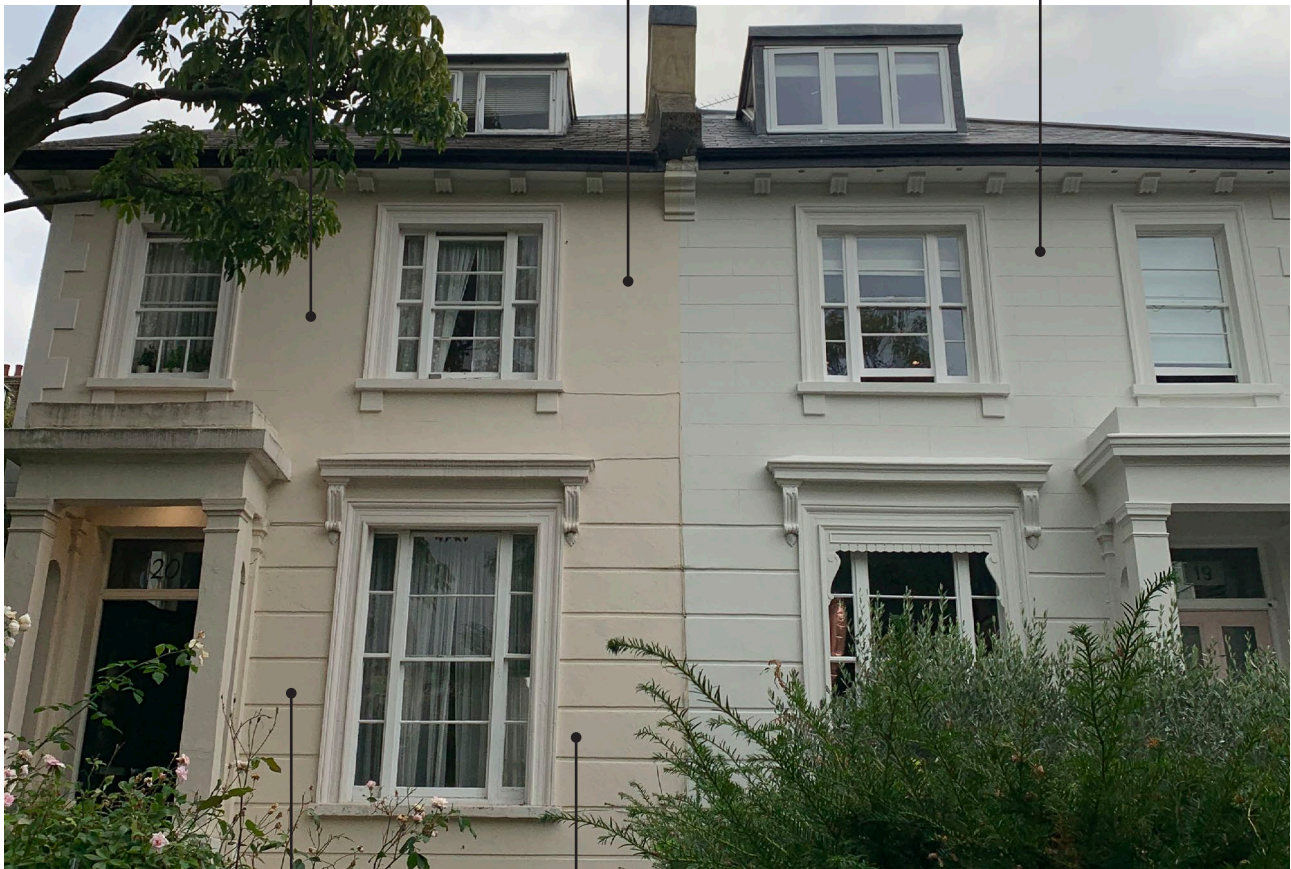
Fig 1

Original mortar joint details no longer visible - mortar joints to be raked out and renovated. See above for additional detail.

Example of visible mortar joints can be seen at No.19 Eton Villas.

Mortar joints on lower half of facade to remain as existing

Mortar joints are to be stripped back and raked out to restore original detailing of the facade. This will remove layers of built up paint, whilst maintaining the original mortar beneath. Any areas where new pointing is required will be in lime-based mortar to match the original. Mortar joints to be recessed to reveal and reflect the original facade detail. All of these renovation works will further protect the condition of the original stone and stucco facade. See below for further information.

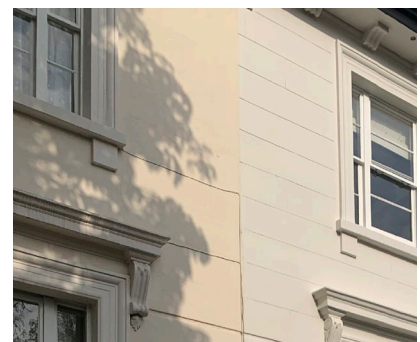
Fig. 2
Image showing the original mortar joint details no longer visible on No.20 Eton Villas.

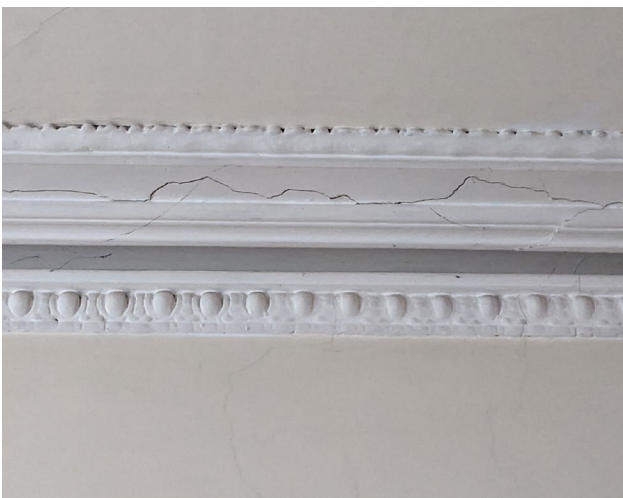
Fig. 3
Typical example of the existing condition of the cornice on the raised ground floor showing cracking in the top section and an in-tact section below.

All existing plasterwork, mouldings and cornices will be retained wherever possible - this will be in locations where no cracking is already evident (Fig.3). Here, the layers of paint will be carefully stripped back to reveal the original plasterwork detail so it can be fully restored. Where cracking is evident (Fig.3), the plasterwork will need to be replaced to ensure safe future use of the house. As outlined above, this will be created from detailed moulds made prior to any renovation works commencing.
