**23 Kelly Street**

Design & Access Statement

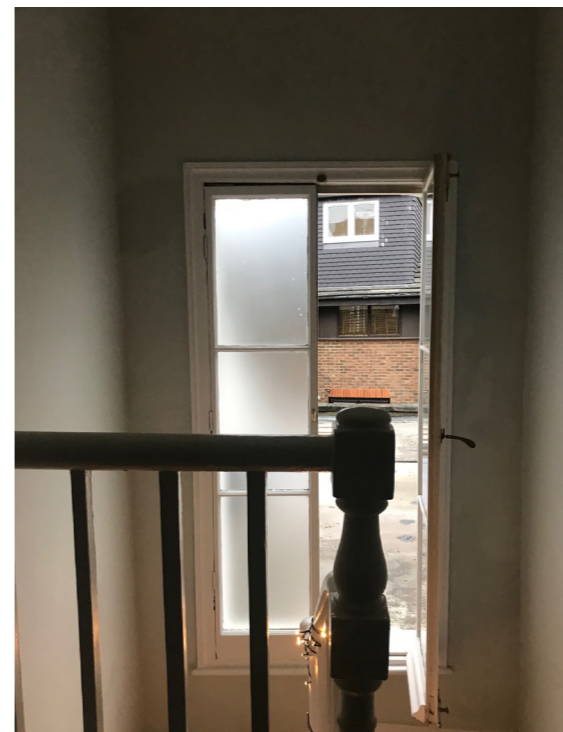
**Figure 2E** Single glazed doors onto flat roof area

We are proposing that the single glazed doors onto the flat roof, which are not historic, are to be replaced with a double glazed unit. Additionally we are proposing all historic windows to be draught proofed and repaired where required.

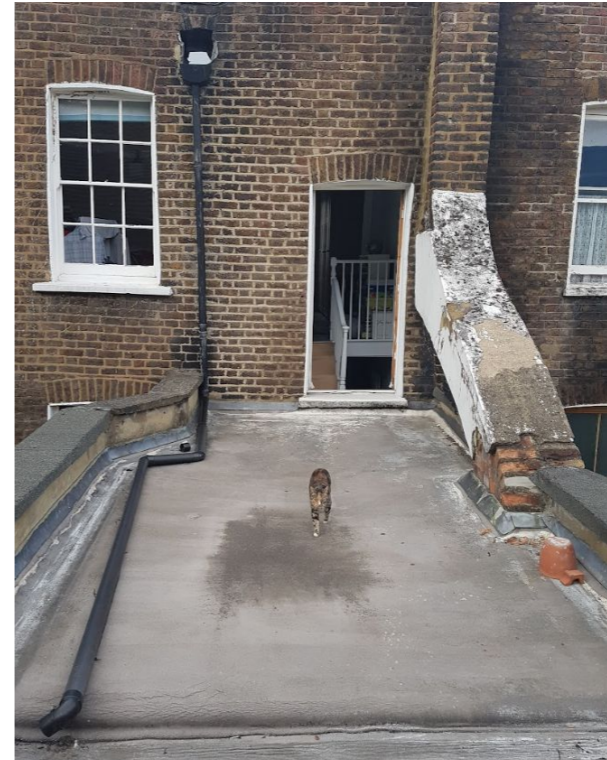
**Figure 2G** The flat roof area: evidence of standing water + unsafe chimney stack

The flat roof area appears largely as it was when constructed. Due to poor design there is evidence of standing water. The original chimney stack which now rests on the flat roof has been subject to cracking and as a result has become unstable and possibly unsafe. An engineer has been commissioned and their report is attached in the Appendix.

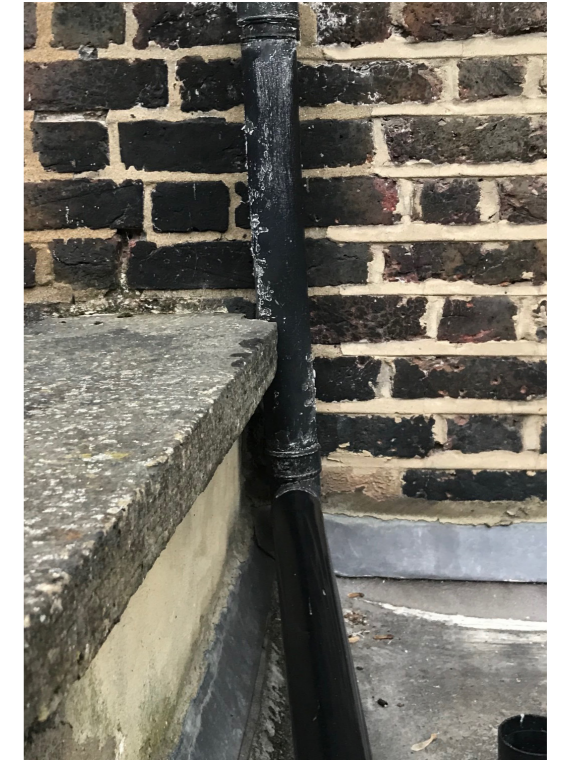
**Figure 2H** Junction between existing rainwater goods + modern PVC addition

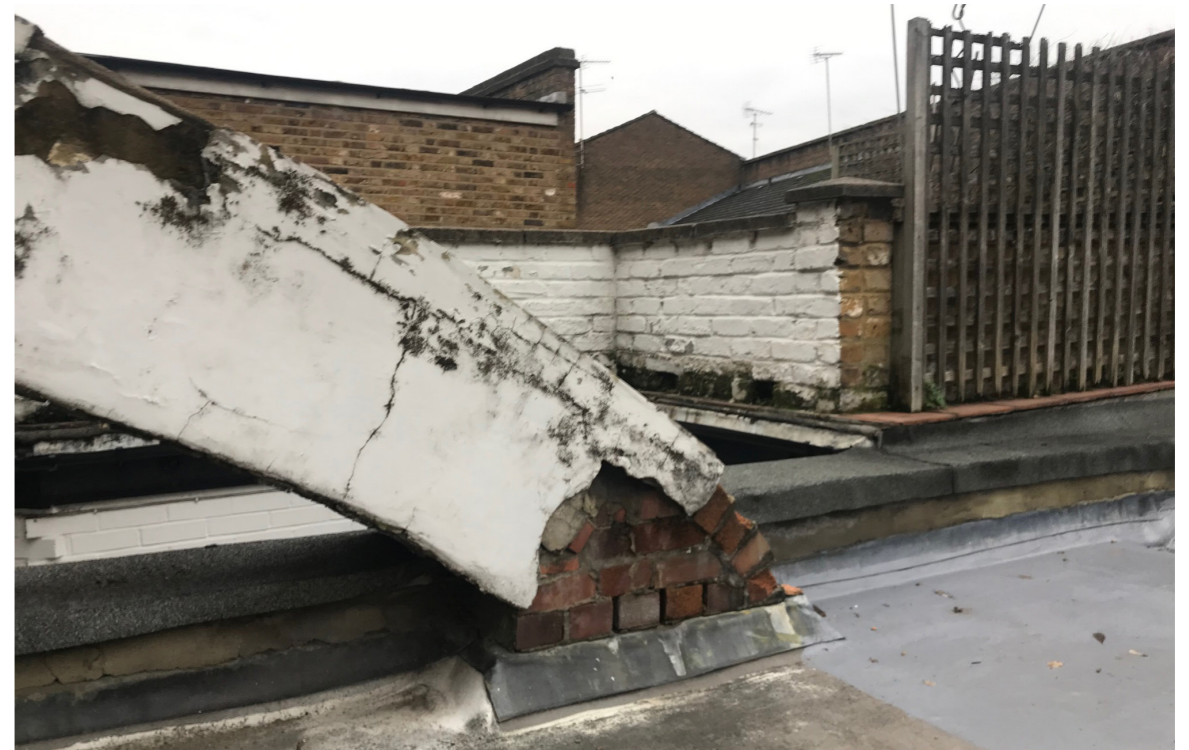
**Figure 2I** Cracked render and unstable bricks at base of chimney stack

Frost damage has caused chipping and cracking to the chimney bricks which, over time, has caused the stack to become unstable. Our proposal is to make essential repairs to the chimney.

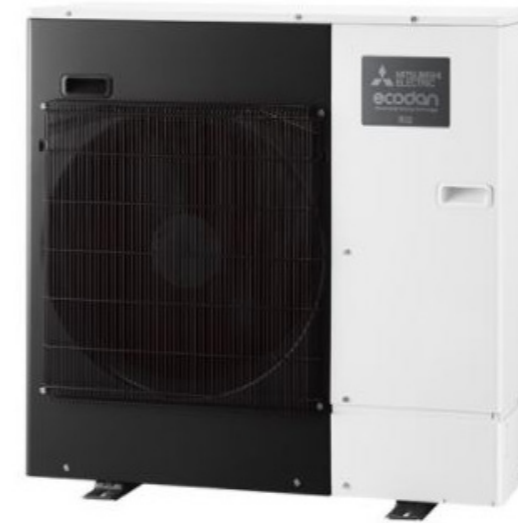
Figure 3G Appearance of proposed heat pump.

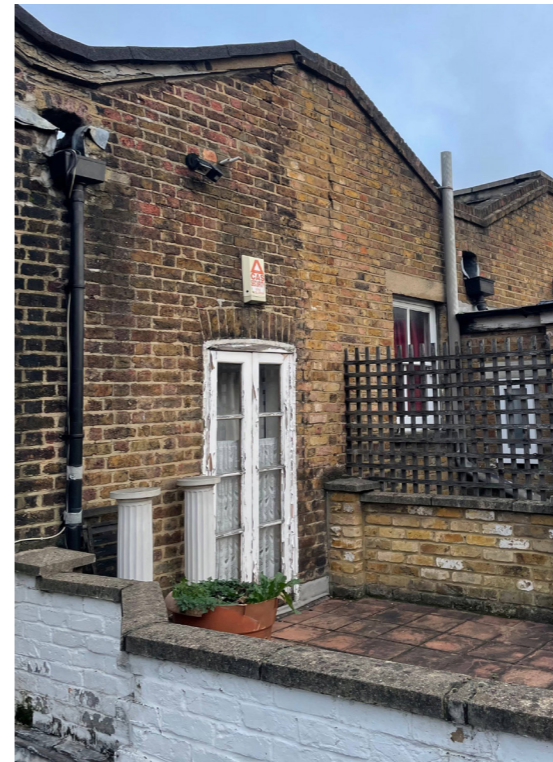
**Figure 3H** Existing masonry wall to terrace of no.21 Kelly Street

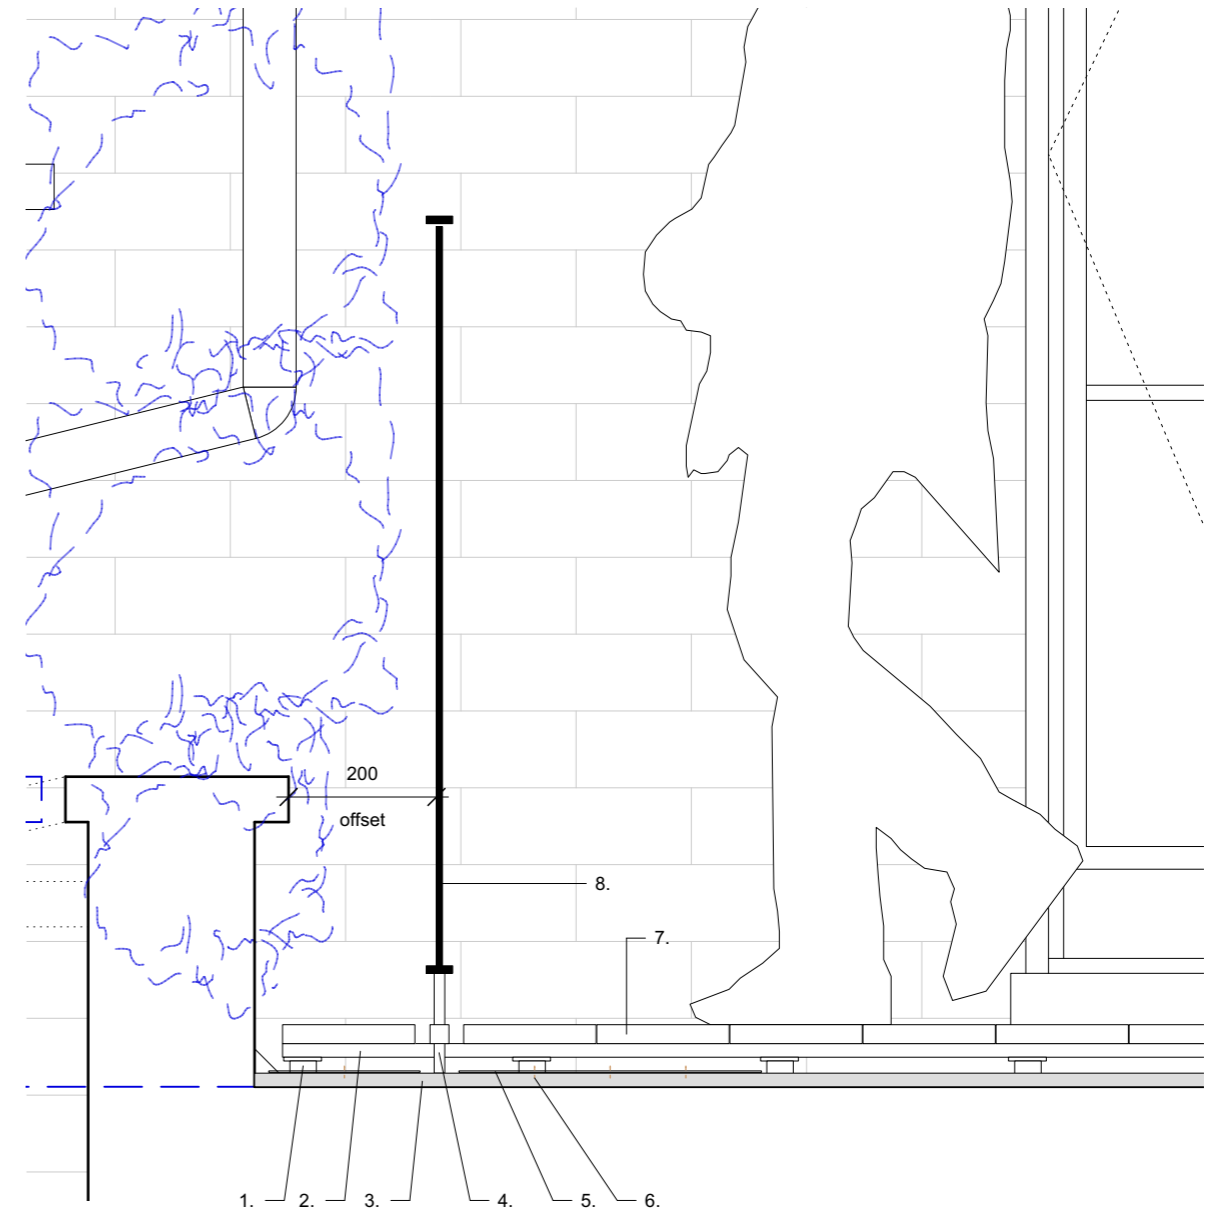
**1 Proposed Balustrade Fixing (indicative only)**  
Scale: 1:10

- 1. Pedestals
- 2. Plywood deck to support floor finish
- 3. Base rail
- 4. Railing foot
- 5. Load support plate
- 6. Load support plate fixings (into base rail)
- 7. New floor finish to terrace
- 8. Slim iron heritage-style balustrade

**Figure 3K** As proposed balustrade system - indicative only

The proposed balustrades would be fixed using a removable, self-supporting system (refer to figure 3J + 3K) allowing for them to be removed in future with no impact on the fabric of the building.
