# Swiss Cottage Library

## Fin Survey Specification

London Borough of Camden

5206133-ATK-XX-XX-RP-SE-000002

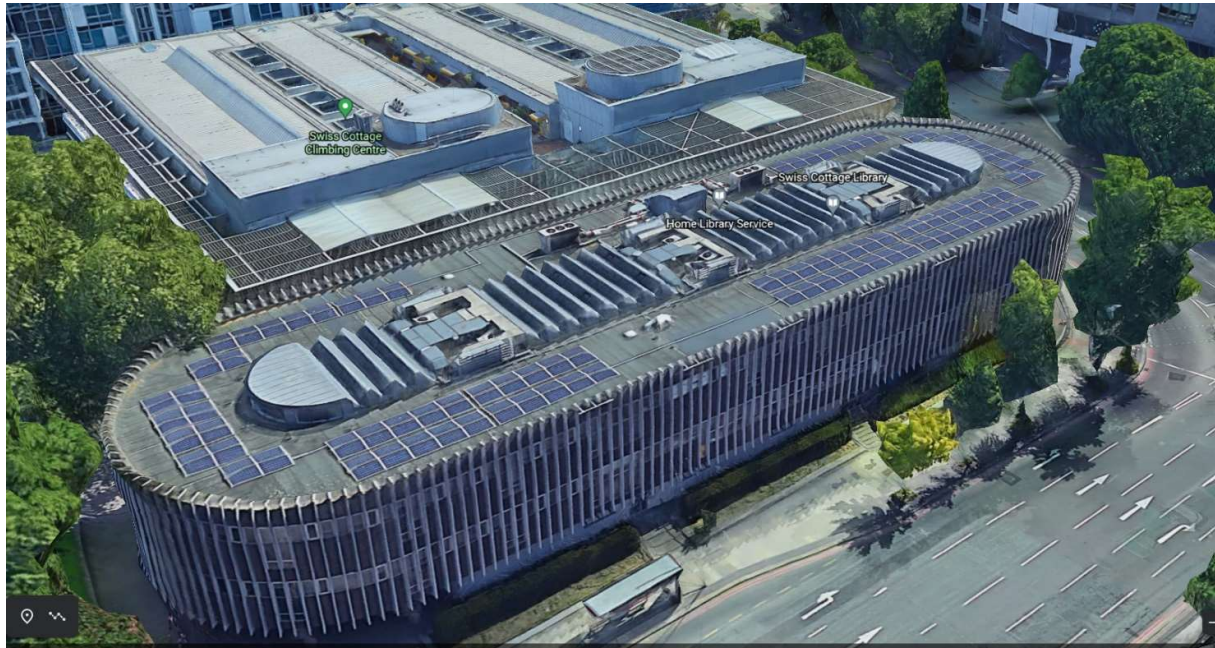
Swiss Cottage Library is a Grade II Listed Building dating from 1963 and is notable for the concrete fins around its perimeter as shown in Figure 1.1.

**Figure 1.1 – Swiss cottage library**

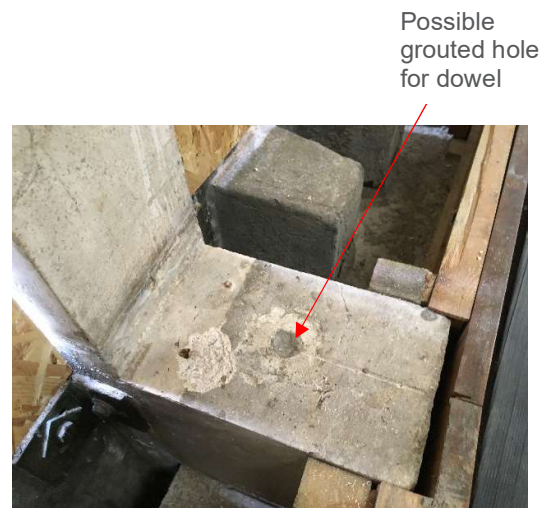
There are 238 fins in total. They are precast reinforced concrete elements fixed to slabs of first floor, second floor and roof by dowels at the perimeter of the building as shown in Figures 2.1, 2.2 and 2.3.

Figure 2.3 – Photo showing possible grouted hole for dowel at fin
