ARBORICULTURAL ASSESSMENT REPORT

For:	Client:	
	Insurer:	Zurich
Site:	Policyholder:	
	Risk Address:	70-75 Auden Place, London, NW1 8ND
Refs:	PRI Ref:	
	Client Ref:	
	Insurer Ref:

1.0 INTRODUCTION & BRIEF

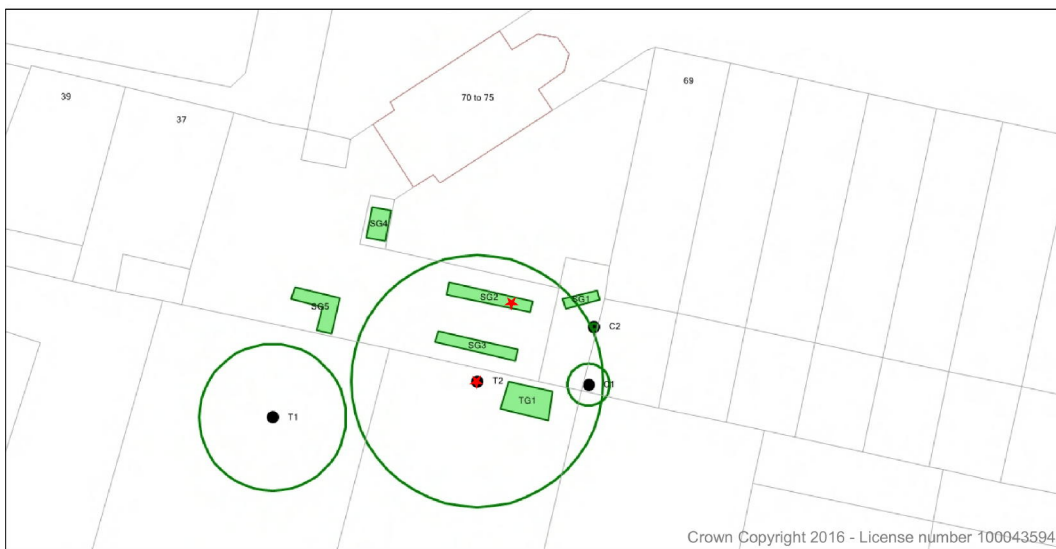
7.0 APPENDIX 2: SITE PLAN

Location:	70-75 Auden Place, London, NW1 8ND
Job Ref:	191430
Survey Date:	10/05/2021 - NTS
By Property Risk Inspection - Insurance Services
