5.5 Sections - Existing & Proposed

5.7 Preservation & Key Details

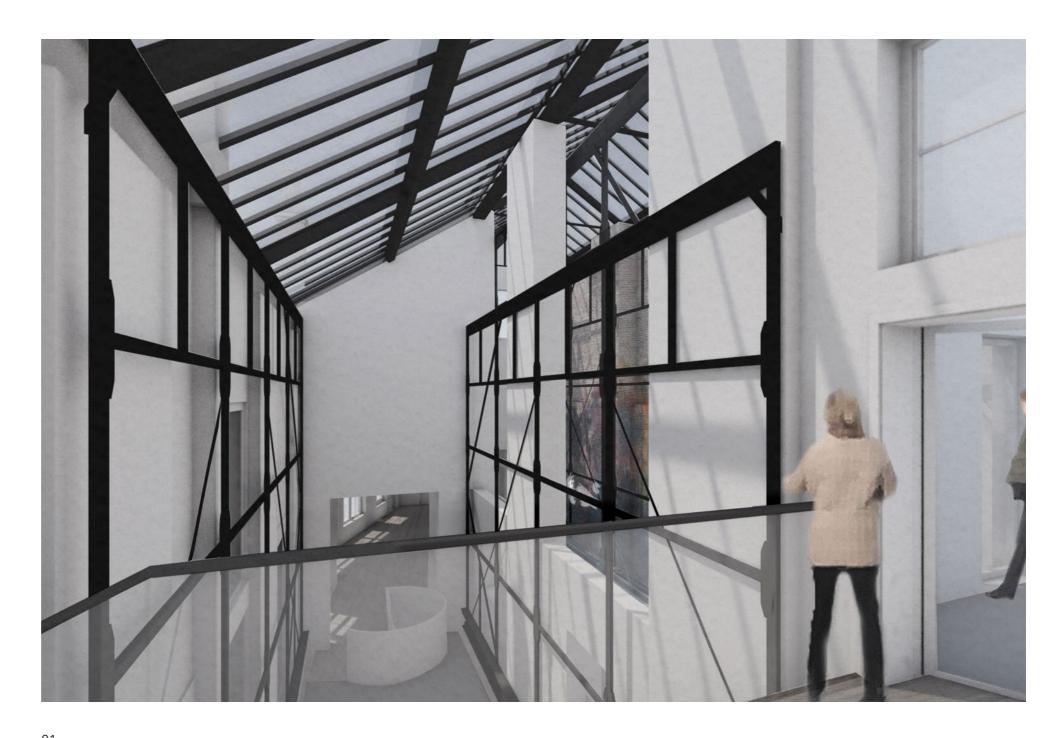
01 Second floor walkway

- 01 From the new second floor walkway looking down into the first floor workspace and towards the glazed roof;
- 02 New floorspace in the ground floor looking down into the basement void and new spiral staircase;
- 03 Looking through the second floor terrace window into the first floor walkspace;
- 04 First floor work space looking towards the new spiral staircase.

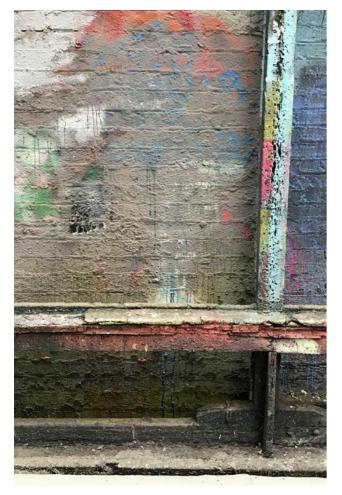
Painting frames in the main work space as existing

The frames (to both galleries) are in a poor condition and have split in numerous instances. Not surprisingly they have been much used over their life and as such have suffered some damage from general wear and tear (fig.02/03). As a result, in areas they are very fragile and splintered.

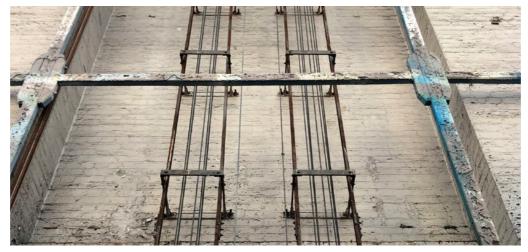
Painting frames mechanism to be retained and cleaned

Consequently, it is proposed that the frames are raised on their tracks so that they sit above the first floor level and fixed in place. The frame, mechanism/rails and the walls adjacent will be carefully cleaned (Fig.04). The frame would then be repaired, repainted and set in position (Fig. 01) using brackets fixed back to the wall.

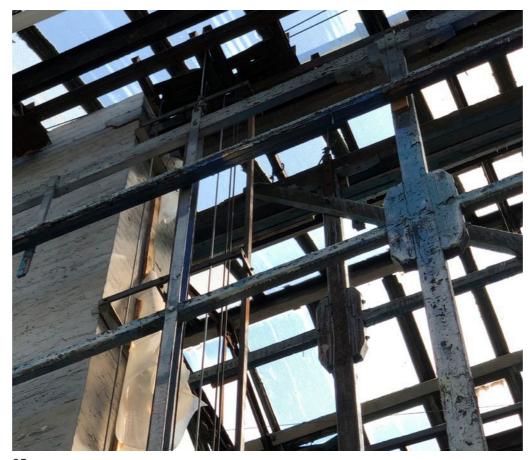
Existing condition of painting frames

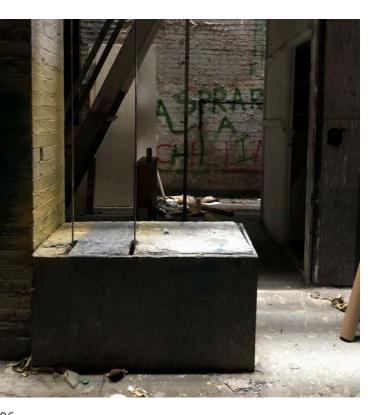
Winch to be retained and encased in clear box

which will require the removal of the equipment to install and provide a full waterproof solution. Two of the winches (Fig.06/07) are to be retained and cleaned. These winches will be encased in an transparent box and will be nonworking, for the ongoing safety of the users in the building.

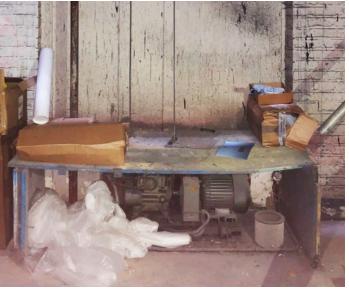
Winch to be retained and encased in clear box

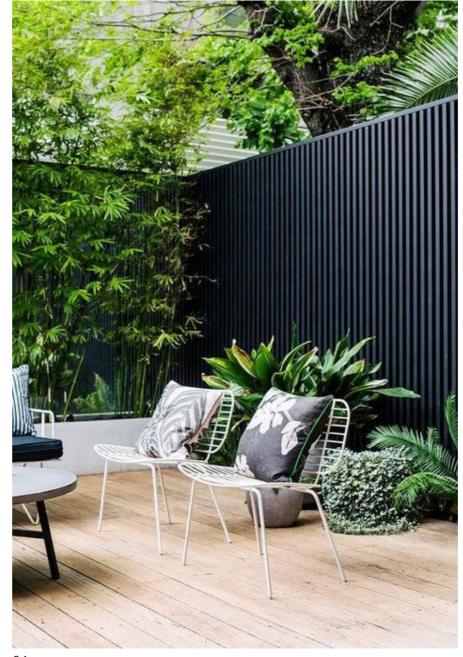
04 Dark grey slatted fence, planters and timber decking
