Job: 2201 Ambassadors Theatre
 Client: Ambassador Theatre Group

Drawing: Proposed Front Elevation
 Drawing no: 2201-3-300 Rev: B Status: Stage 3
 Scale: 1:50@A1, 1:100@A3 Date: 17/06/22

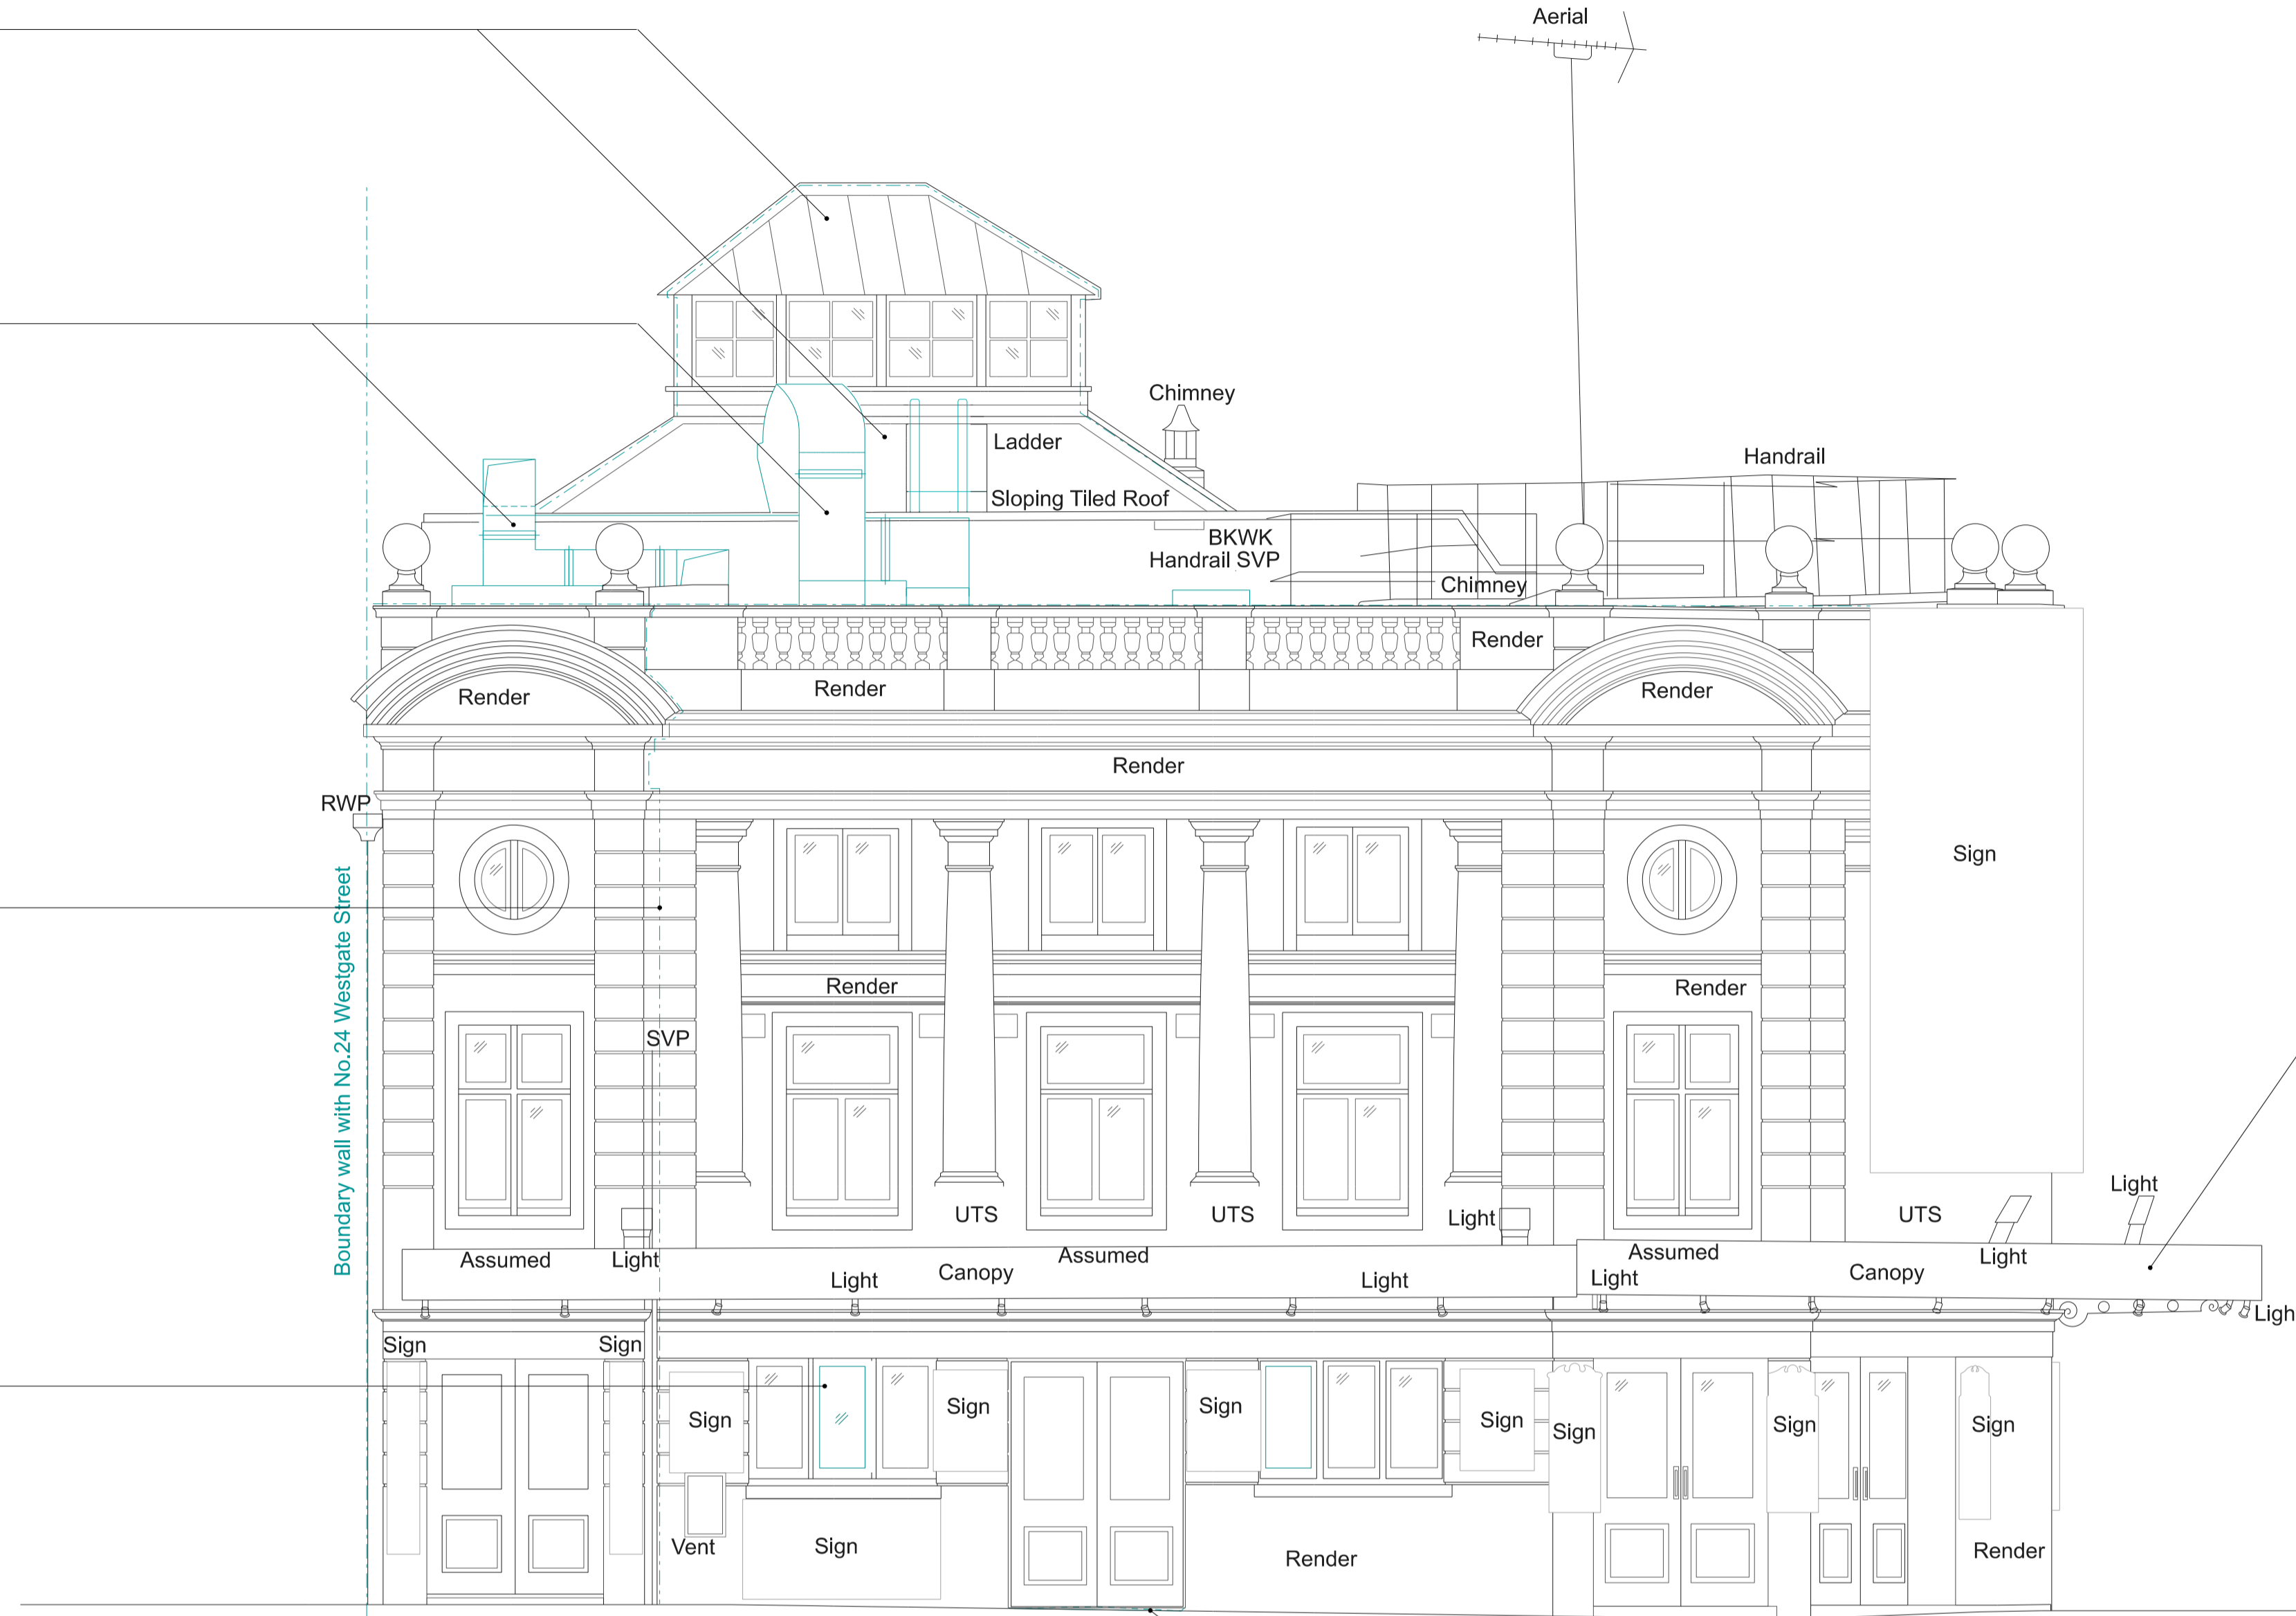
Replace/ reinstate slipped, missing or broken tiles with new slates to match. Remove temporary bitumen repairs and reinstate with matching slates.
 Reinstall roof slates with slates to match existing where unknown slates have been used for roof repairs
 Redecorate timber elements of the lantern and reinstate/ repair the lead flashing where missing or misplaced to prevent the deterioration and decay of the lantern timber elements

New M+E roof equipment behind second floor parapet

New lightning system to follow existing rain water pipes route

Existing extract grille removed and window pane reinstated to match existing

Painted steelwork supporting the glazed canopy to be refurbished/ redecorated to address isolated corrosion and peeling of decorative finishes to prevent further deterioration/ further corrosion.

Reduced scope of works to altering 1no door cill only - see side elevation on Tower Court
 Allow for levelled door thresholds and low energy automatic swing/ power assisted door openers and intercom installed to improve access for wheelchair users. Existing cills repaired as required

Note:
 Mansafe system installed to allow for access and maintenance of roof and gutters. Final mansafe layout to be determined following roof inspection.
 Clean, repoint and repair all masonry parapets and coping stones to prevent water ingress.
 Refurbish existing windows throughout.
 Fractures, low level impact damage, blown/ detached surfaces and blistering/ peeling paint in stucco render surfaces to be repaired to prevent further deterioration and detachment of Stucco render surfaces. Fractured and impact damaged stone/ stucco window collared to be repaired as well to prevent potential water ingress and further deterioration.
 Isolated bricks were fractured, with minor impact/ abrasion damage at low level to be replaced in matching brick/ repaired to prevent water ingress into the structure. Isolated soiling and graffiti to be cleaned.
 Painted steelwork supporting the glazed canopy to be refurbished/ redecorated to address isolated corrosion and peeling of decorative finishes to prevent further deterioration/ further corrosion.

All rainwater downpipes to be cleared. Where existing original elements need to be replaced, replace with like for like.
