Job: 2201 Ambassadors Theatre
Client: Ambassador Theatre Group

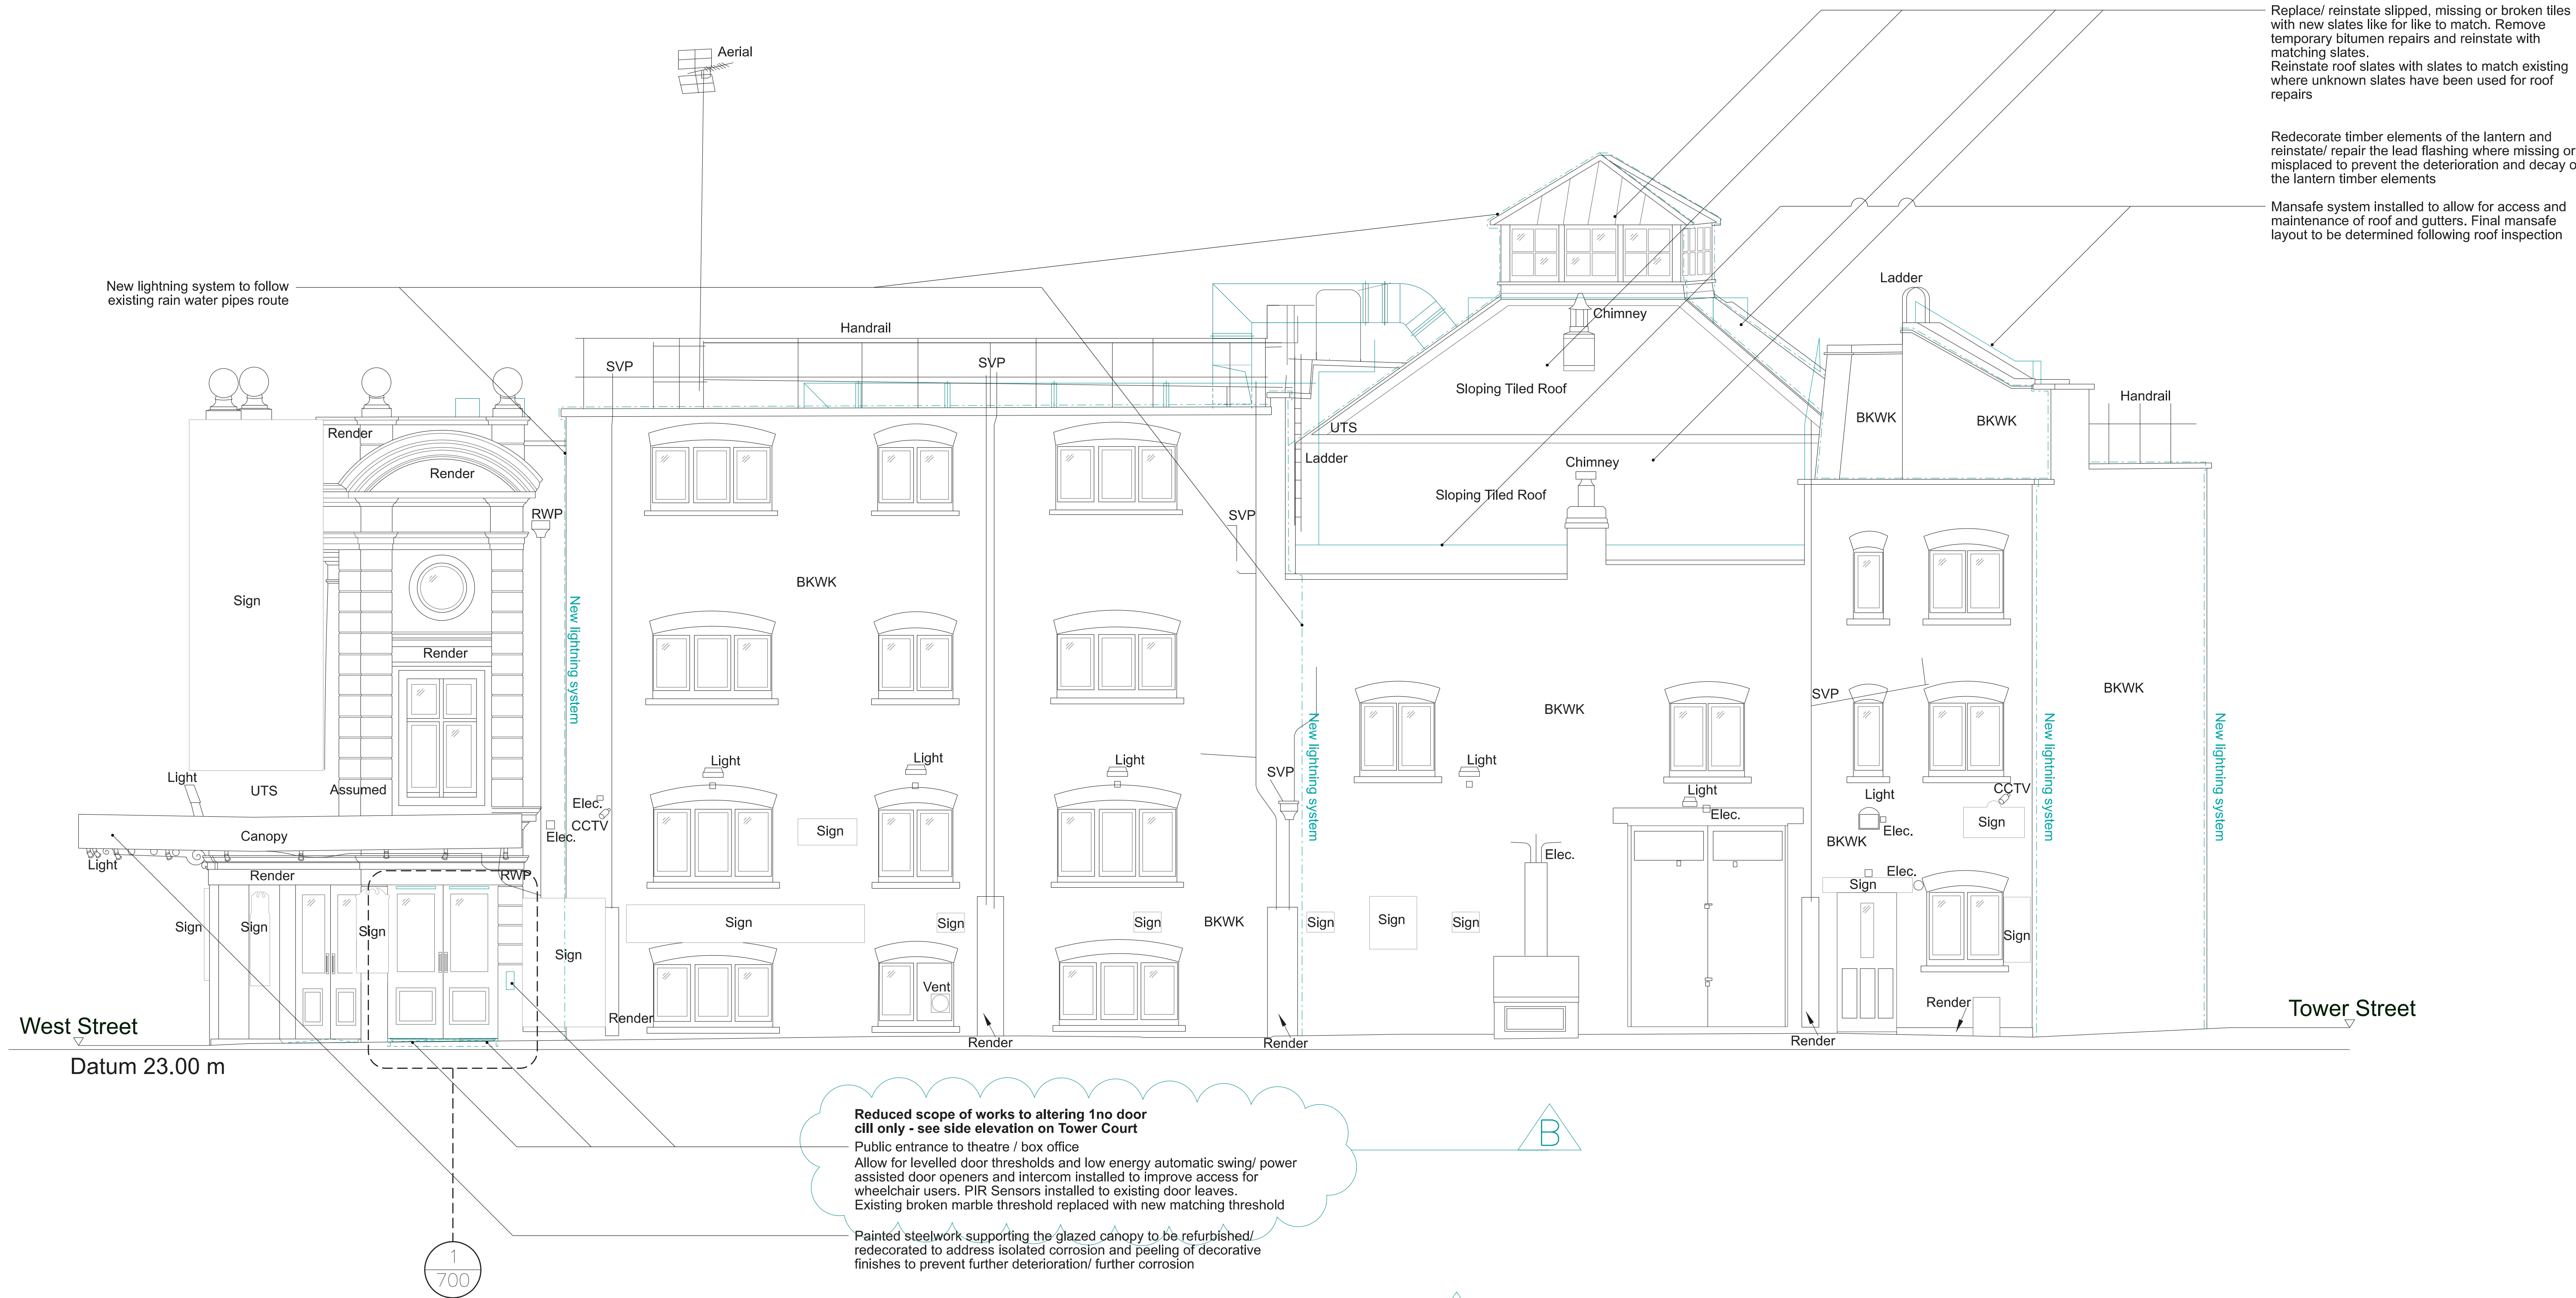
Replace/ reinstate slipped, missing or broken tiles with new slates like for like to match. Remove temporary bitumen repairs and reinstate with matching slates.
Reinstate roof slates with slates to match existing where unknown slates have been used for roof repairs

Redecorate timber elements of the lantern and reinstate/ repair the lead flashing where missing or misplaced to prevent the deterioration and decay of the lantern timber elements

Mansafe system installed to allow for access and maintenance of roof and gutters. Final mansafe layout to be determined following roof inspection

Reduced scope of works to altering 1no door cill only - see side elevation on Tower Court
Public entrance to theatre / box office
Allow for levelled door thresholds and low energy automatic swing/ power assisted door openers and intercom installed to improve access for wheelchair users. PIR Sensors installed to existing door leaves.
Existing broken marble threshold replaced with new matching threshold

Painted steelwork supporting the glazed canopy to be refurbished/ redecorated to address isolated corrosion and peeling of decorative finishes to prevent further deterioration/ further corrosion

All rainwater downpipes to be cleared. Where existing original elements need to be replaced, replace with like for like.
