Reduced scope of repairs

Job: 2201 Ambassadors Theatre Client: Ambassador Theatre Group

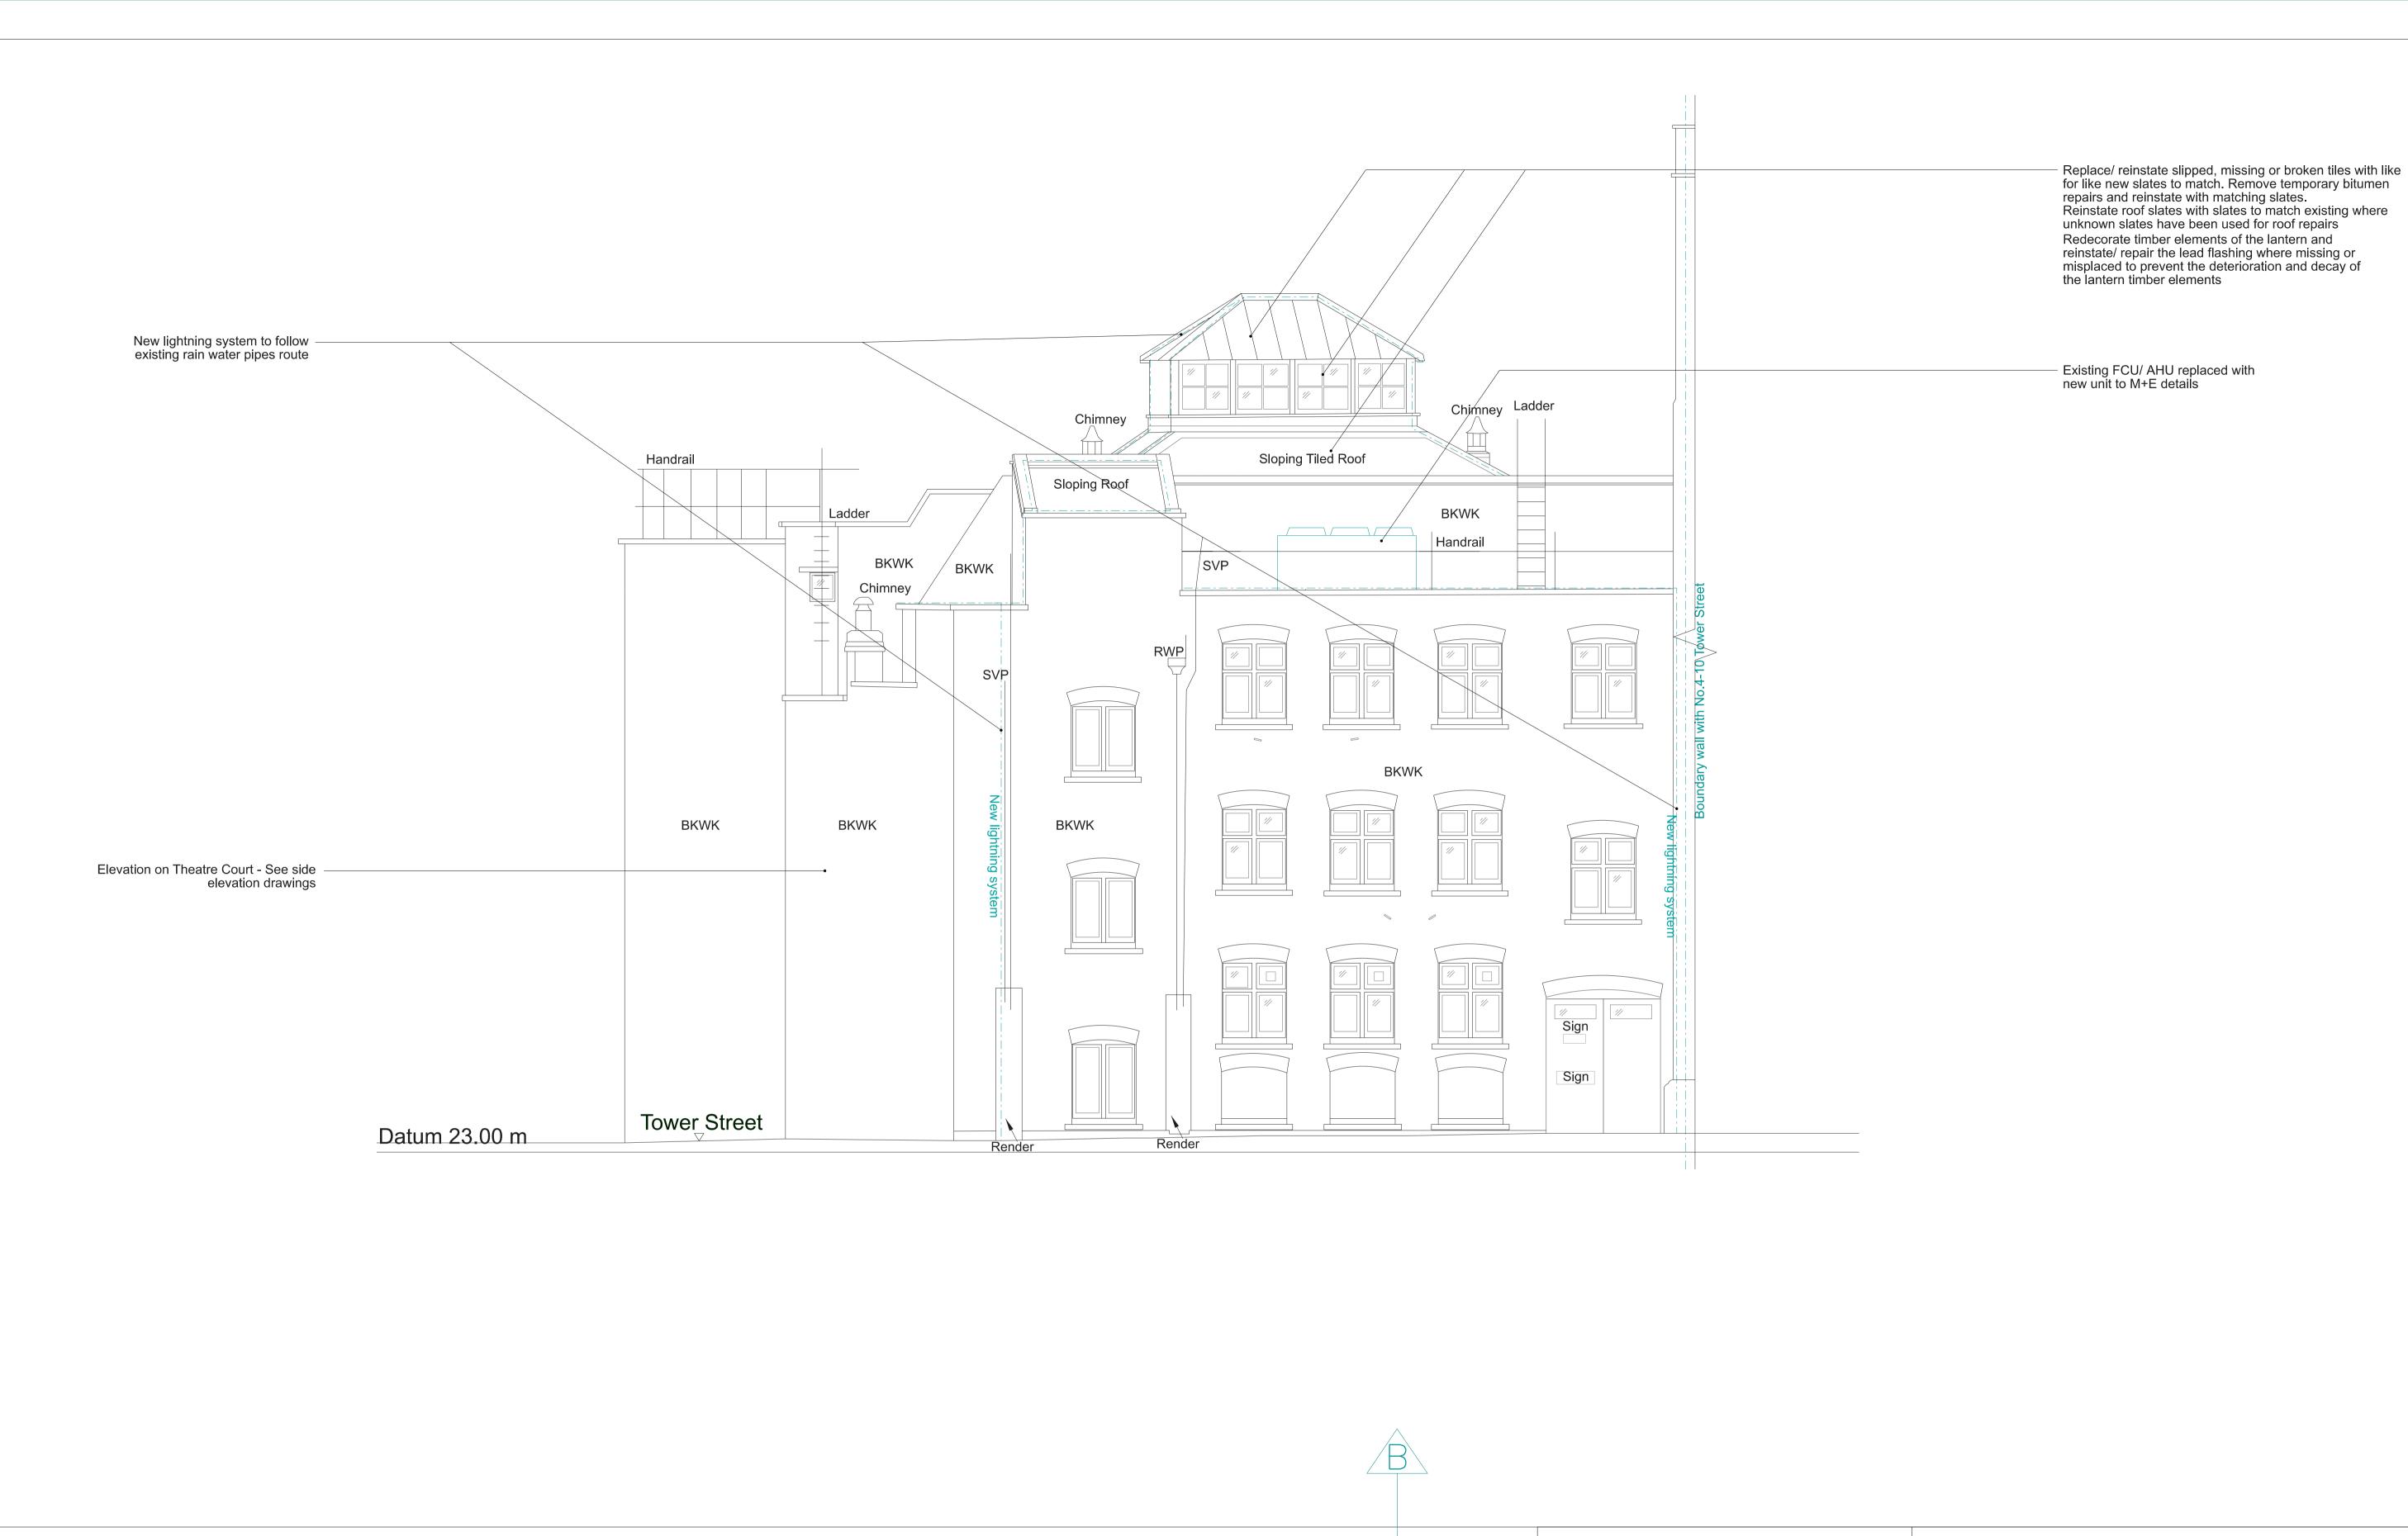
Existing Proposed Mansafe system installed to allow for access and maintenance of roof and gutters. Final mansafe layout to be determined following roof

Clean, repoint and repair all masonry parapets and coping stones to prevent water ingress.

Refurbish existing windows throughout.

Fractures, low level impact damage, blown/ detached surfaces and blistering/ peeling paint in stucco render surfaces to repaired to prevent further deterioration and detachment of Stucco render surfaces. Fractured and impact damaged stone/ stucco window collared to be repaired as well to prevent potential water ingress and further deterioration.

Isolated bricks were fractured, with minor impact/ abrasion damage at low level to be replaced in matching brick/ repaired to prevent water ingress into the structure. Isolated soiling and graffiti to be cleaned.

Painted steelwork supporting the glazed canopy to be refurbished/ redecorated to address isolated corrosion and peeling of decorative finishes to prevent further deterioration/ further corrosion.

All rainwater downpipes to be cleared. Where existing original elements need to be replaced, replace with like for like.
