Project: G523 – 104 - 110 Haverstock Hill, Belsize Park, London, NW3 2BD, UK

STRUCTURAL

REPORT

CLIENT  
ORIGIN HOUSING

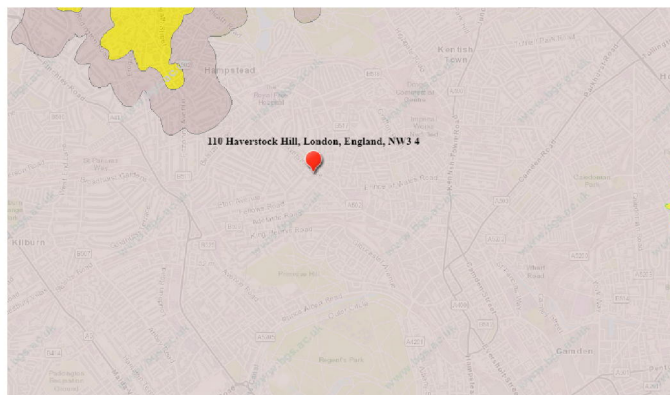
According to British Geological Historical Society Maps (Figure 2) the underlying ground conditions near the site London clay. The bore hole logs available online within proximity to the property confirm these soil conditions.

FIGURE 2: BGS MAP EXTRACT SHOWING COMBINED GEOLOGY
