MBP	Michael Barclay Partnership
consulting engineers	
1 Lancaster Place	
London WCE2 7ED	
T 020 7240 1191	F 020 7240 2241
E london@mbp-uk.com	
www.mbp-uk.com

32 Langbourne Avenue, N6 6PX

Structural Engineer's Desk Study for Planning
November 2022
P1-planning

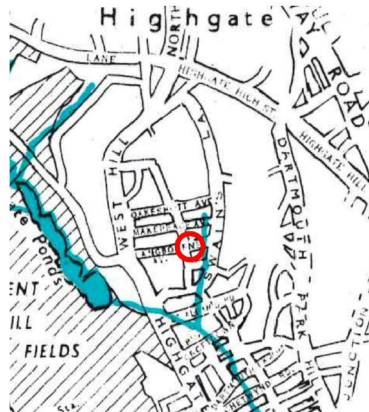
Figure 6 - Extract from *The Lost Rivers of London*; Nicholas Barton; Historical Publications Ltd, 1982

There are many rivers running under London that feed into the Thames. No 32 Langbourne is close to a tributary river feeding the Fleet, however the river is sufficiently distant to have no impact on the proposed development.
