**DESIGN AND ACCESS STATEMENT FOR PROPOSED NEW SASH WINDOWS – SLIDING SASHES ONLY:  
Flat 2, 38 Compayne, London NW6 3RY**

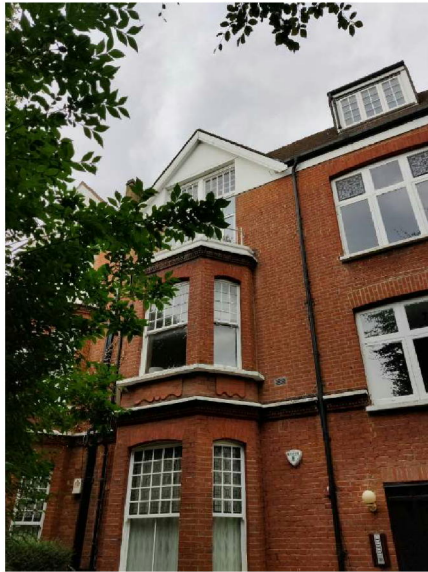
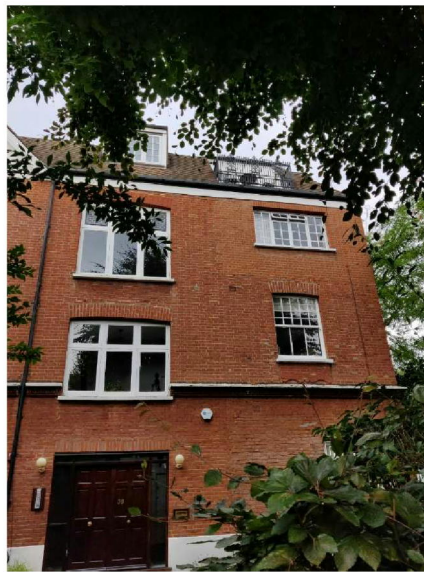
**South elevation**

The main front elevation of the house is dominated by the two storey bay window on the left side. This is the only part of the front elevation to incorporate sash windows. The remainder of the front elevation is predominantly casement windows with more recent casements and a French door on the second floor dormer. A more modern communal entrance door is in the centre of the elevation. The front elevation has striking orange brick stock with decorative brick corbels.

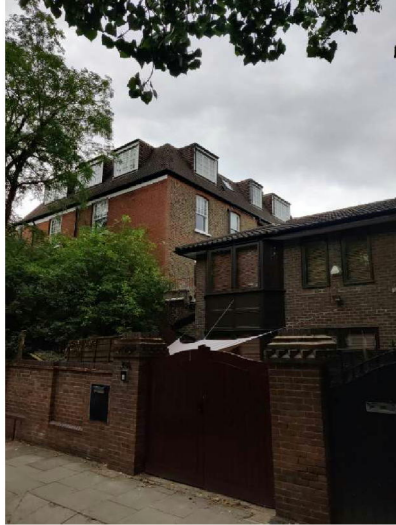
**North Elevation**

Predominantly sash windows on the rear of the property with once again casement windows to more recent dormer additions. The rear has more utilitarian brick stock and less decorative elements.

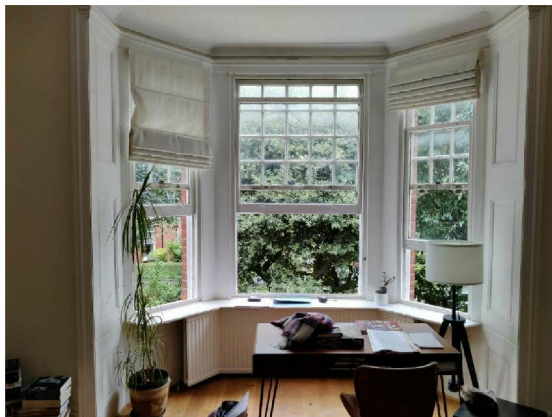
#### **ITEM 1 – FIRST FLOOR FRONT SOUTH ELEVATION – LIVING ROOM**

This item is a bay window comprising 2 pairs of 12 over 1 equal split sashes on the returns and 1 pair of 20 over 1 equal split sashes in the centre. It is the intention to replace just the sliding sashes as the box frame is in good order. However, it has been noted that a cill on the left-hand side viewed internally is in need of replacement along with splice repairs to the outer jambs of the frame in the centre.

The joinery will be timber made from sustainable Accoya wood. Cill replacement on Item 1 will be in hardwood. Accoya in particular provides excellent weathering being virtually rot free as well as being a very stable timber and therefore limiting movement over time and eliminating joint cracking.

The proposal is limited predominantly to replacing just the sliding sash elements. The cill and frame repairs are a necessary factor required to eliminate further issues as a result of water ingress. If left unattended then there will likely result further damage and impact to the fabric of the building.

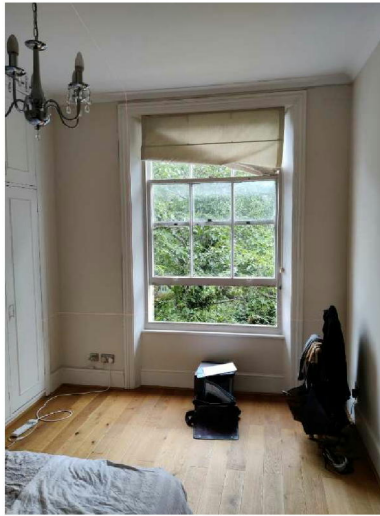
ITEM 2 – FIRST FLOOR REAR NORTH ELEVATION – BEDROOM (MASTER)

This item is a 1 pair of 3 over 3 equal split sashes. No additional repairs are required.

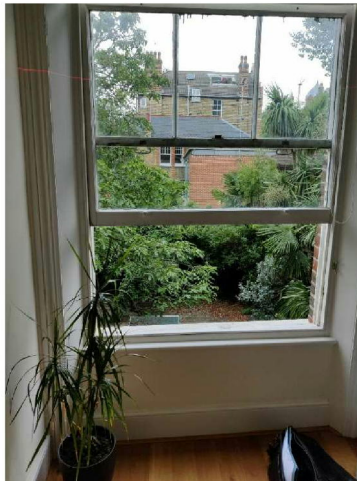
ITEM 3 – FIRST FLOOR REAR NORTH ELEVATION – BEDROOM

This item is a 1 pair of 3 over 3 equal split sashes. No additional repairs are required. It should be noted that the bottom sash of this item is currently one pane, it is the intention to reinstate this as a 3 pane bottom sash to match the original sash design.
