1.83 x 2.4m Georgian Woodford Shed-
Layout C with Georgian style windows
on floating concrete base to avoid tree root
disturbance

Scale @ 1:100

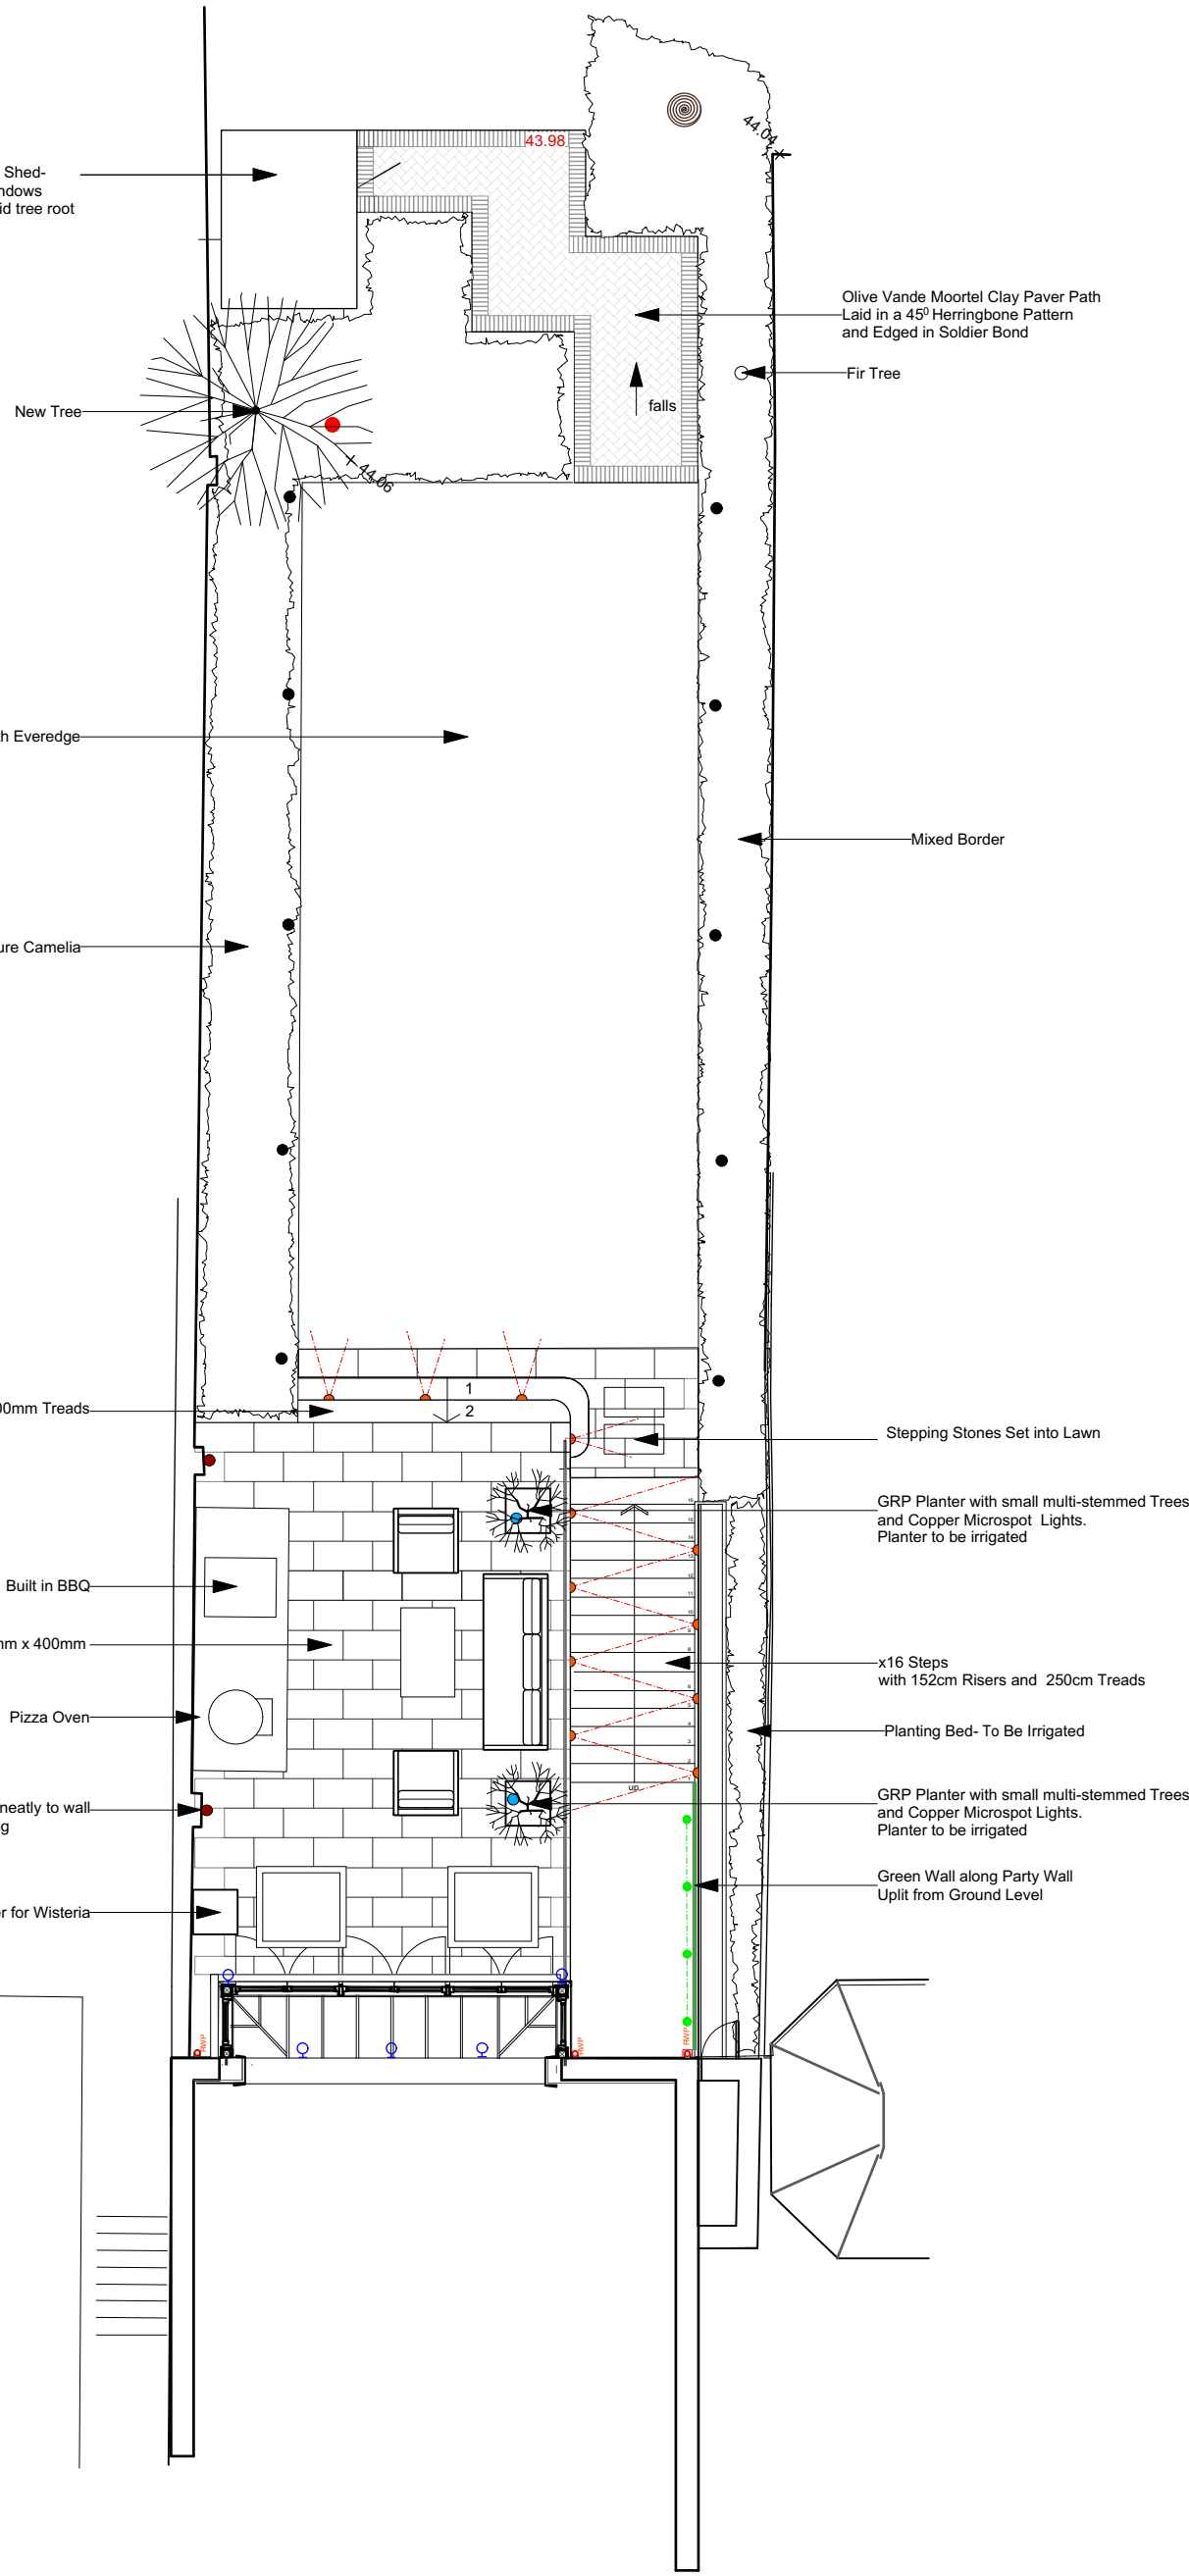
Olive Vande Moortel Clay Paver Path
Laid in a 45° Herringbone Pattern
and Edged in Soldier Bond

Lawn Edged with Everedge

x2 Paved Steps
with 190mm Risers and 300mm Treads

GRP Planter with small multi-stemmed Trees
and Copper Microspot Lights.
Planter to be irrigated

x16 Steps
with 152cm Risers and 250cm Treads

Porcelain Paving -Mandarin Stone - Hendra Creme 800mm x 400mm
laid in a staggered stretcher bond on pedestals

Hendra Creme Porcelain
800mm x 400mm x 20mm

Wires for lighting clipped neatly to wall
or housed in copper piping

Green Wall along Party Wall
Uplift from Ground Level

-     4No. Elipta Taurus Spike Spotlight- 12v- Bronze Finished Brass Body- Fitted with 5w lamp- Warm White
-     Light Visuals LV-CU802 Spike Light- Solid Copper
-     Collingwood WL220CWBM27 Copper angled Wall Light 40° beam angle
-     Light Visuals LV-CU602R- Solid Copper Round Eyelid Step Light Centres positioned 400mm above step treads
-     13No. Elipta Compact Spike Spotlight- Black- 12v MR16 Lamps- Warm White. 5w for trees and 3W for flowerbeds
-     LuxR Modux Two Wall Washer in Copper Set into Paving. Distance from wall will be dependant on depth of green wall planting
