STORY CONTRACTING LTD

LEC1/9E REGENTS CANAL UNDERBRIDGE

ARBORICULTURAL IMPACT ASSESSMENT

DATE ISSUED: 24/11/2022
JOB NUMBER: GM12516
REPORT NUMBER: 001
VERSION: V1
STATUS: FINAL

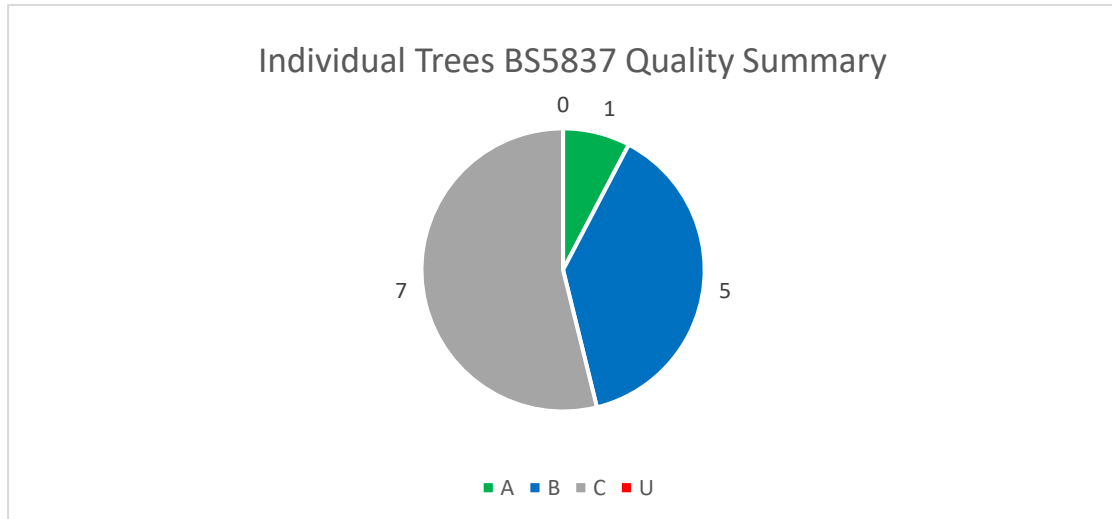
Figure 2: Overview of the BS 5837 quality of individual trees found on Site

- 3.1.4 A detailed description of all trees surveyed and recommended works (irrespective of the proposed development) for these trees can be found in the Tree Survey Schedule in Appendix 1. Table 1 below summarises the BS 5837 quality grading of the trees found on Site, with these figures represented in graph format in Figure 2.

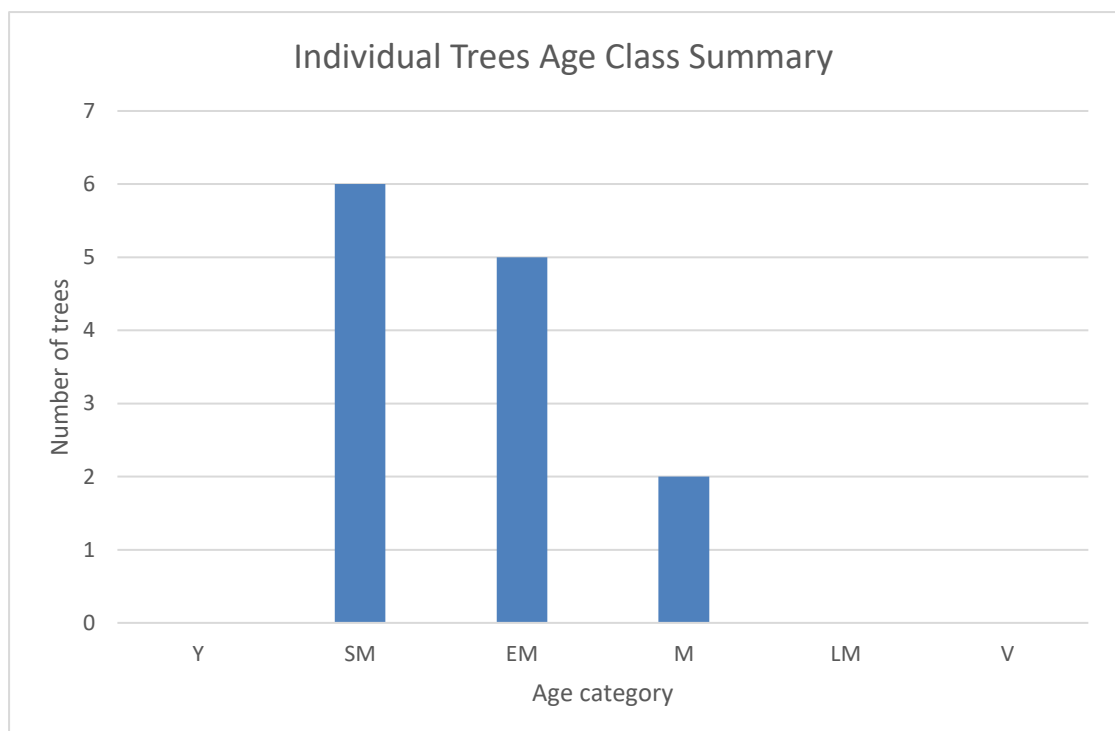
Figure 3: Individual trees age class assessment summary

3.1.5 An assessment of the age class of the individual tree population on Site, reveals that the population is predominantly made up of semi-mature trees, with these accounting for 46% of the population. The remaining individual tree population is made of early-mature trees, accounting for 39% of the population and mature trees accounting for 15% of the population. No young or late-mature individual trees were found during the survey. A summary of the age class assessment for individual trees is shown in the graph below in Figure 3.
