Optera Structural Solutions

Method statement for the installation of a traditional root barrier

POLICY HOLDER ADDRESS: 29 Elsworthy Road, London. NW3 3BT

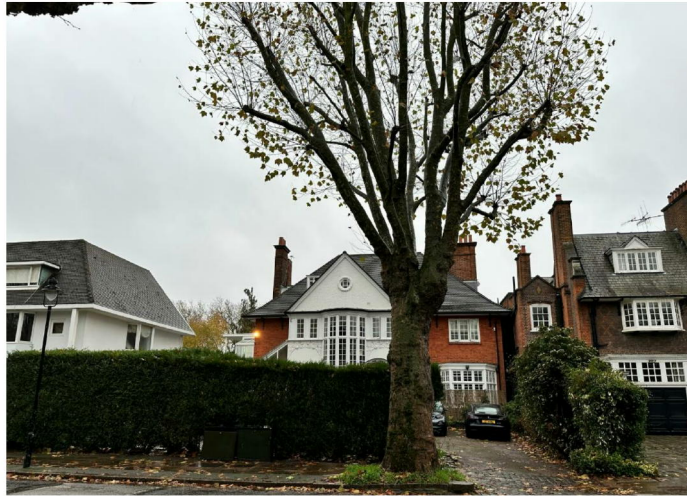
Front elevation of property, Plane tree within footpath.
