**Fitzroy Hotel,
41 Fitzroy Street, Camden.
London. W1T 6DZ**

Design and Access Statement,

**Application for removal of modern
partitions, internal re-arrangement.
Repair and restoration of windows
and front door. Re-instatement of
historical features. Retain existing
hotel use.**

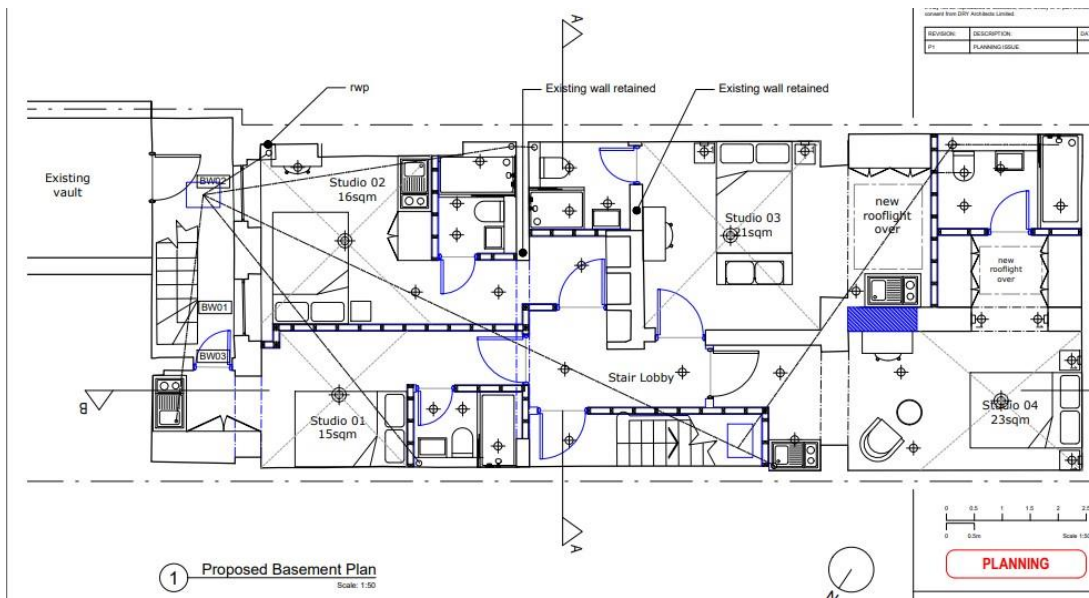
Basement floor

- Brick wine store retained
- Defective plaster removed and replaced
- Bin refuse storage provided in vaults
- Joinery renewed, skirtings and doors reinstated.

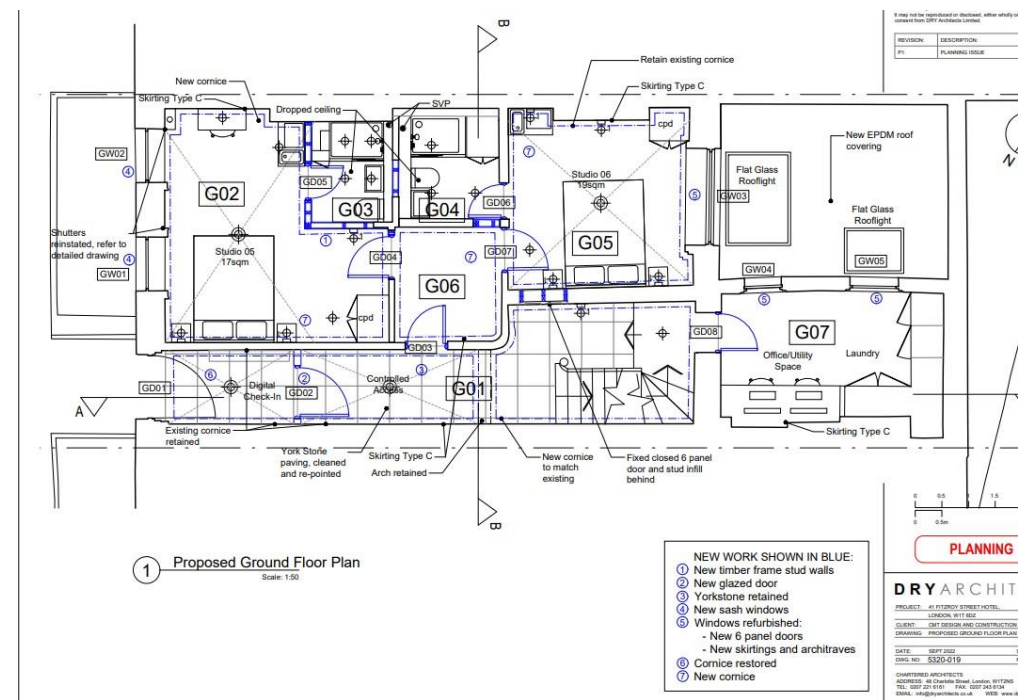
Ground floor

- Removal of C21st century partition walls ,
- reinstatement of historic cornice
- Shutters reinstated to front windows
- Front windows replaced to reinstate original design

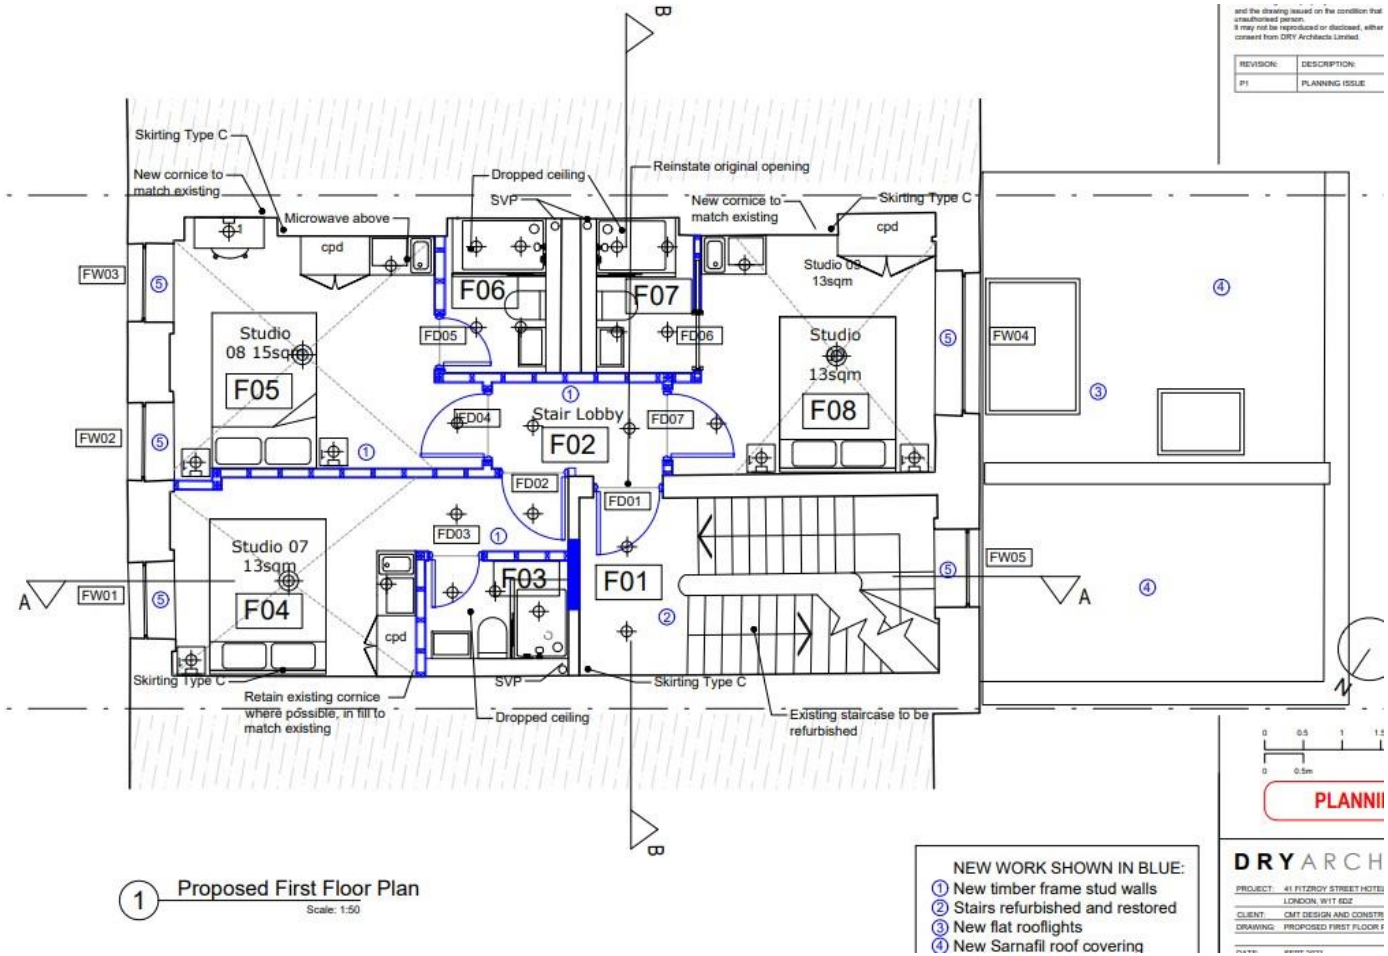
First floor

- Windows restored,
- Cornices reinstated
- Modern partitions reconfigured.
- Main staircase restored
- Six panel doors reinstated

The blocked doorway will be opened giving access from the stair and the existing doorway will be blocked up. The front room will be retained as two rooms as per the existing arrangement, but with a slightly different configuration. This will not entail the loss of historic fabric save for a modest section of wall to create the stair lobby. A downstand will be retained at ceiling level to enable the retention of the cornice which will be retained and repaired. Where sections of cornice are missing, these will be pieced in like for like. The proportions of the spaces at this floor level have already been compromised through the insertion of the corridor and ensuites such that it is considered less sensitive to further change. Internal shutters will be reinstated to the sashes on the front elevation, which is supported as reinstating some significance.

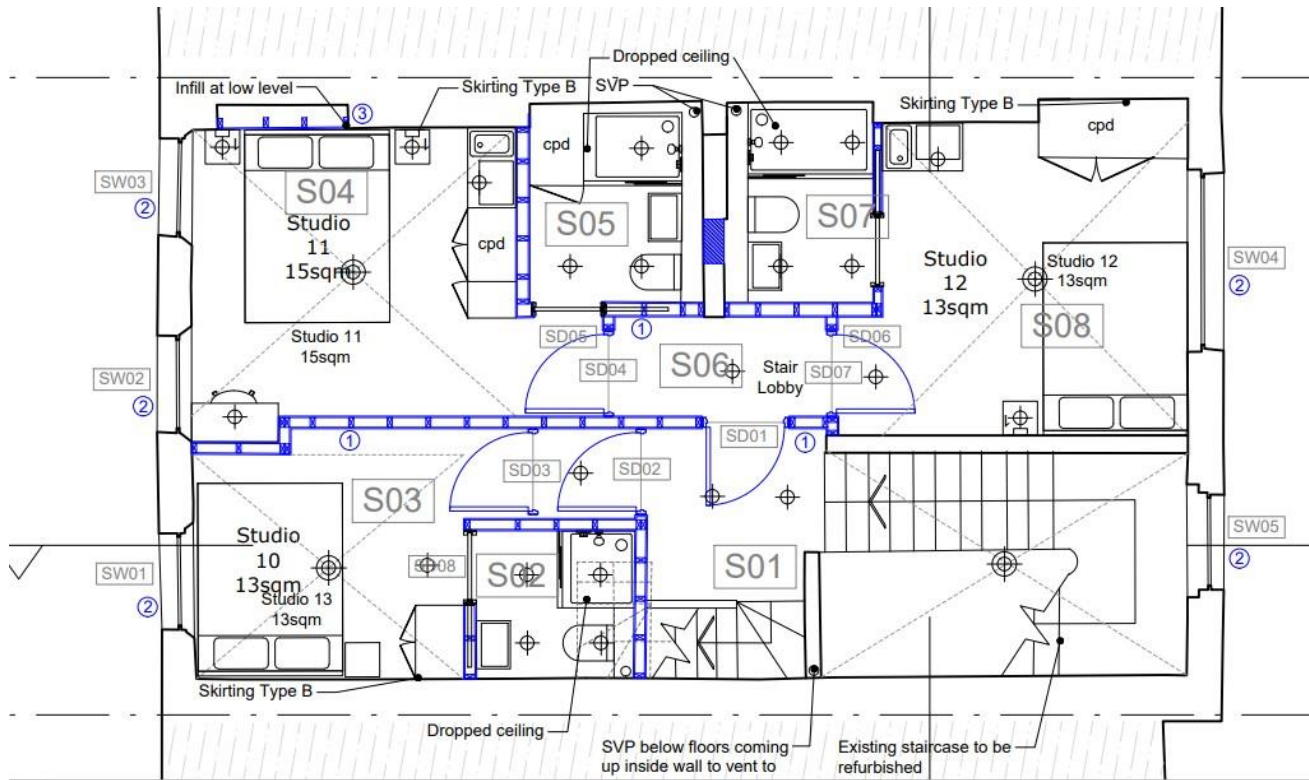
Second floor

- Windows restored,
- Cornices reinstated
- Modern partitions reconfigured.
- Main staircase restored
- Six panel doors reinstated

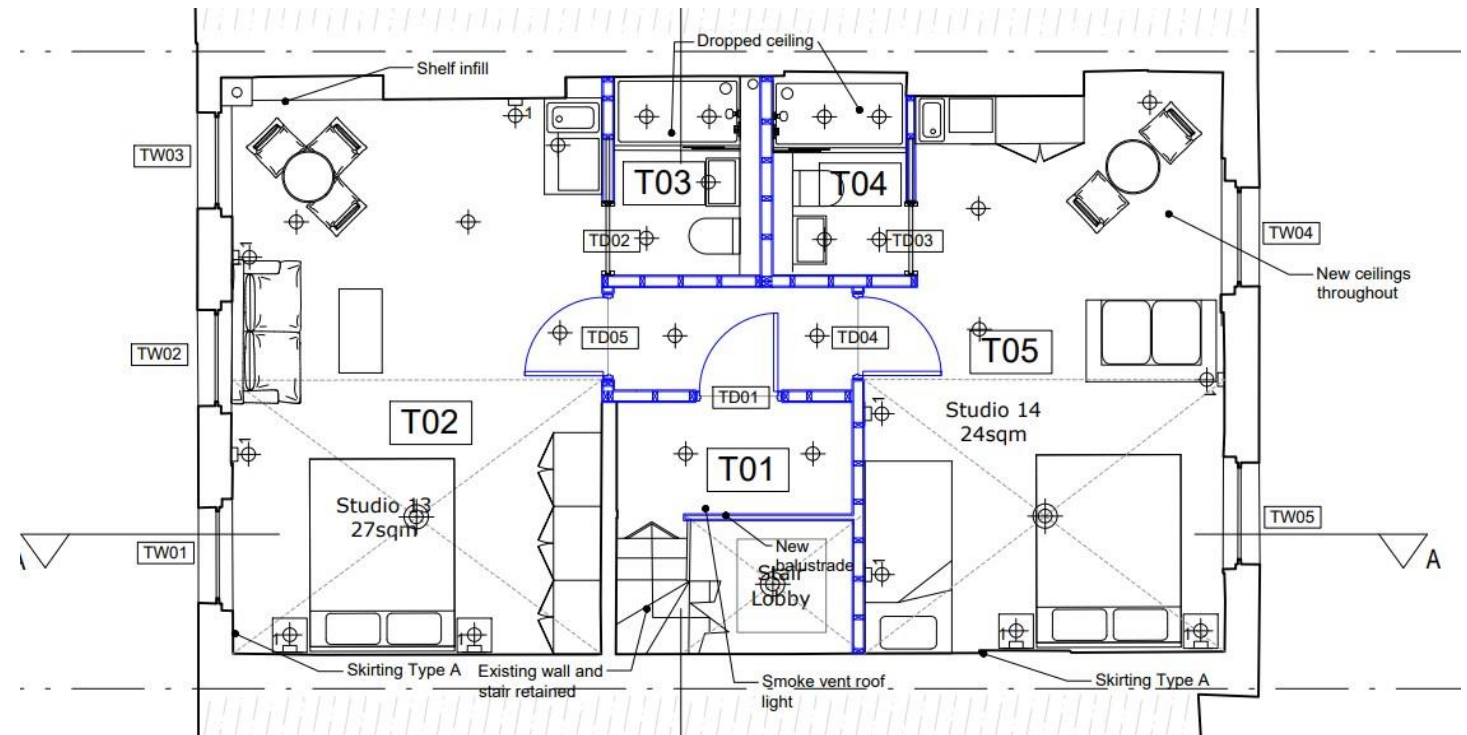
Windows restored,
Cornices reinstated
Modern partitions reconfigured.
Main staircase restored
Six panel doors reinstated

Third floor The third floor is in very poor condition with no surviving historic partitions and areas of ceiling having been lost. The floor will be re-planned to create two larger studios to the front and rear respectively with ensuite bathrooms. Given the extent of loss of historic fabric and plan form, the proposals are not considered to result in any further loss of significance.

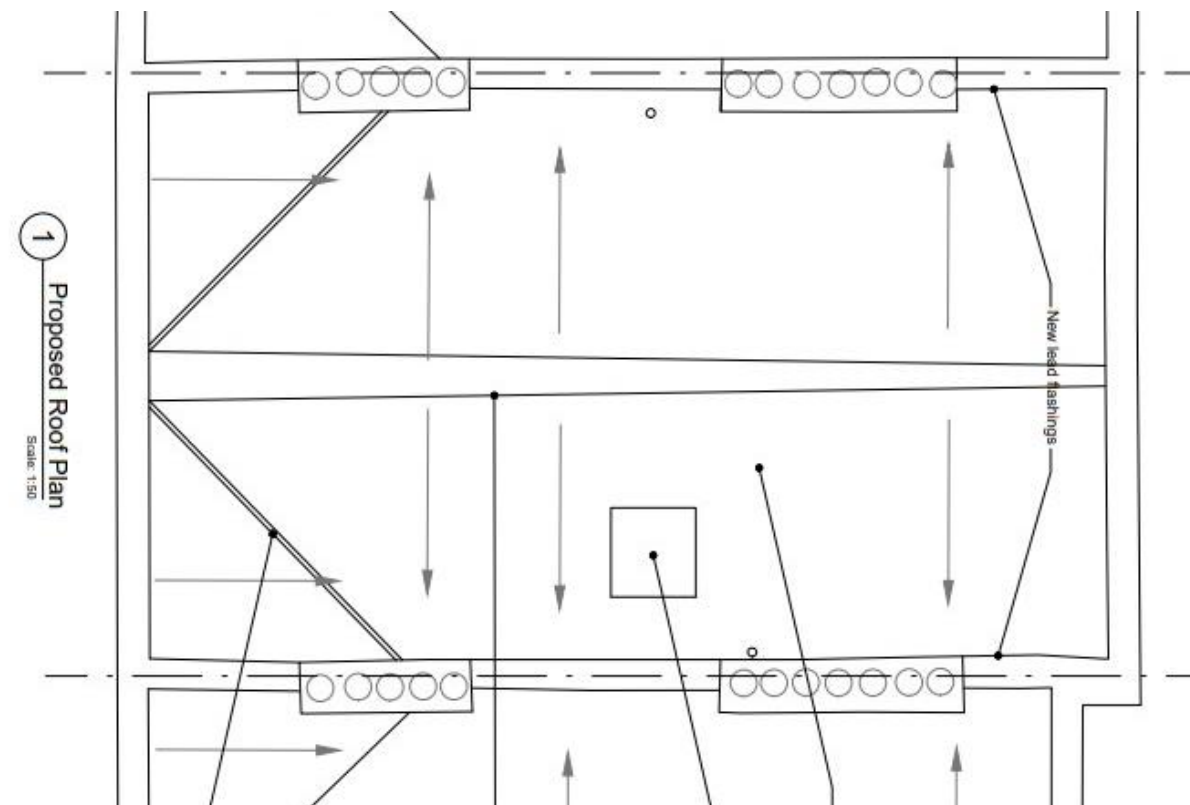
Roof plan

Fire and flood damaged timber replaced like for like ,
roof stripped, reinstated and new lead flashings

The roof is in a derelict state and will be repaired with replacement timbers and natural slates. This is supported, and encouraged as a matter of urgency.

A full structural survey of the roof has been undertaken by a structural engineer (report attached). The main beam that supports the butterfly roof will be retained and the remaining charred and damage roof structure will be re-built, like for like.
