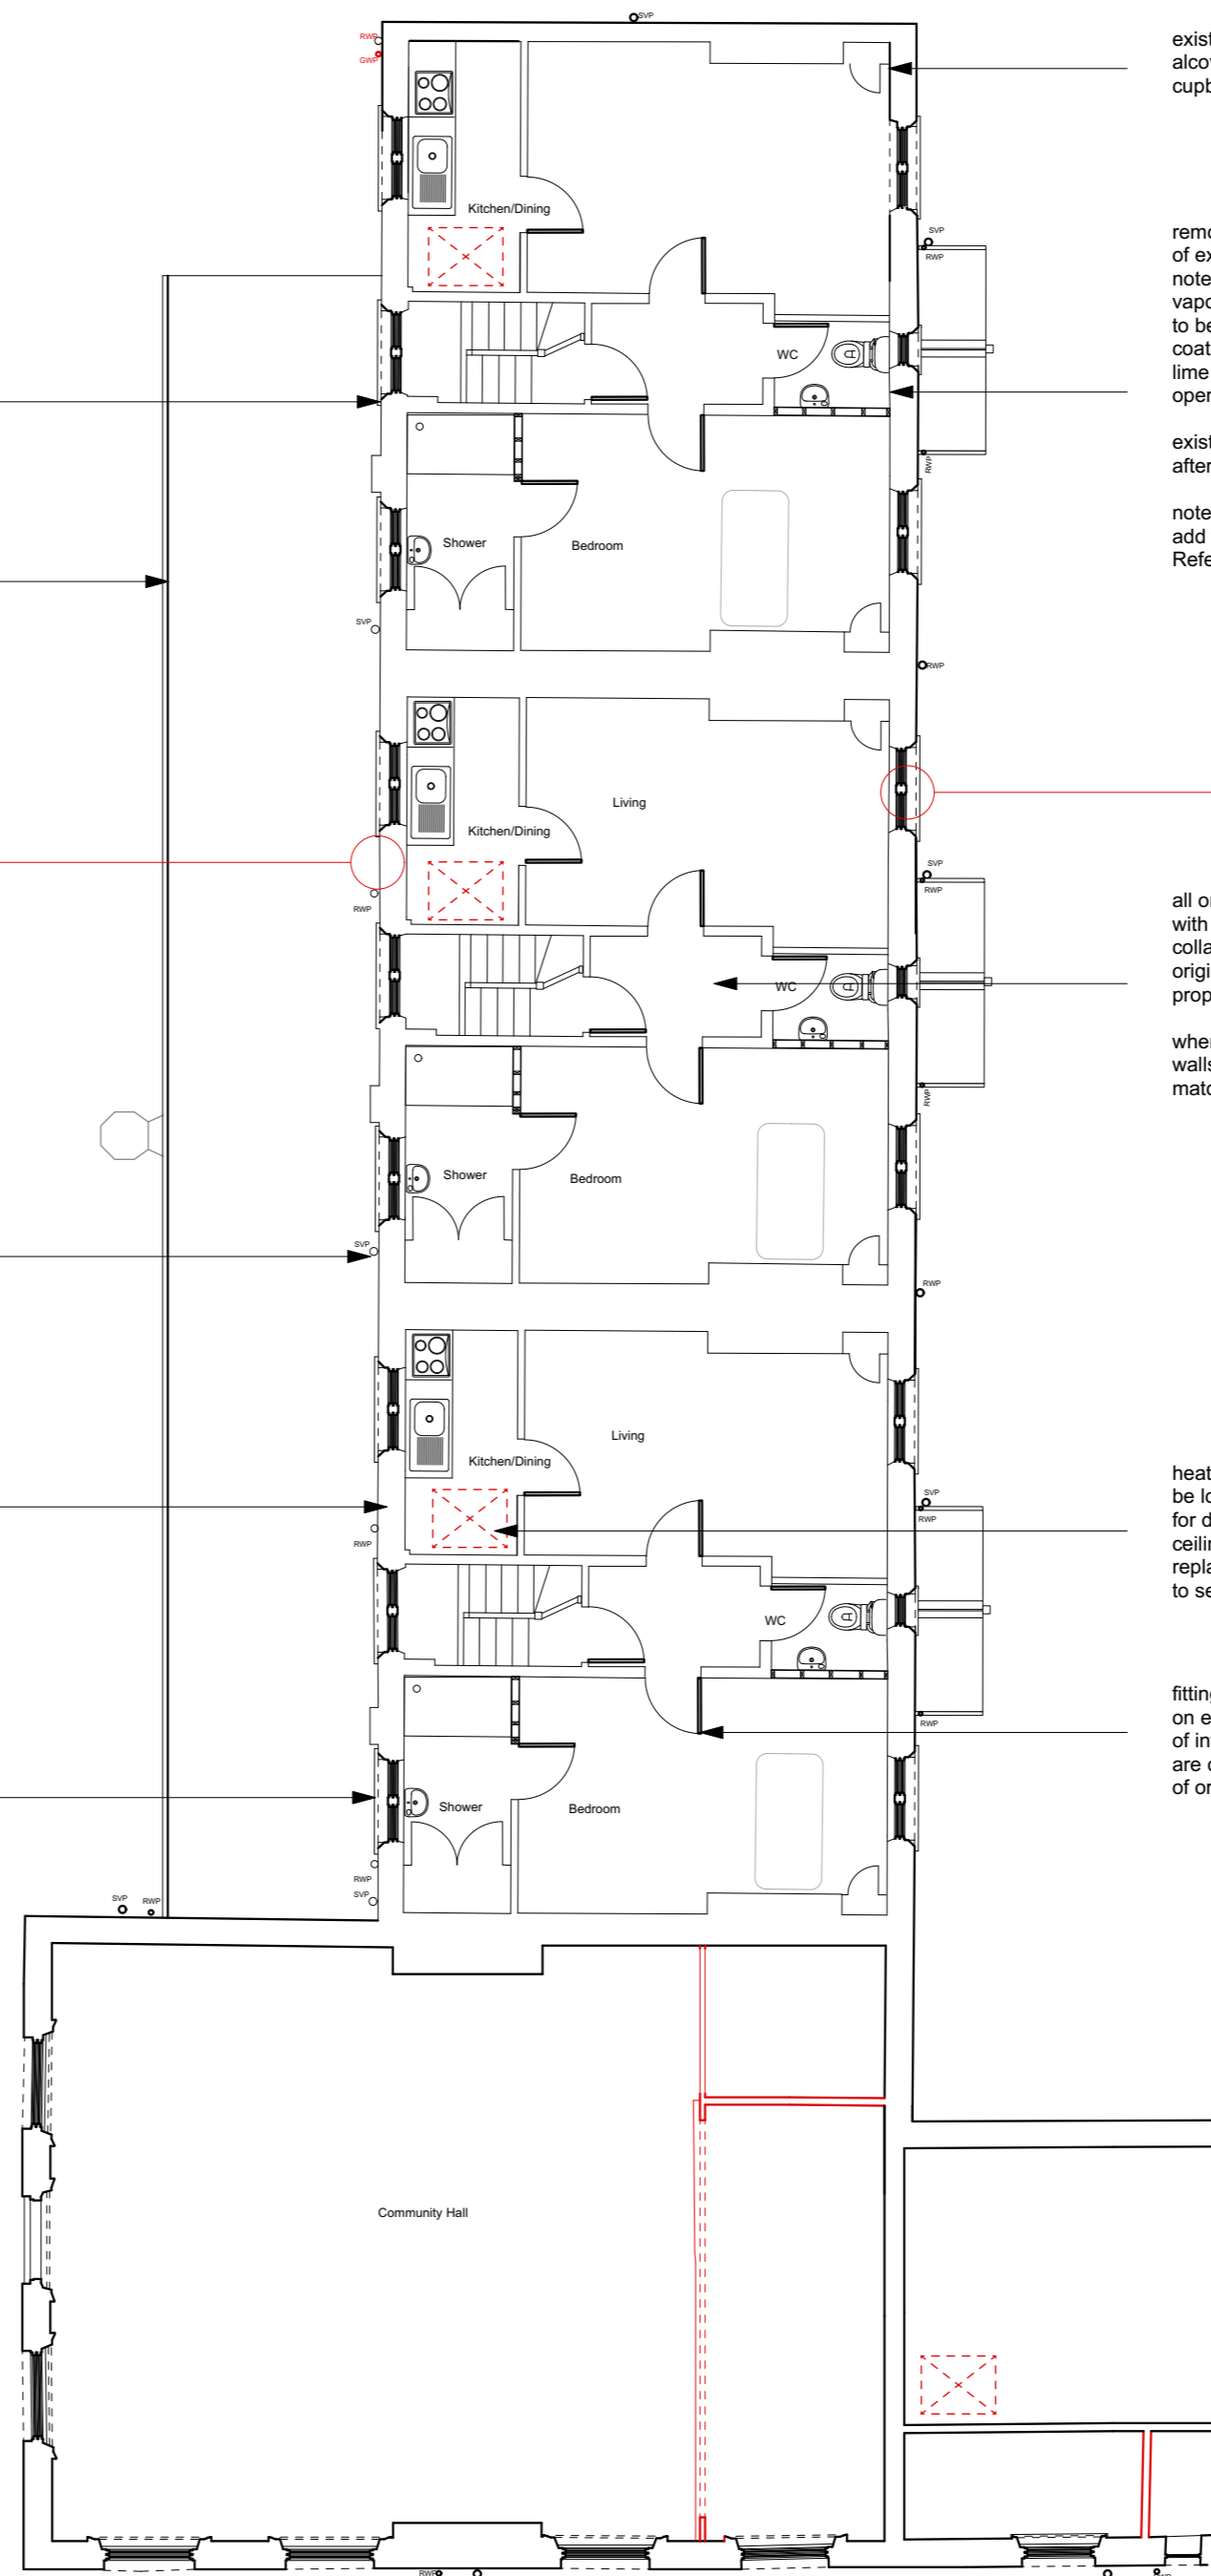
all original ceilings previously replaced with plasterboard following dangerous collapse - only entrance hallways retain original cornice which is unaffected by proposed works.

where replacement cornice runs across walls fitted with IWI the cornice will be matched

heat recovery units and pipework runs to be located within attic space - openings for ducts let into existing plasterboard ceiling - original lime plaster ceilings were replaced previously - intumescent collars to secure fire compartmentation

fitting of underfloor heating overlay system on existing timber floor requires lower edge of internal doors to be raised - all internal doors are contemporary FD30 doorsets so no loss of original fabric occurs
