# AMBASSADORS THEATRE

**Listed Building Consent**

Follow Up Information to Condition 5

# Listed Building Consent Ref. 2022/3599/L Condition 5

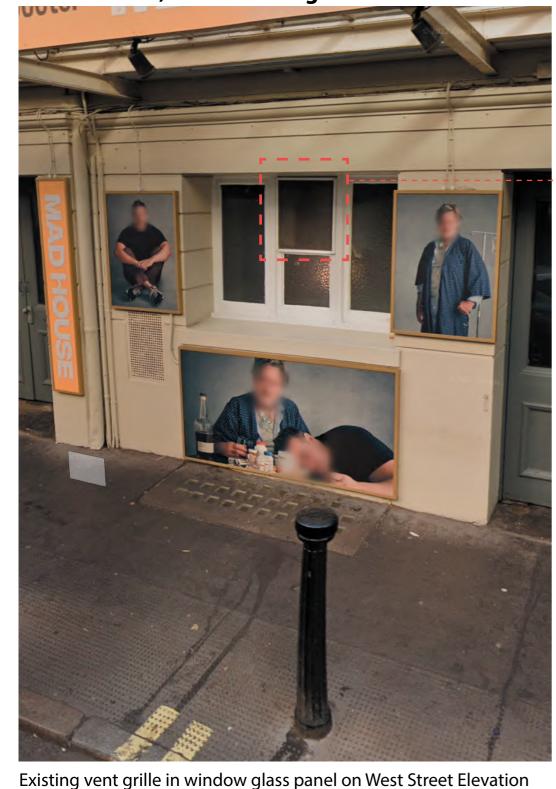
Existing vent grille in window glass panel on West Street Elevation and ductwork behind

It is proposed to reinstate the original window layout by removing the existing vent grille currently mounted on the window glass panel (West Street Elevation) and ductwork behind. The new glass panel will match the existing side glass panels by installing a matching Flemish Pilkington Glass panel or equivalent approved and reinstating the glass beads with matching tim-ber beads.

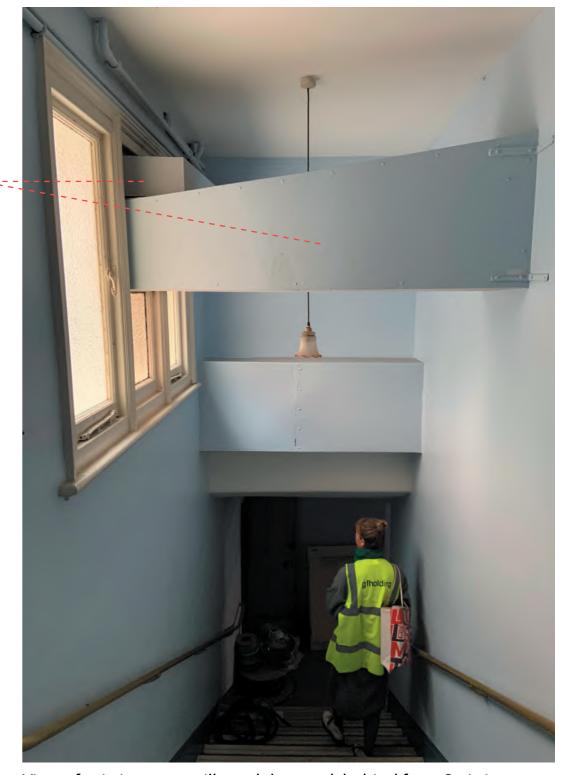
View of existing vent grille and ductwork behind from Stair 2

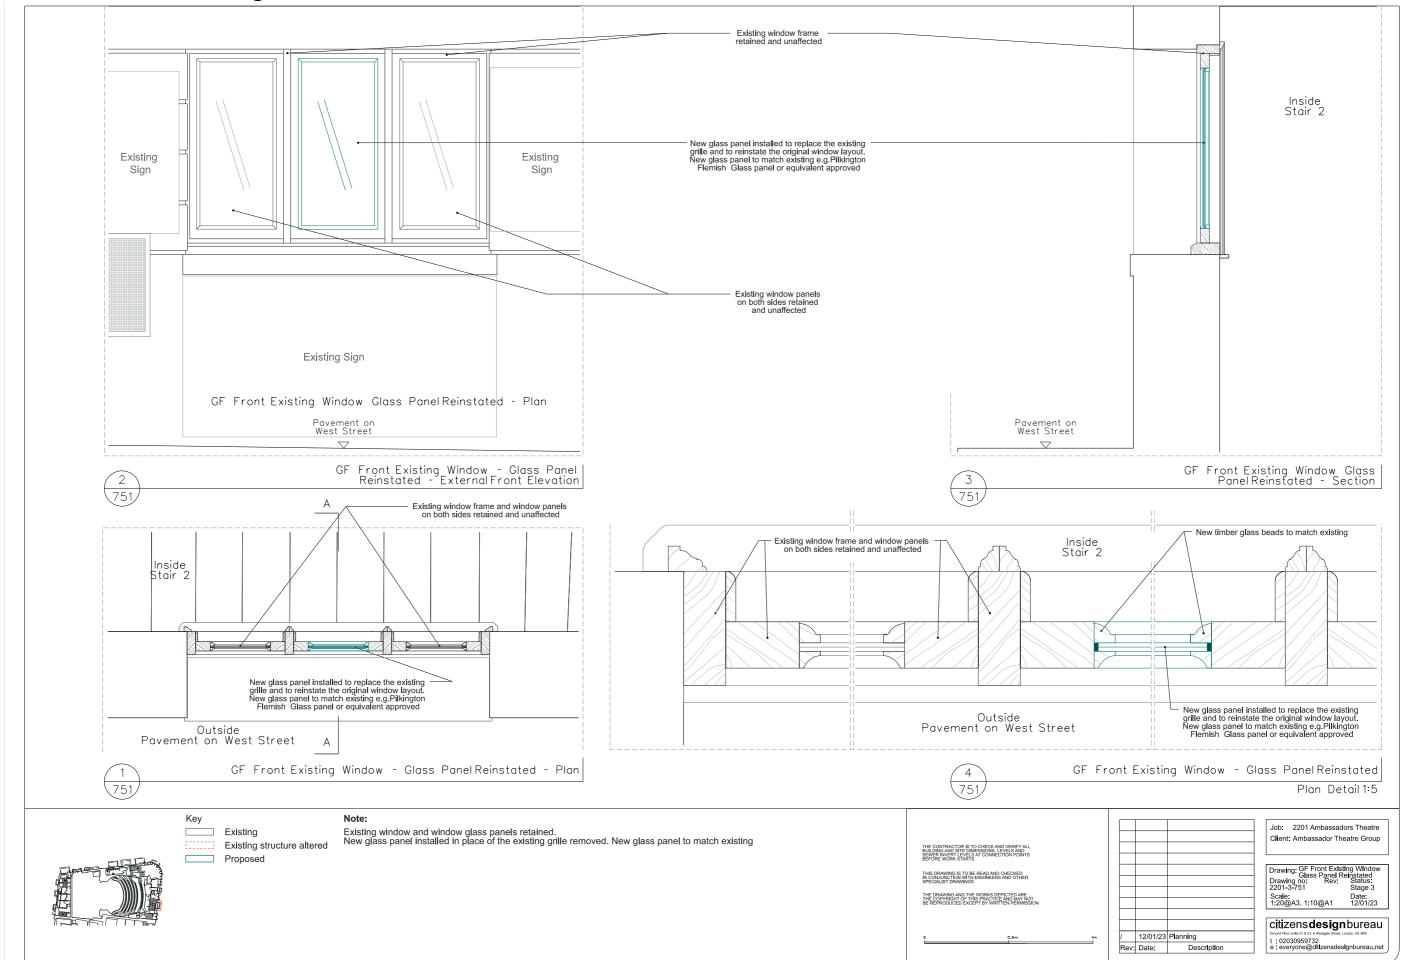
### Ground Floor, Front Existing Window Glass Panel Reinstated, West Street Elevation

The side glass panels and existing window frame will remain unaffected.

See drawings 2201-3-749 and 751

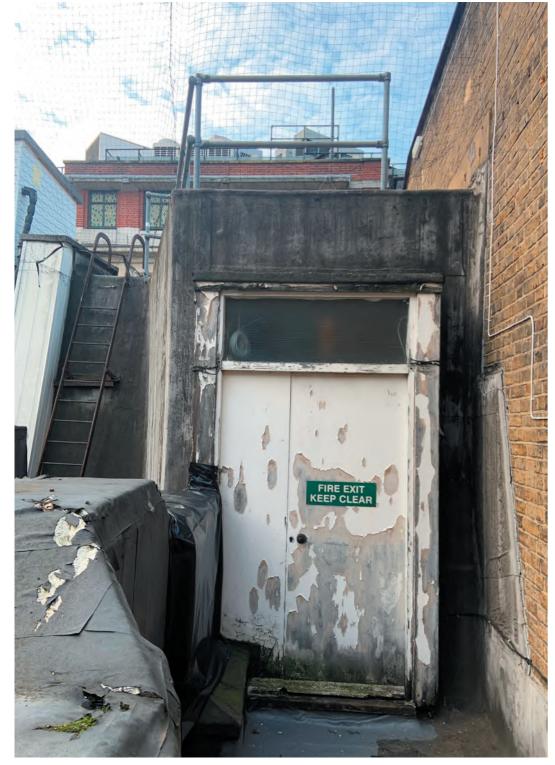
View of the existing dilapidated door from the roof plant outside

The existing fire escape exit door S-D01 is currently in extremely poor condition, visibly rotten at the bottom and sides. The door surrounds are also in poor condition and rotten in parts. This fire

escape door is also missing any ironmongery required by a fire escape door, including any emergency fire exit sign, which will need to be incorporated in the new door design.

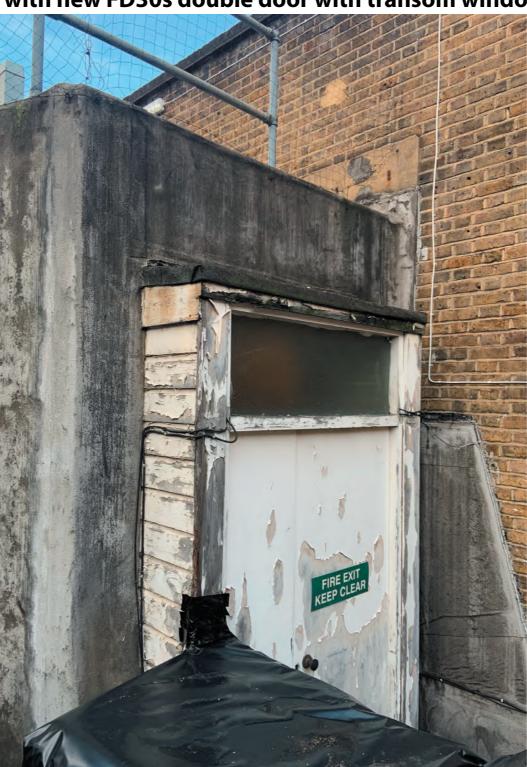
View of the existing door cladding details to be replicated in the new door surrounds

It is proposed to install a new FD30s double door and surrounds matching the existing timber cladding details and structural door opening dimensions.

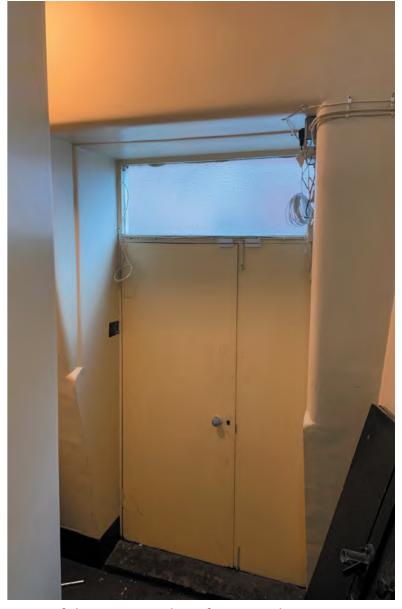
View of the existing door from inside Stair 6

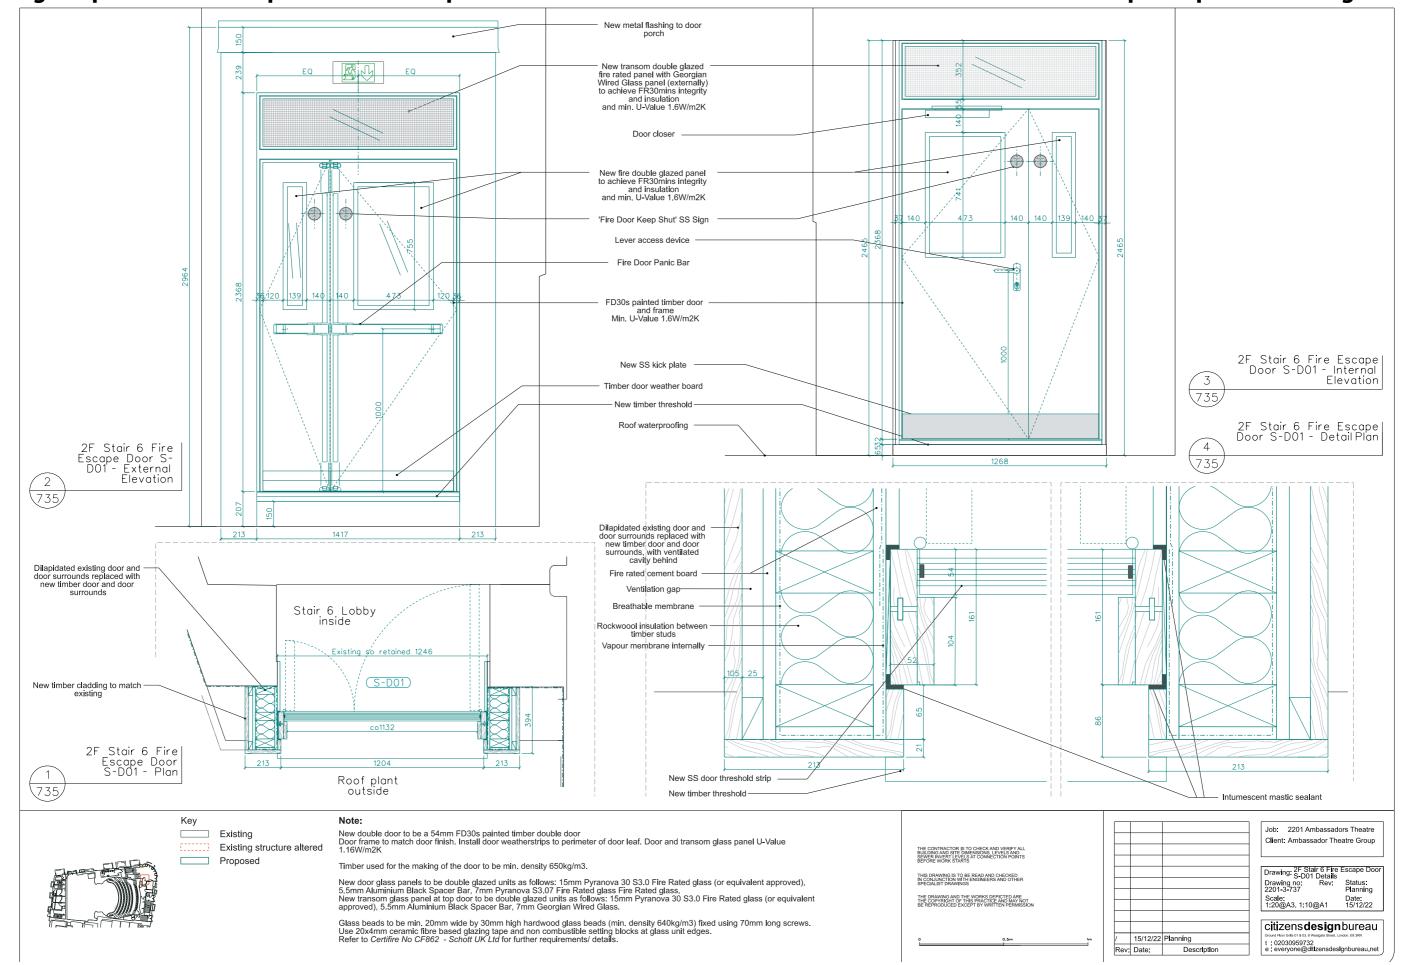
## Existing dilapidated fire escape door S-D01 replaced with new FD30s double door with transom windows at top - Proposed drawing

See drawing 2201-3-735 for proposed S-D01 door details.

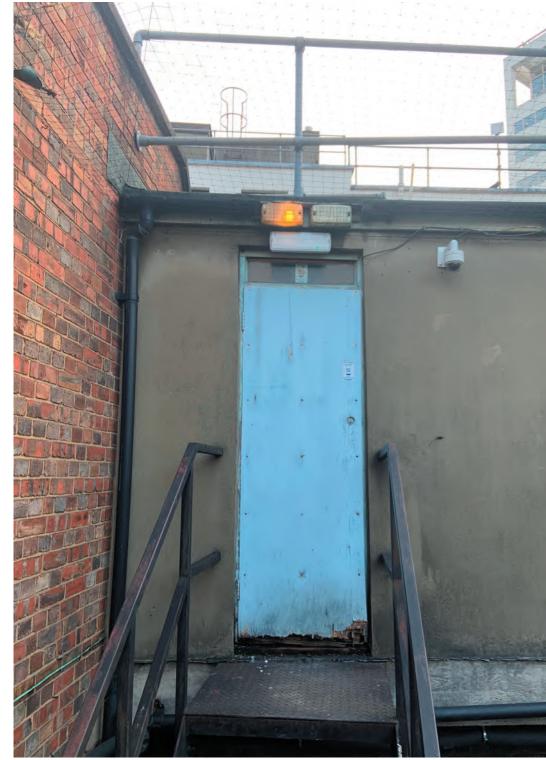
View of the existing dilapidated door from the roof plant outside

The existing door S-D02 is currently in extremely poor condition, visibly rotten at the bottom. This door provides a secondary fire escape route to the 2F office area, externally via the roof and into Stair 6 via S-d01 door described above. This fire escape door is missing any ironmongery required by a fire escape door, which will need to be incorporated in the new door design. It is proposed to install a new FD30s double door to matching the existing structural door opening dimensions.

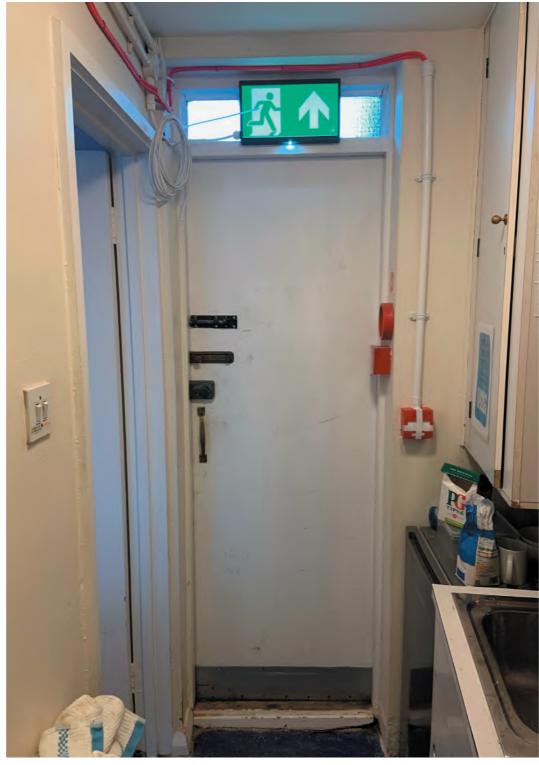
View of the existing door from the 2F office kitchenette inside

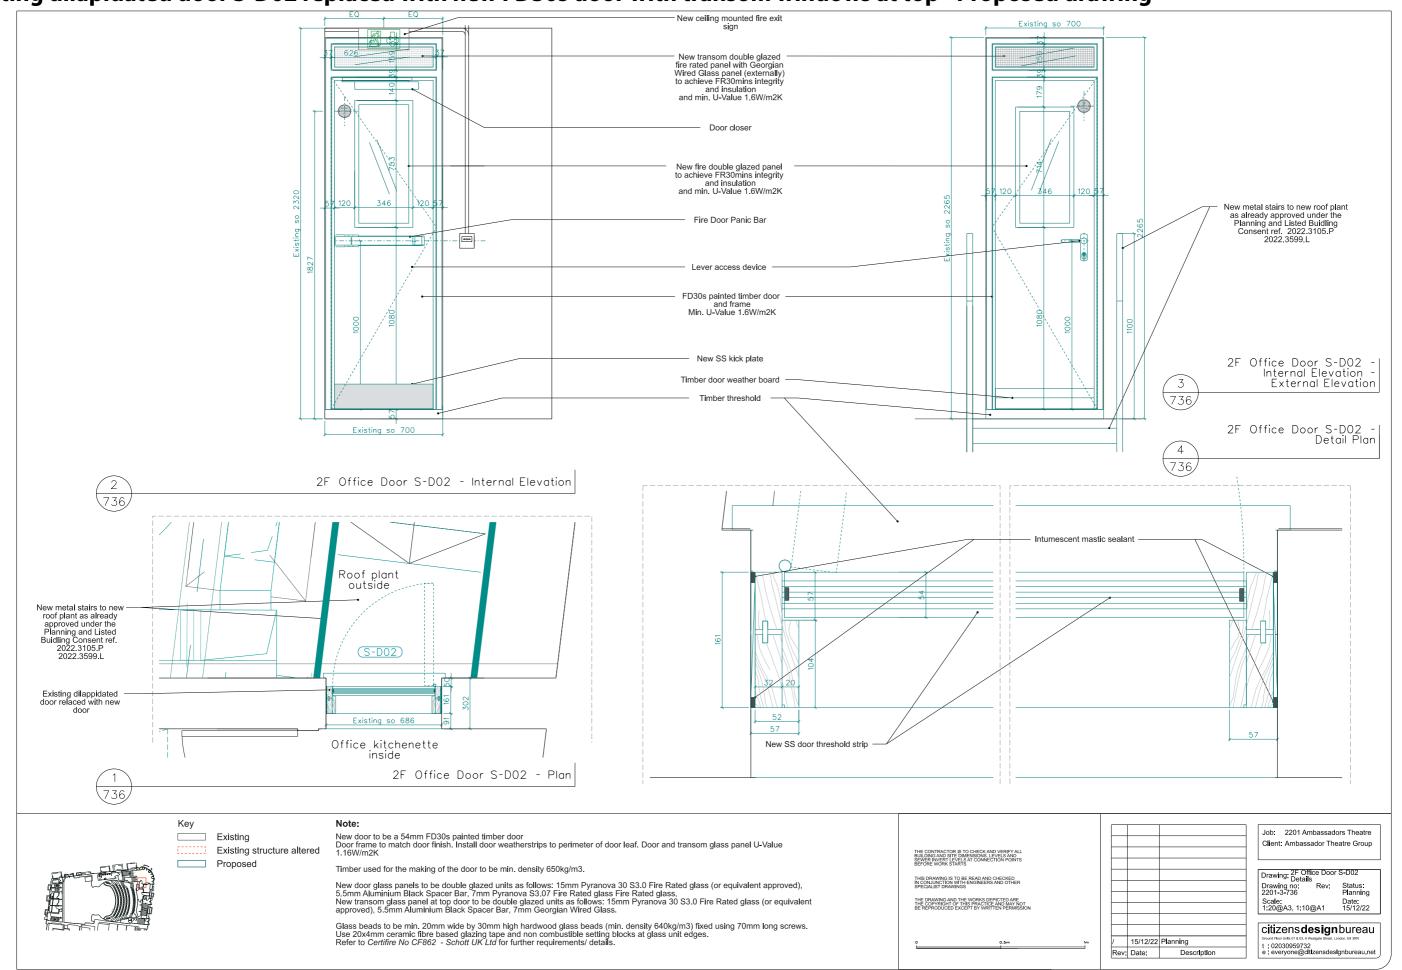
### Existing dilapidated door S-D02 replaced with new FD30s door with transom windows at top - Proposed drawing

See drawing 2201-3-736 for proposed S-D02 door details.

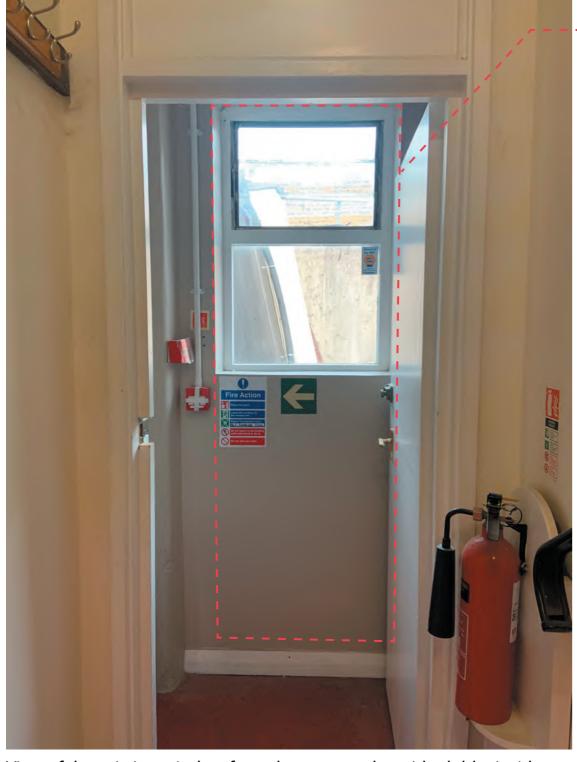
To form the new FD30s door it is proposed to extend the existing window cill without affecting the existing window width and height at top.

View of the existing window from the protected corridor lobby inside

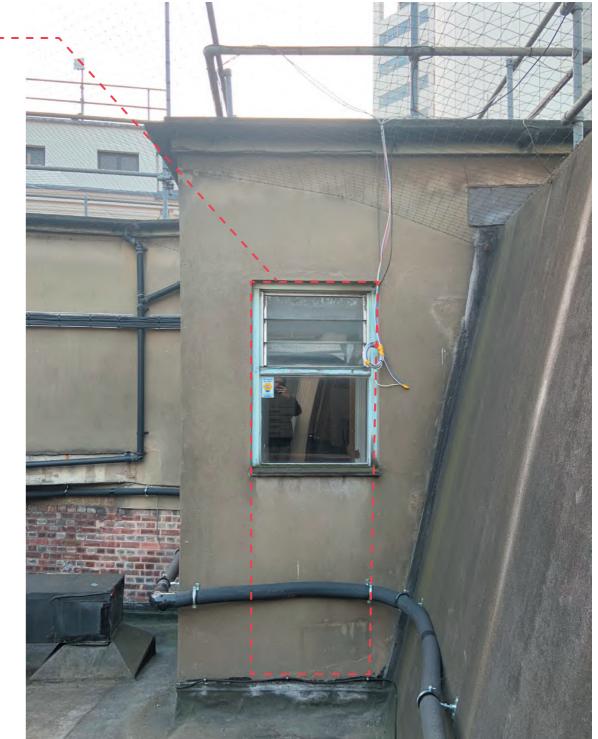
View of the existing window from the roof plant outside

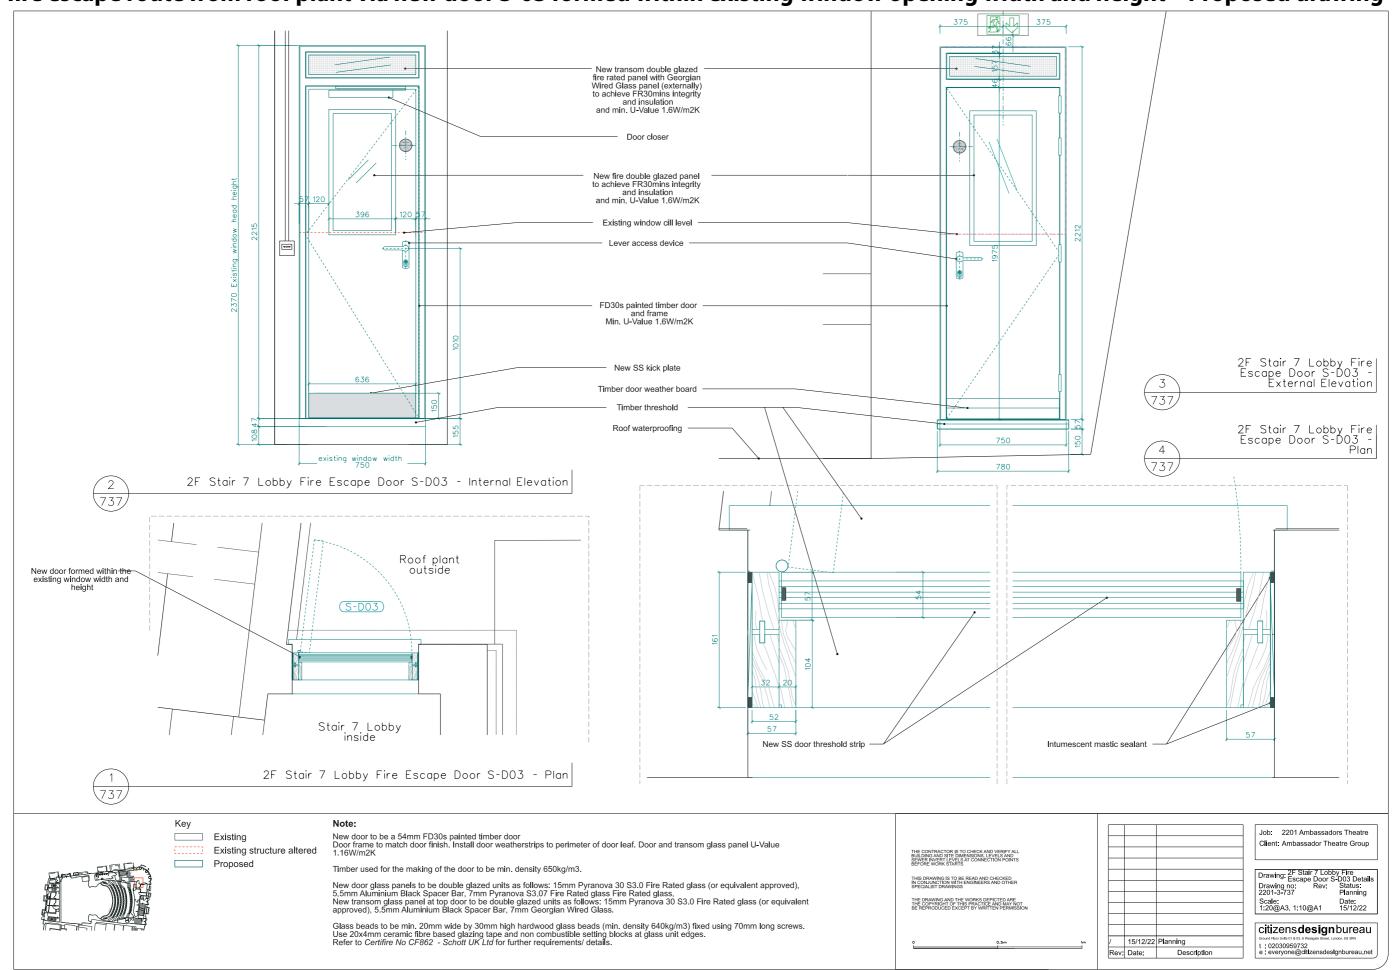
New fire escape route from roof plant via new door S-03 formed within existing window opening width and height - Proposed drawing

The existing roof plant has currently 2no fire escape exit doors. One of the two (S-D02) opens into a kitchenette and office spaces without providing direct access to any fire protected corridor and should therefore be discarded as fire exit at 2F level as not compliant with the Building Control requirements.

It is proposed to install a new FD30s fire rated door, as require by the Fire Engineer (FireTec), to provide an new fire escape route able to give direct access to a protected fire escape corridor/ lobby from the new roof plant. It is proposed to form this new fire escape door S-03 by extending the existing window cill without affecting the existing window width and height at top. See drawing 2201-3-737 for proposed S-D03 door details.
