## SITE INVESTIGATION FACTUAL REPORT

Report No: [REDACTED]  
Client: Sedgwick International UK - Morley (Leeds)  
Site: 45 Gondar Gardens  
Client Ref: [REDACTED]  
Date of Visit: 13/05/2019

Home Emergency Response - Subsidence Investigation - Drainage Services – Crack & Level Monitoring – Property Video Surveys

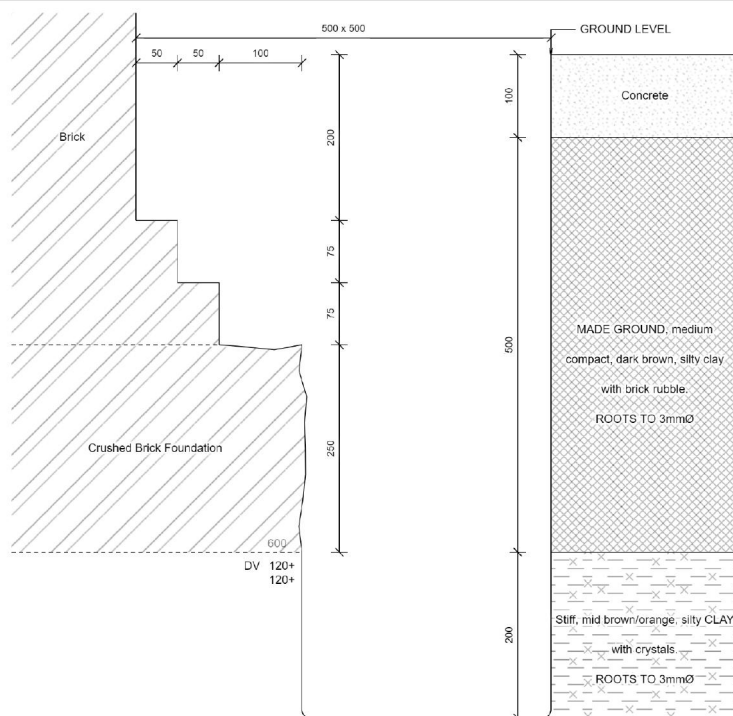
TEST REPORT: Trial Pit

EXCAVATION METHOD: Hand tools

For Strata below 800mm see Bore Hole log

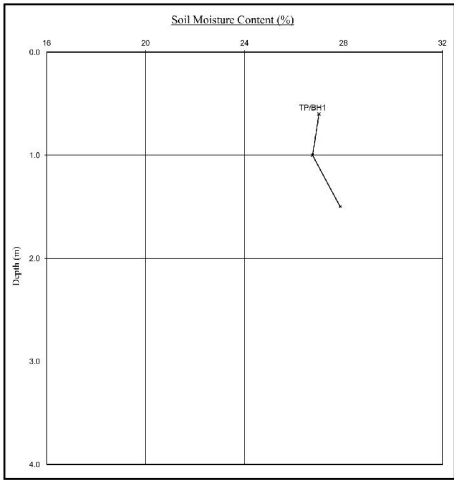
Moisture Content Profiles

Notes:  
1. If plotted, 0.4 LL and PI -2 (after Driscoll, 1983) should only be applied to London Clay (and similarly overconsolidated clay) at shallow depths.  
2. Unless specifically noted the profiles have not been related to a site datum.

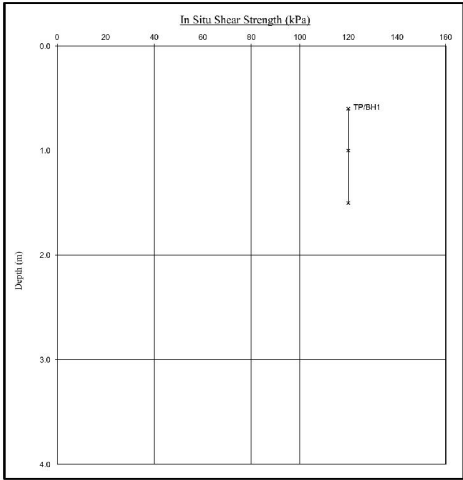
Shear Strength Profiles

Note:  
1. Unless otherwise stated, values of Shear Strength were determined in situ by CPT using a Pkane Hand Vane the calibration of which is limited to a maximum reading of 120 kPa.  
2. Unless specifically noted the profiles have not been related to a site datum.

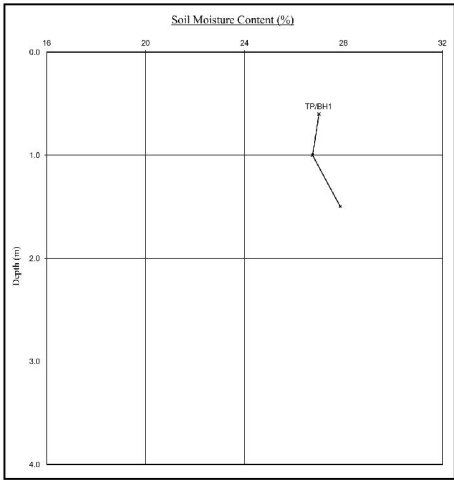
Moisture Content Profiles

Notes:  
1. If plotted, 0.4 LL and PI = 2 (after Driscoll, 1983) should only be applied to London Clay (and similarly overconsolidated clay) at shallow depths.  
2. Unless specifically noted the profiles have not been related to a site datum.

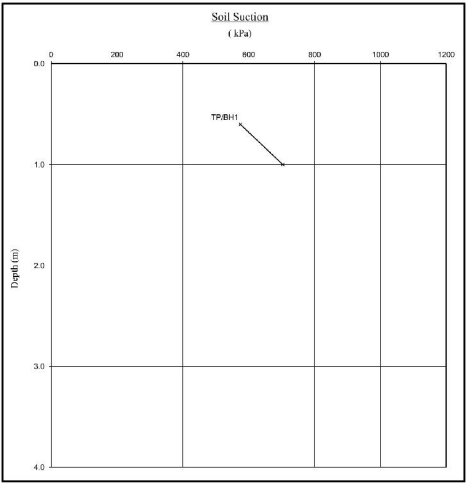
Soil Suction Profiles

Note:  
When shown, the theoretical equilibrium suction profiles are based on conventional assumptions associated with London Clay (and similarly overconsolidated clays) at shallow depths. Note that the sample disturbance component is dependent on the method of sampling and any subsequent recompaction. The above plots show this to be 100kPa which is the value suggested by the BS7 on the basis of their limited number of tests on recompacted samples. This may or may not be appropriate in this instance and judgement should be exercised.
