INTRODUCTION

1) a single storey rear extension with associated internal reconfiguration

The site is situated in the London borough of Camden and is on the boundary of the South Hampstead Conservation Area which was designated in 1988. The subject site is not a listed property but has been identified as a positive contributor to the conservation area.

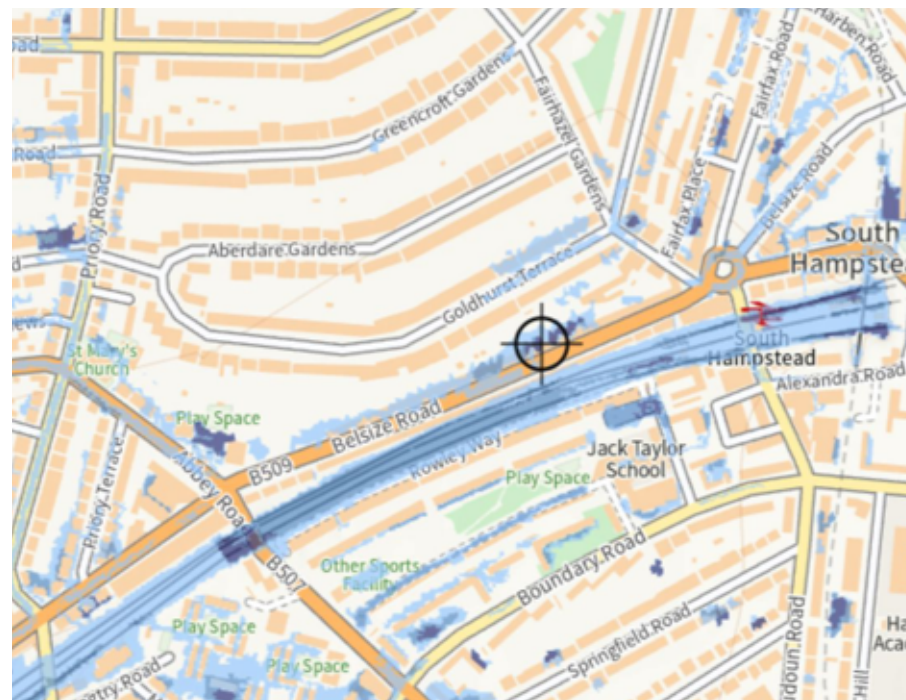
Extract from long term flood risk planning map (gov.uk)

The extract opposite shows the surface water flooding risk of the subject site (high) as well showing that the majority of properties along Belsize Road are also at risk of surface water flooding.

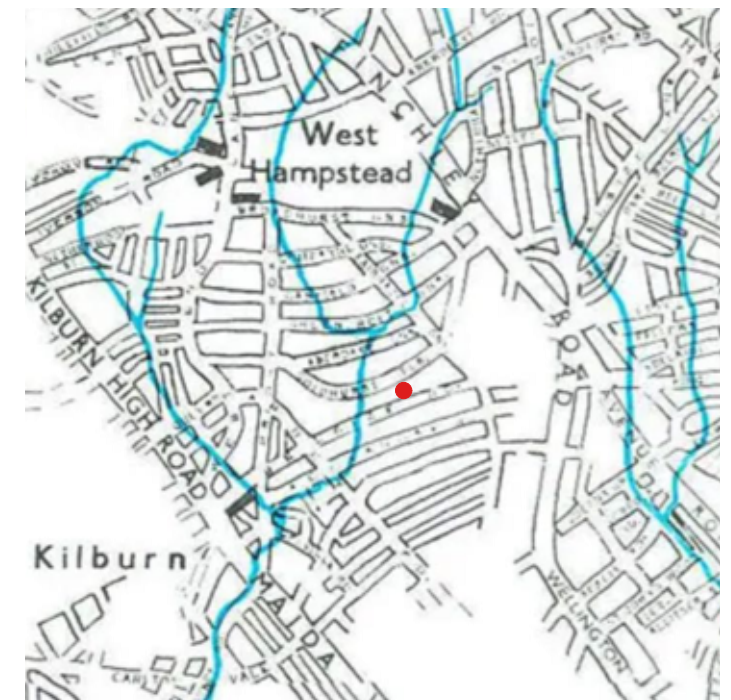
Extract from 'The Lost Rivers of London'

There are no primary, secondary or tertiary rivers identified nearby to the site. 'The Lost Rivers in London' by Nicholas Barton and Camden's Local Plan Map 6 show that a historic stream used to flow to the west of the site, further along Belsize Road. There are no known artificial waterbodies in close proximity to the site.

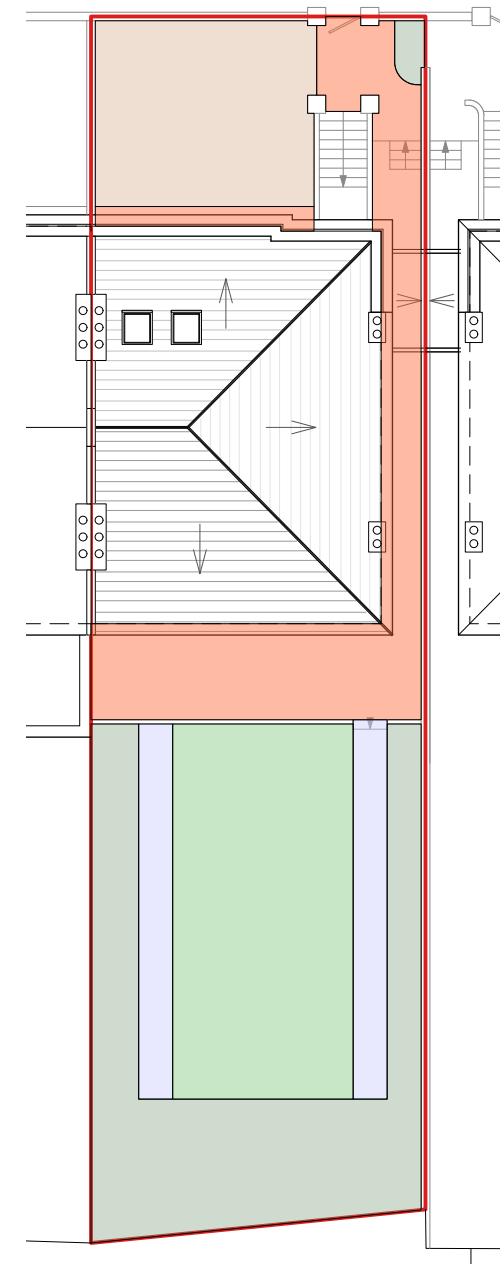
Existing site plan

The site, despite having a very large rear garden is mainly hardstanding. This spans across the front entrance, front lightwell, side access and across the whole rear. In total this is 45.6sqm of hardstanding which is approximately 17% of the site. To improve overall run off rates and to ensure storm water drains slower, permeable paving is proposed along the side access and across the whole rear extension. This reduces the overall hard standing to only approx. 6% of the overall site (a reduction of 11%).

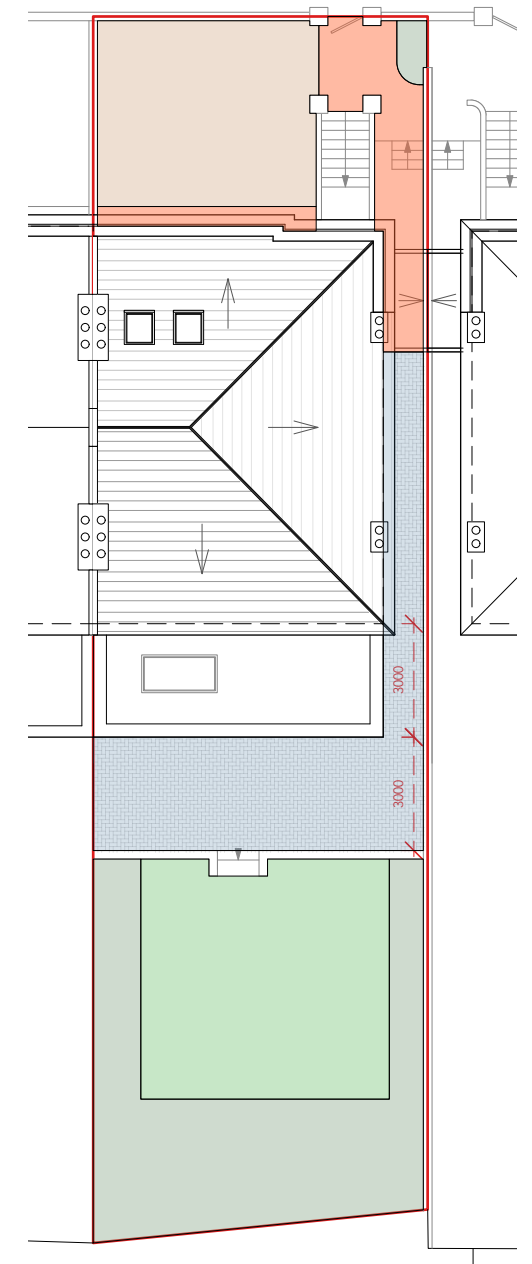
Proposed site plan

In summary, despite there being a rear extension proposed, there is an improvement of surface water drainage with the implementation of permeable paving.

The subject site is located within a high risk of surface water flooding and in one of Camden's Local flood areas. Due to this, a large amount of permeable paving is proposed to replace the majority of the existing hard standing on the site. Using the permeable paving with a subbase to reduce the overall run off rates will positively impact the site and improve the overall surface water drainage.
